Expertise

Protocol number: 46776622  
Order No. / Reference: 26801895  
Inspection date: 28 Jul 2026

Model: E 220 d T 9G-TRONIC Avantgarde

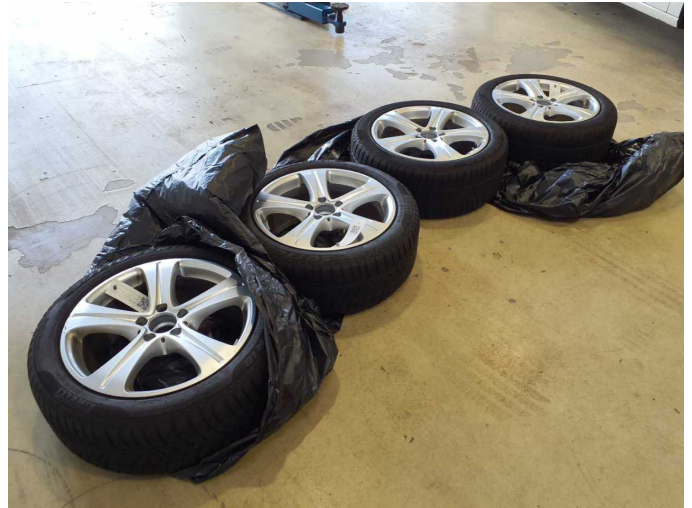
Figure 14: Additional tyres

| No. | Component group | Description |
|---|---|---|
| 4 | 2nd wheel set | 1 tyre - Broken / torn - Replace |
| 5 | 2nd wheel set | 1 tyre - Broken / torn - Replace |
| 8 | 2nd wheel set | 1 alloy rim - Scratch(es) - Replace |

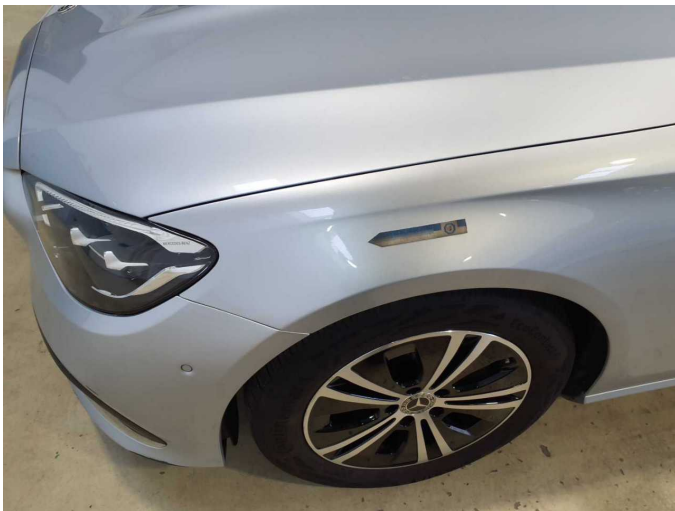
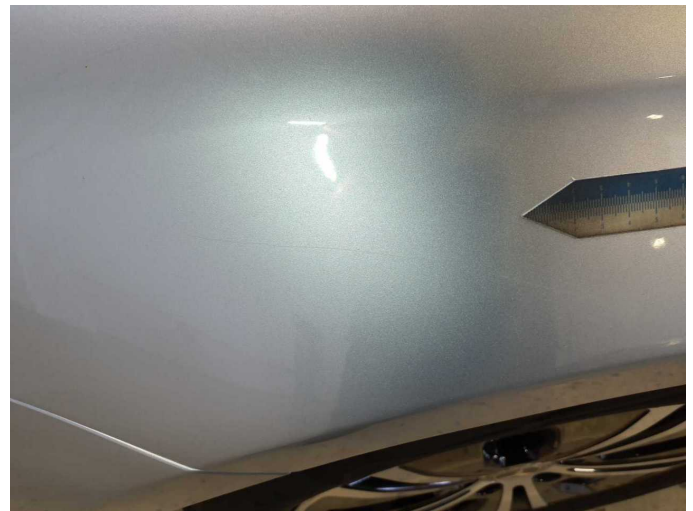
**Damage 1:** Mudguard - left side: Mudguard - left side - Scratch(es) - Smart repair

| No. | Component group | Description |
|---|---|---|
| 1 | Mudguard - left side | Mudguard - left side - Scratch(es) - Smart repair |

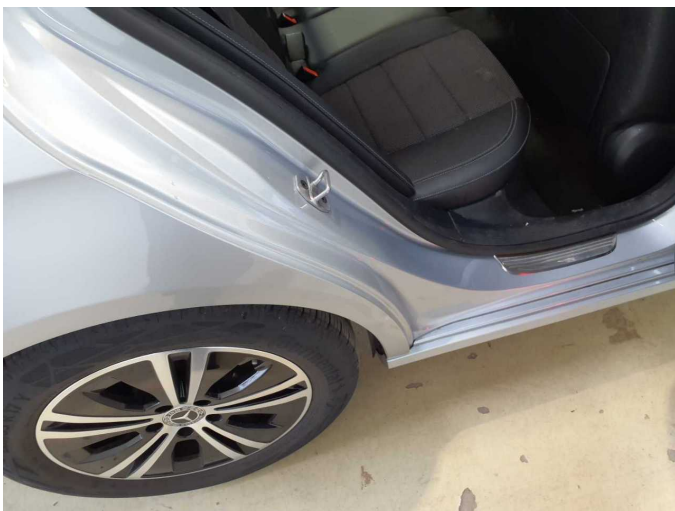
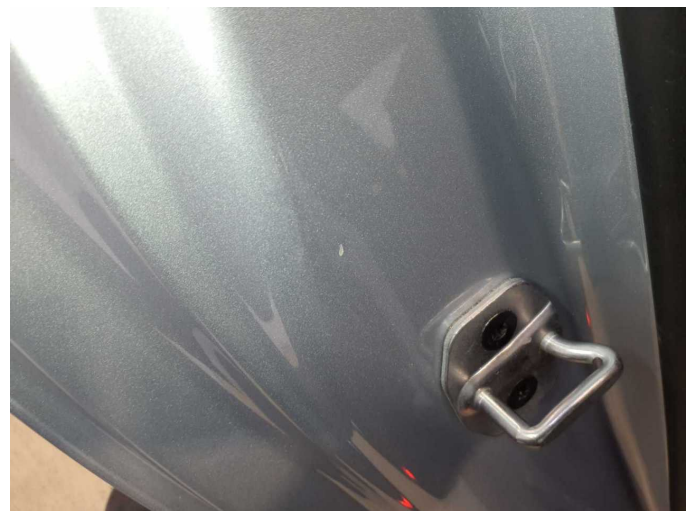
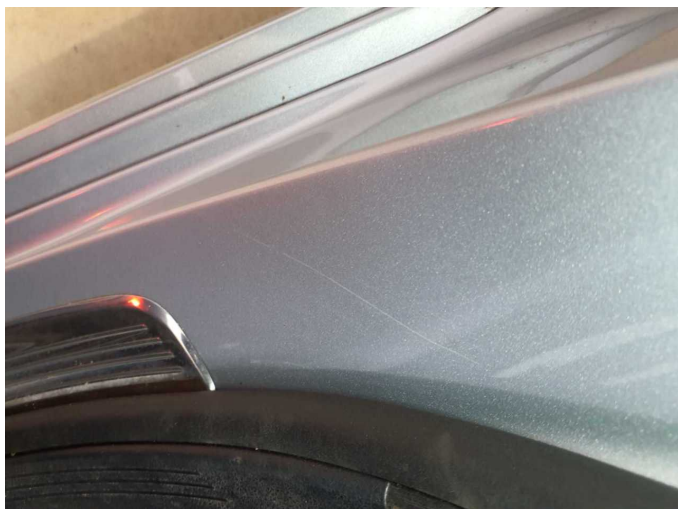
**Damage 2:** Side panel - rear right side: Sill - Dent / paintcoat damage - Smart repair

| No. | Component group | Description |
|---|---|---|
| 2 | Side panel - rear right side | Sill - Dent / paintcoat damage - Smart repair |

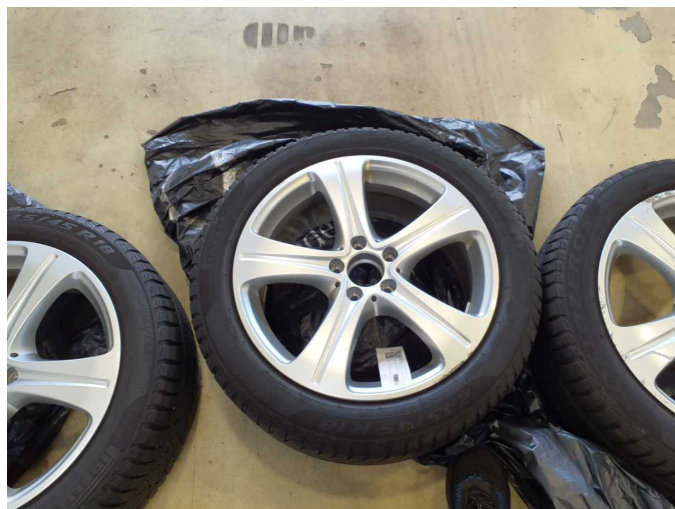
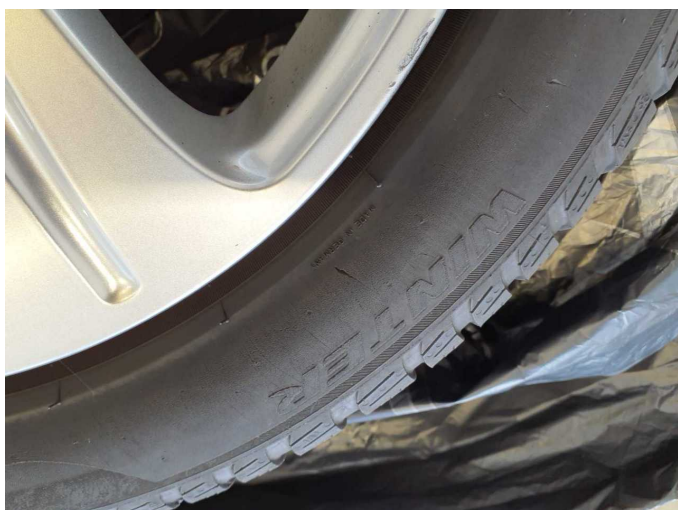
**Damage 4:** 2nd wheel set: 1 tyre - Broken / torn - Replace

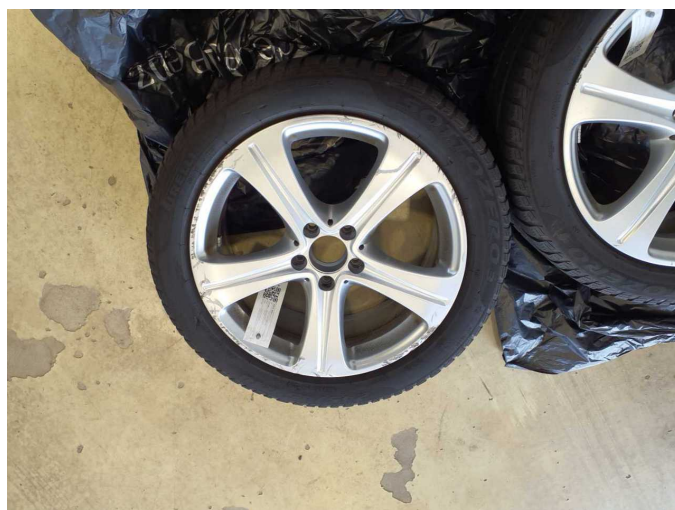
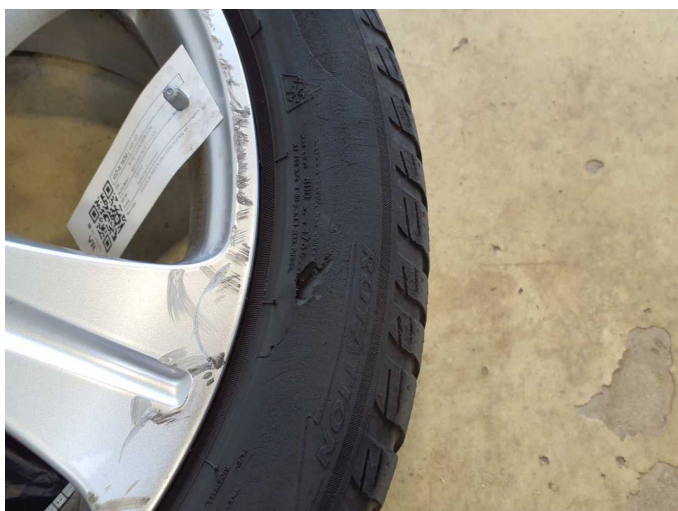
**Damage 5:** 2nd wheel set: 1 tyre - Broken / torn - Replace

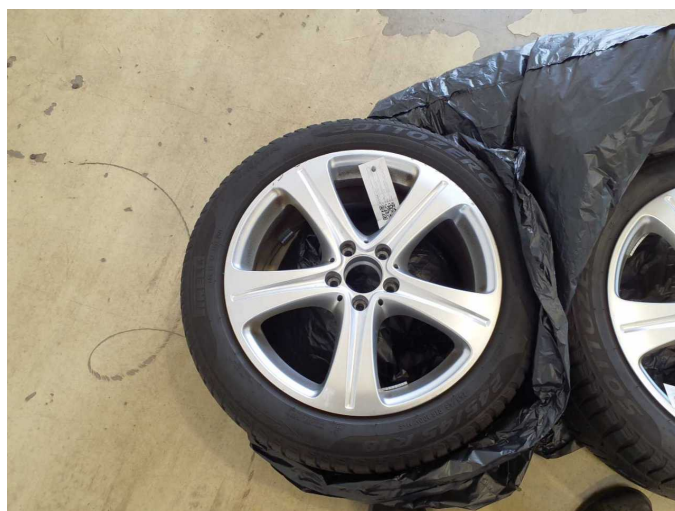
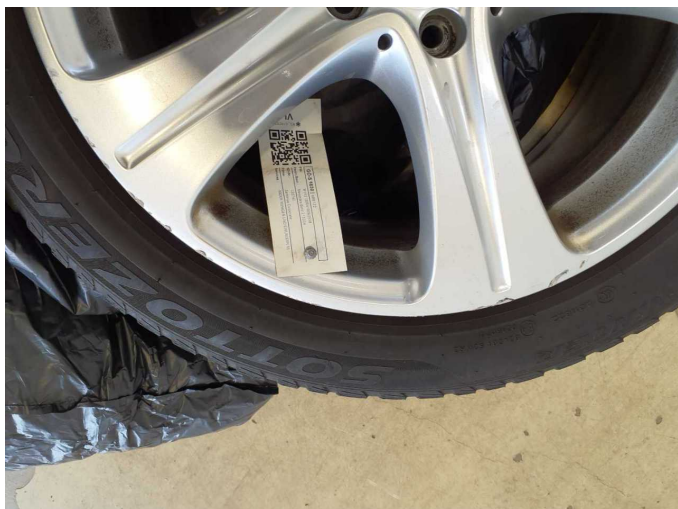
**Damage 6:** 2nd wheel set: 1 alloy rim - Scratch(es) - Loss in value

| No. | Component group | Description |
|---|---|---|
| 6 | 2nd wheel set | 1 alloy rim - Scratch(es) - Loss in value |

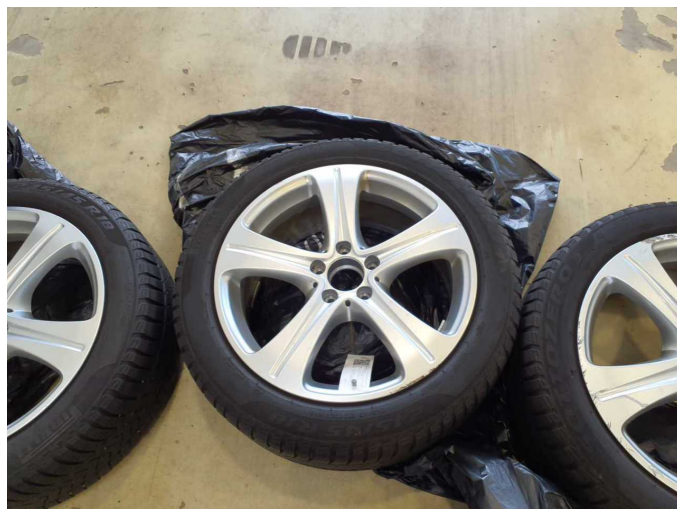
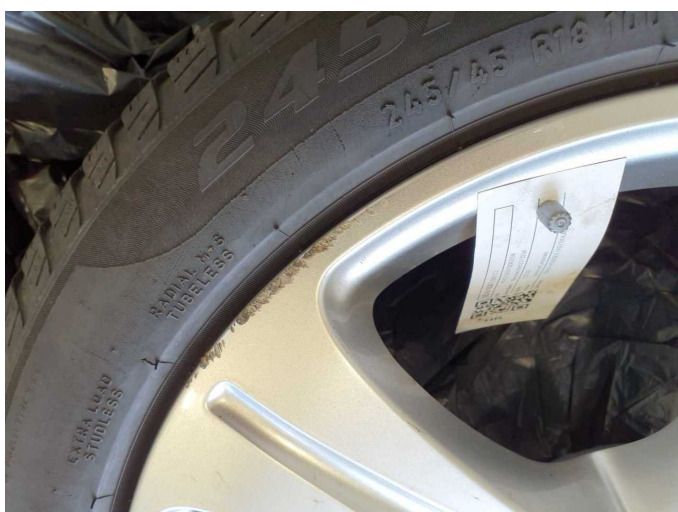
**Damage 7:** 2nd wheel set: 1 alloy rim - Scratch(es) - Loss in value

| No. | Component group | Description |
|---|---|---|
| 7 | 2nd wheel set | 1 alloy rim - Scratch(es) - Loss in value |

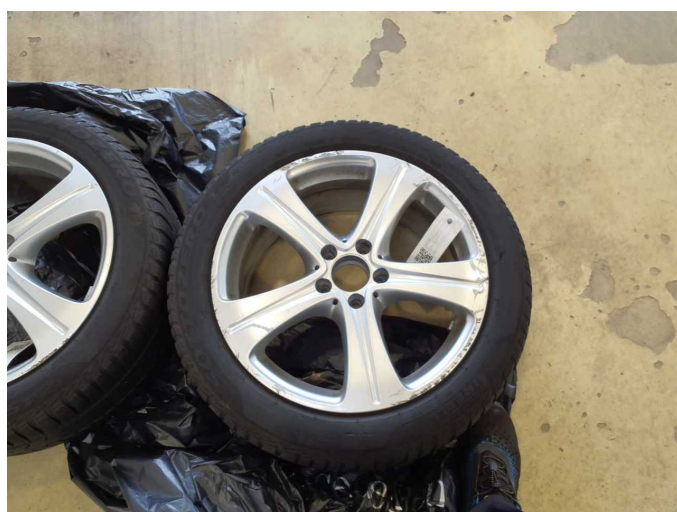
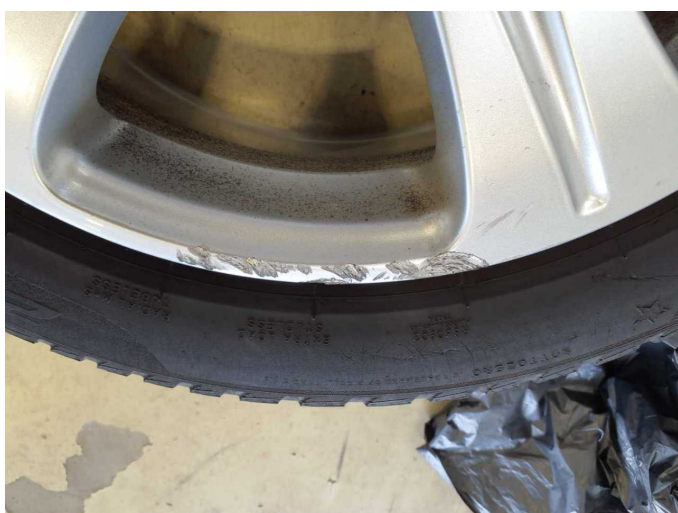
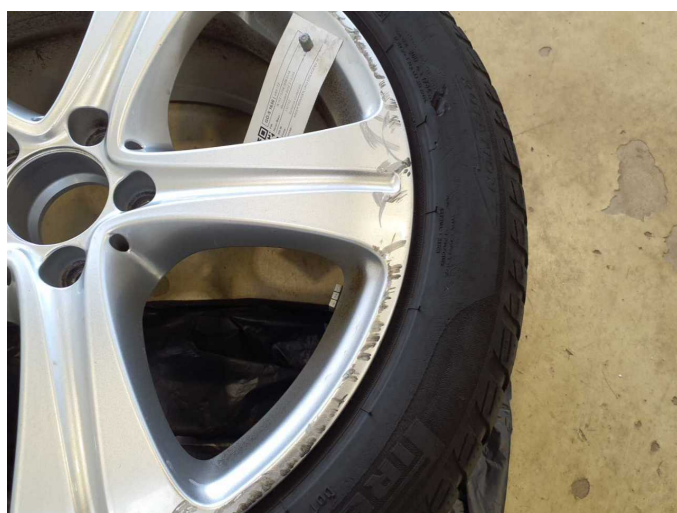
**Damage 8:** 2nd wheel set: 1 alloy rim - Scratch(es) - Replace

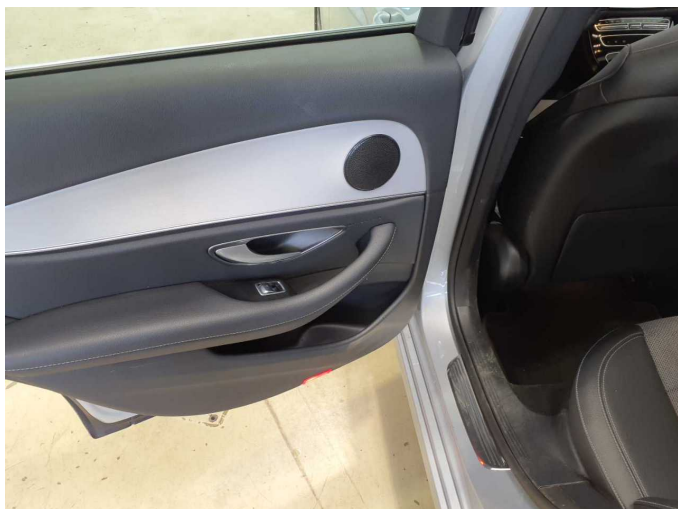
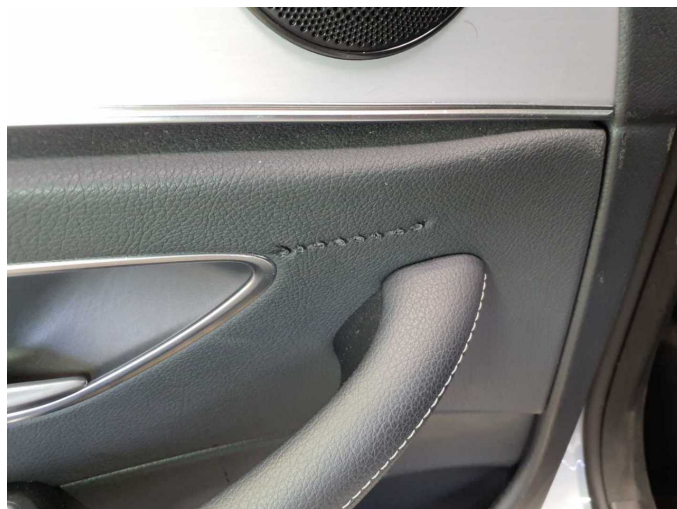
**Damage 9:** Trim / covers: Door trim - rear left side - Scratch(es) - Replace

| No. | Component group | Description |
|---|---|---|
| 9 | Trim / covers | Door trim - rear left side - Scratch(es) - Replace |

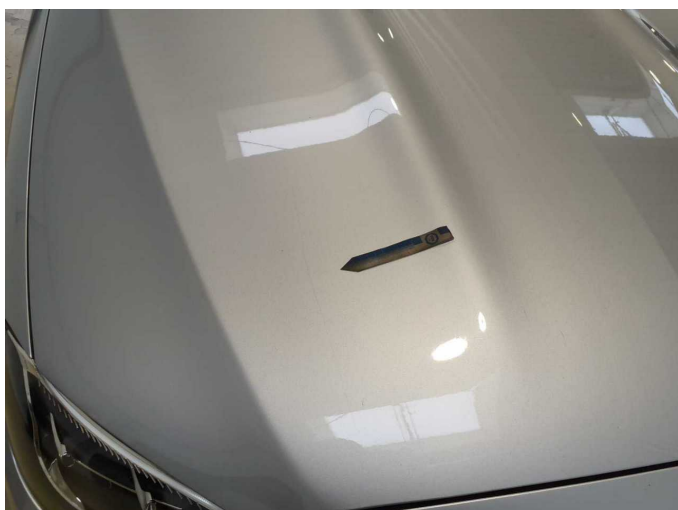
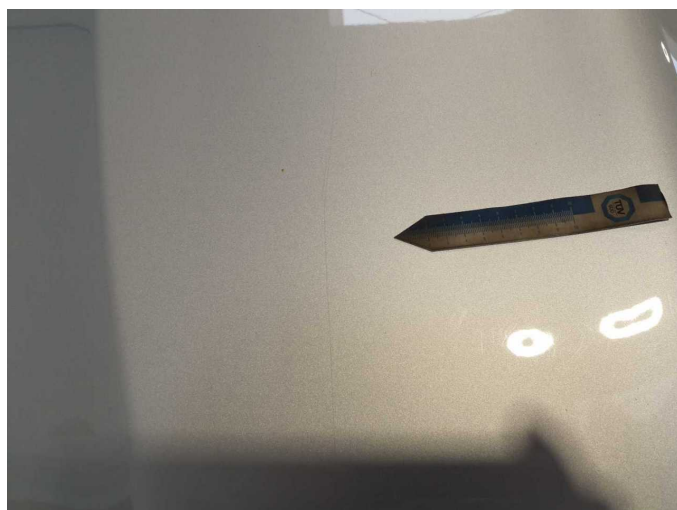
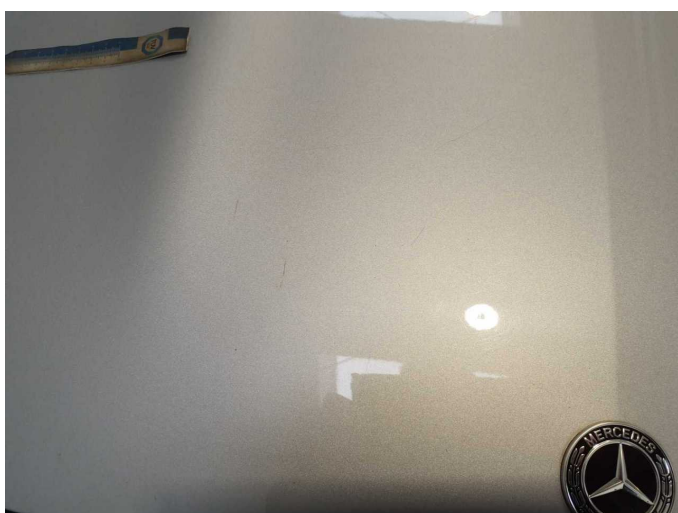
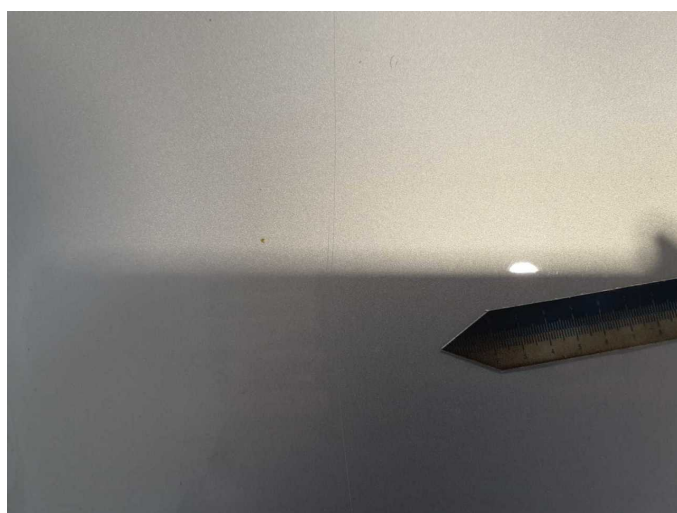
**Damage 10:** Bonnet: Bonnet - Scratch(es) - Paint

| No. | Component group | Description |
|---|---|---|
| 10 | Bonnet | Bonnet - Scratch(es) - Paint |

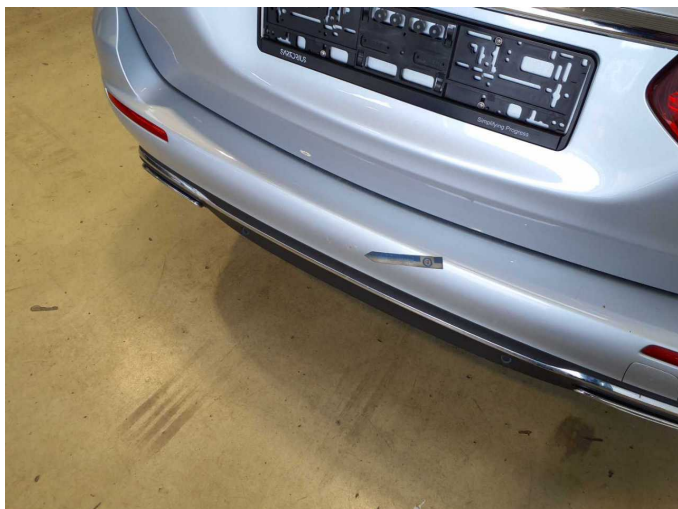
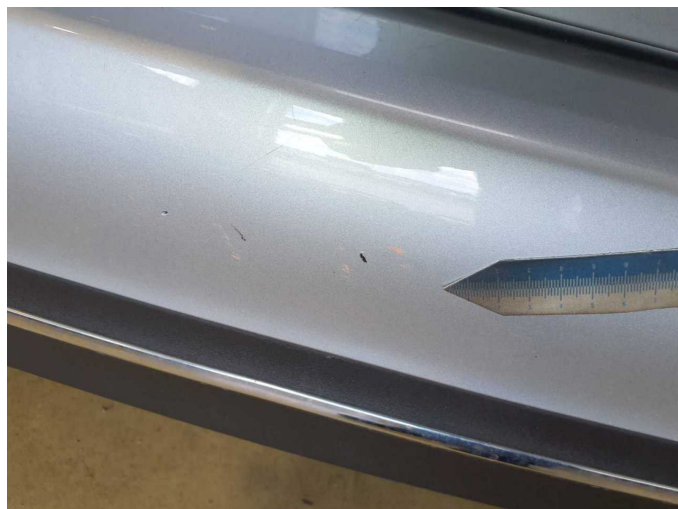
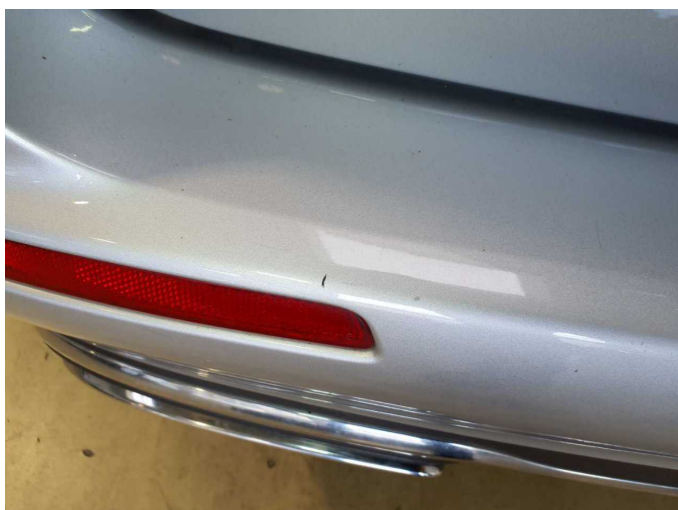
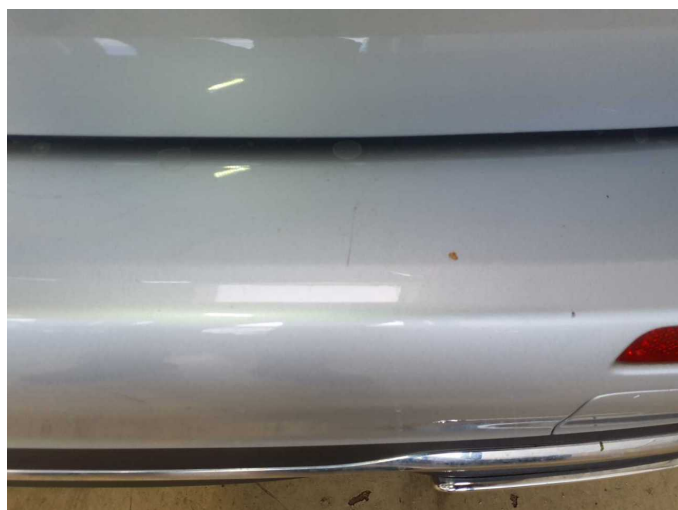
**Damage 11:** Rear bumper: Rear bumper - Scratch(es) - Paint

| No. | Component group | Description |
|---|---|---|
| 11 | Rear bumper | Rear bumper - Scratch(es) - Paint |

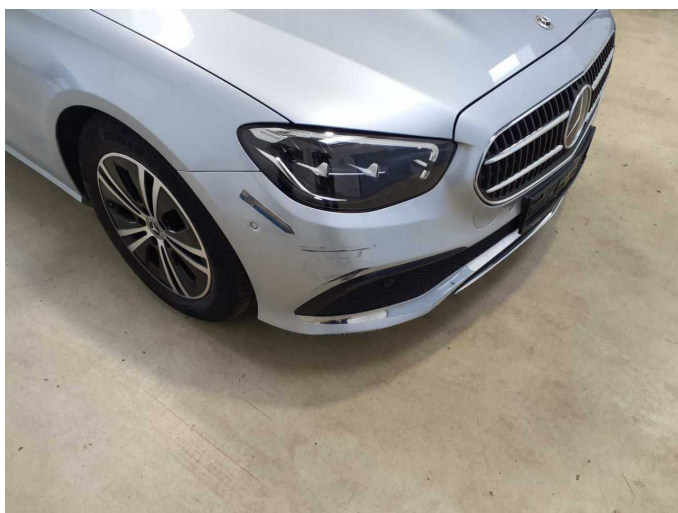
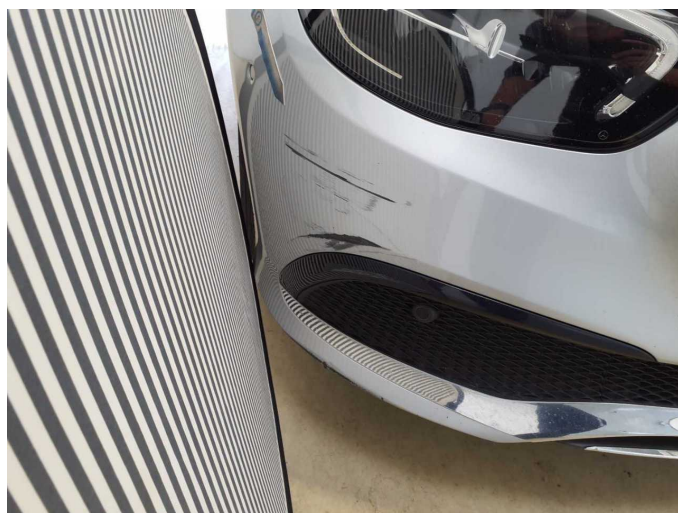
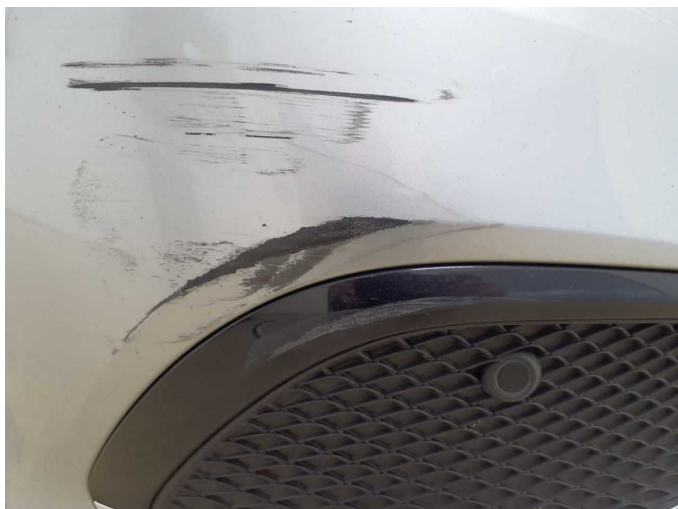
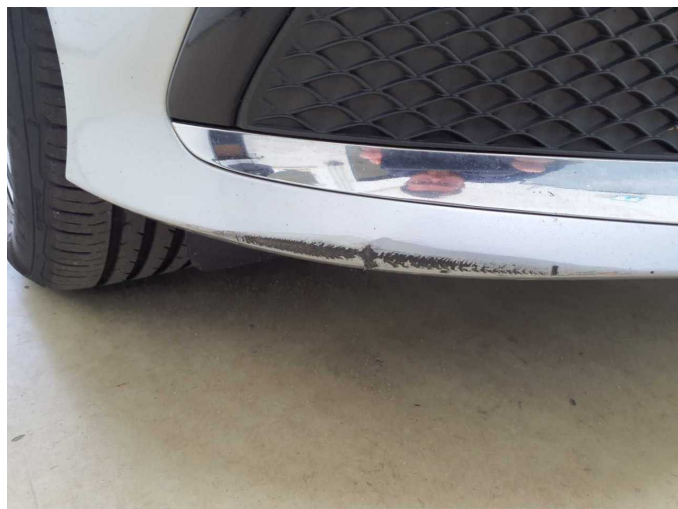
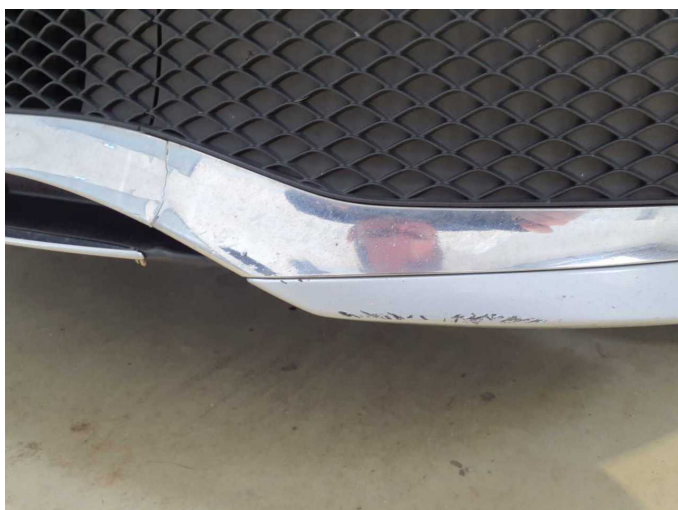
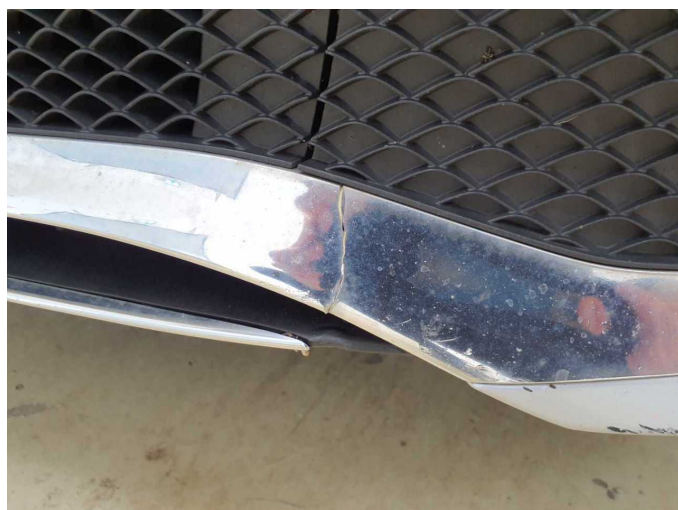
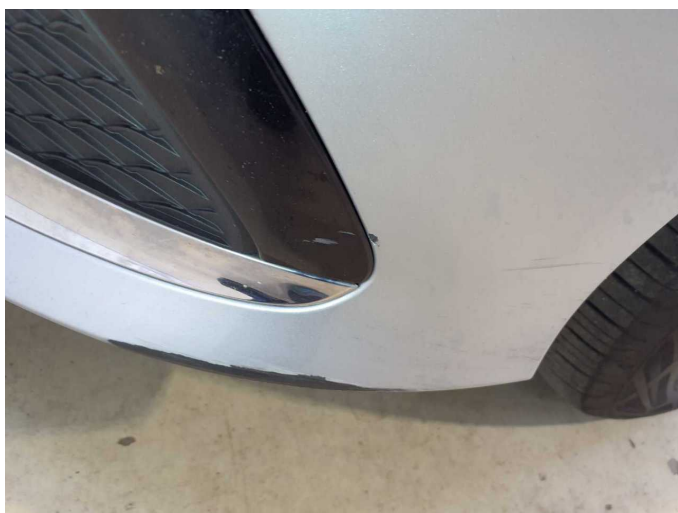
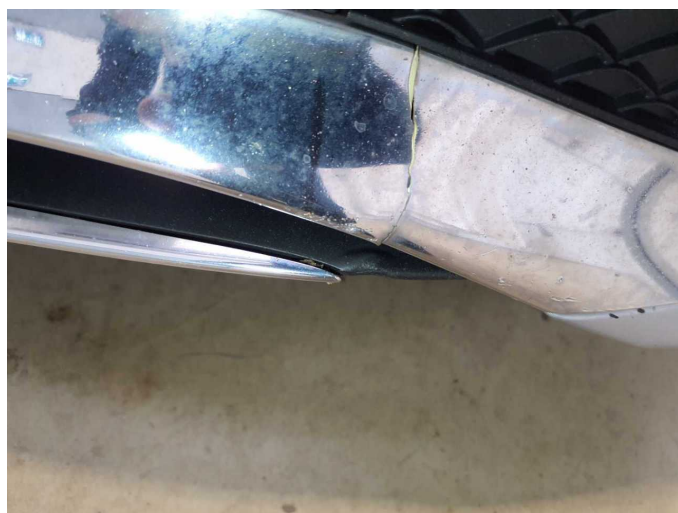
**Damage 12:** Front bumper: Front bumper (+ Zierleiste+Blende erneuern)  
- Dent / paintcoat damage - Repair and paint

| No. | Component group | Description |
|---|---|---|
| 12 | Front bumper | Front bumper (+ Zierleiste+Blende erneuern) - Dent / paintcoat damage - Repair and paint |

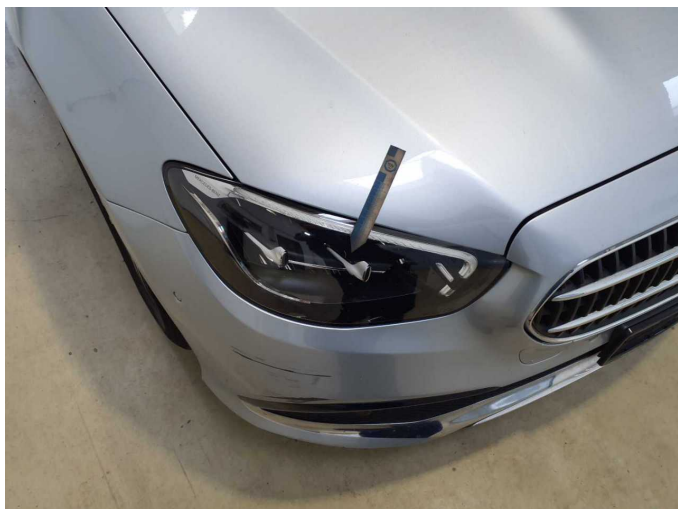
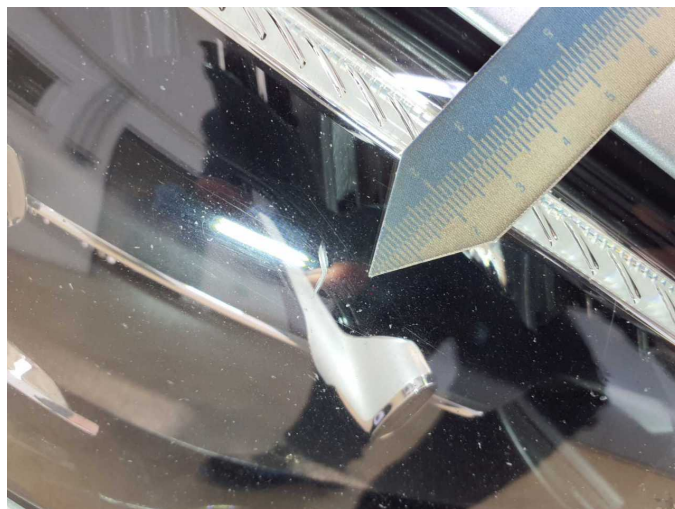
Der Scheinwerfer wurde aufgrund der Laufleistung und des Alters gemindert.

**Damage 13:** Headlight: Headlight - right side - Scratched - repair according to calculation

| No. | Component group | Description |
|---|---|---|
| 13 | Headlight | Headlight - right side - Scratched - repair according to calculation |

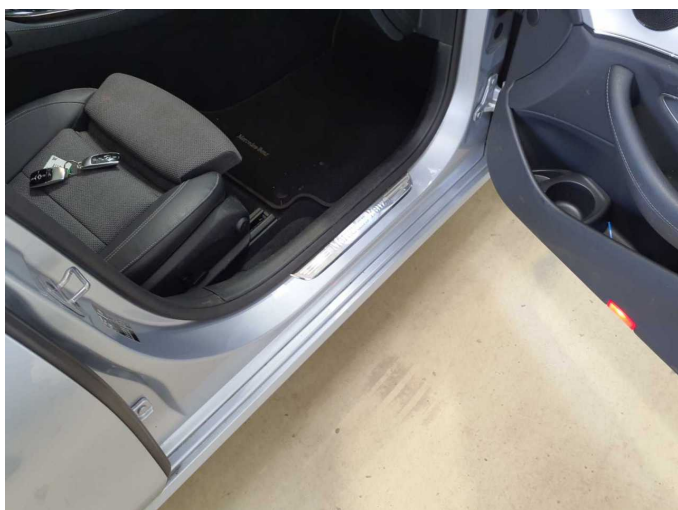
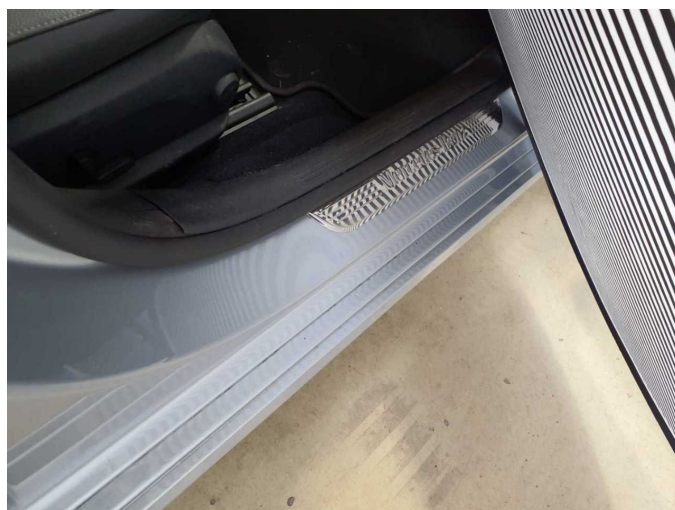
**Wear and tear 6:** Sill - right side: Sill - dent(s) - Smooth repair work

| No. | Component group | Description |
|---|---|---|
| 6 | Sill - right side | Sill - dent(s) - Smooth repair work |

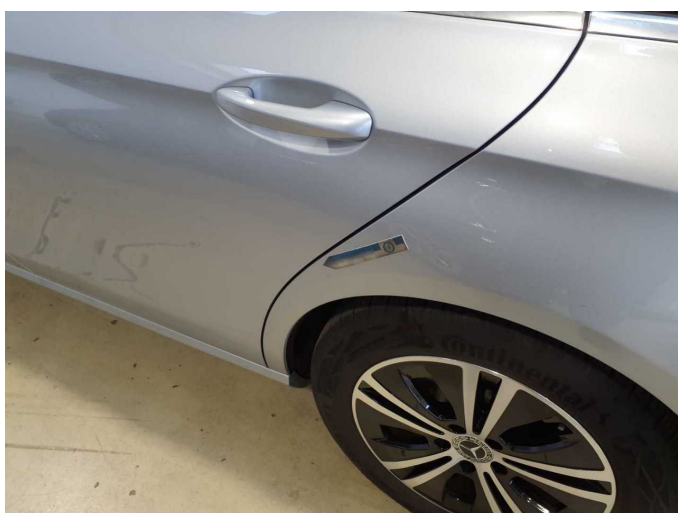
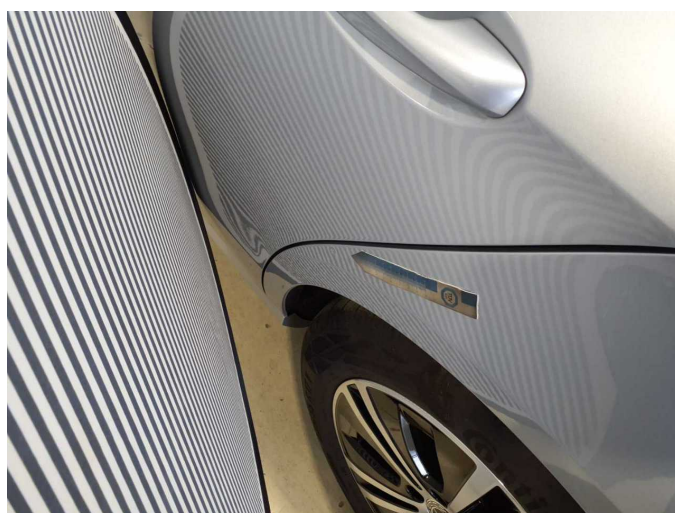
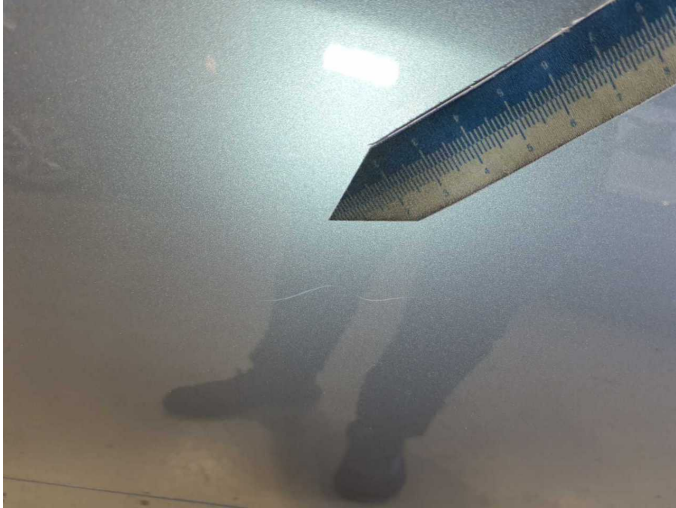
**Wear and tear 7:** Side panel - rear left side: Side panel - Dent / paintcoat damage - No deduction

| No. | Component group | Description |
|---|---|---|
| 7 | Side panel - rear left side | Side panel - Dent / paintcoat damage - No deduction |

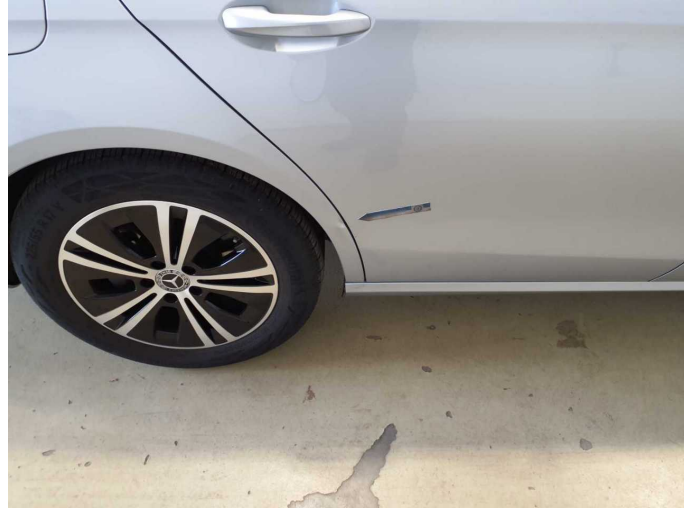
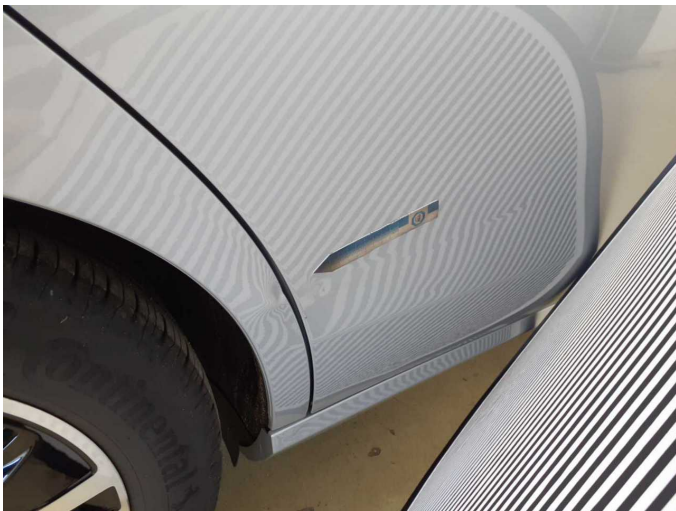
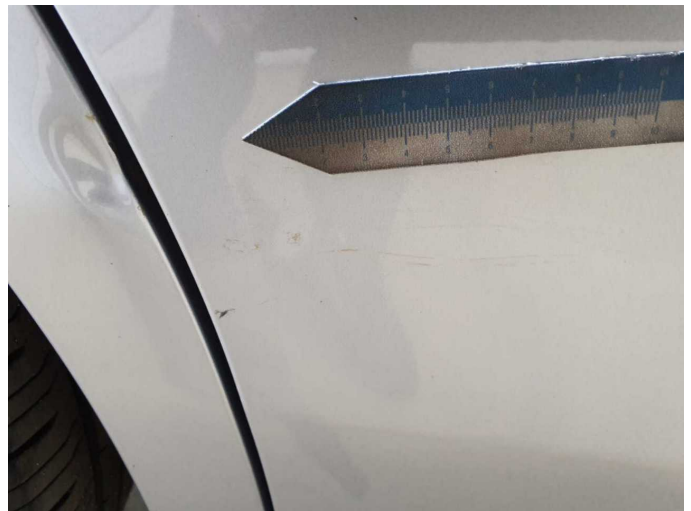
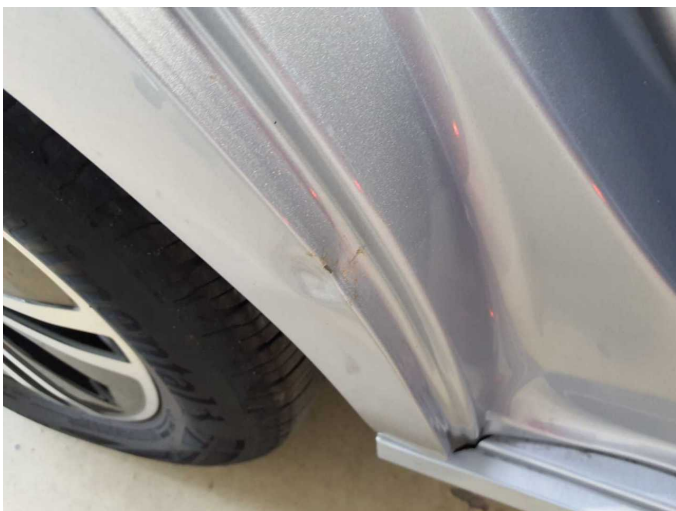
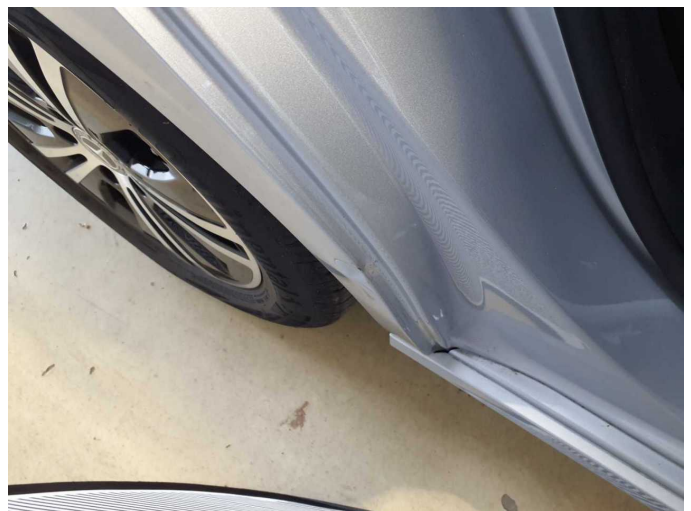
1 Side right

**Accident 1:** Side right

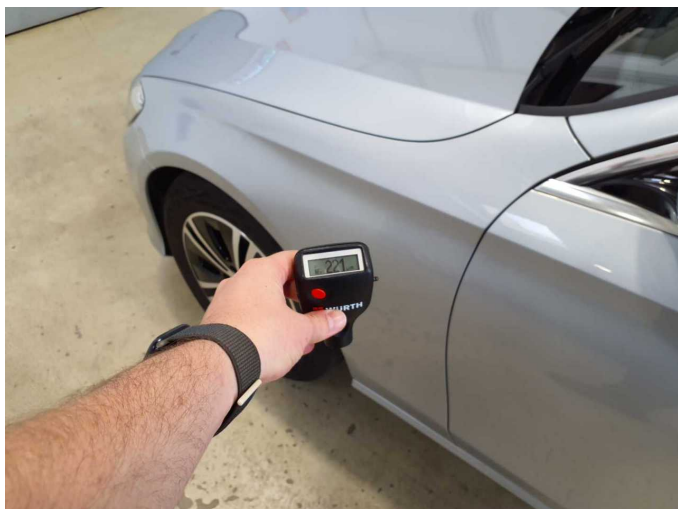
1 Mudguard - left side, Professionally carried out, Invoice of repair done Non-existent

221 µm |

**Repainting 1:** Mudguard - left side
