Expertise

Protocol number: 46361229  
Order No. / Reference: 26638177  
Inspection date: 3 Jul 2026

Manufacturer: Mercedes-Benz

Model: GLC 200 d 4Matic 9G-TRONIC AMG Line

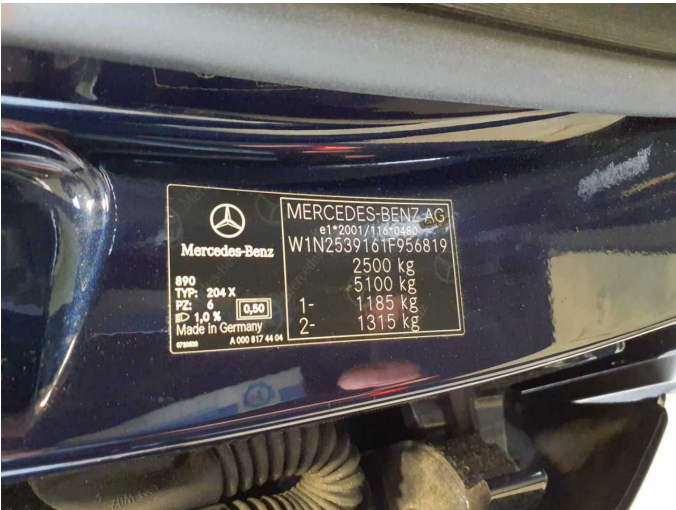
| VIN comparison | The vehicle identification number (VIN) was read from the vehicle and its conformity with the submitted documents was confirmed by the undersigned during the inspection. |

Figure 11: VIN

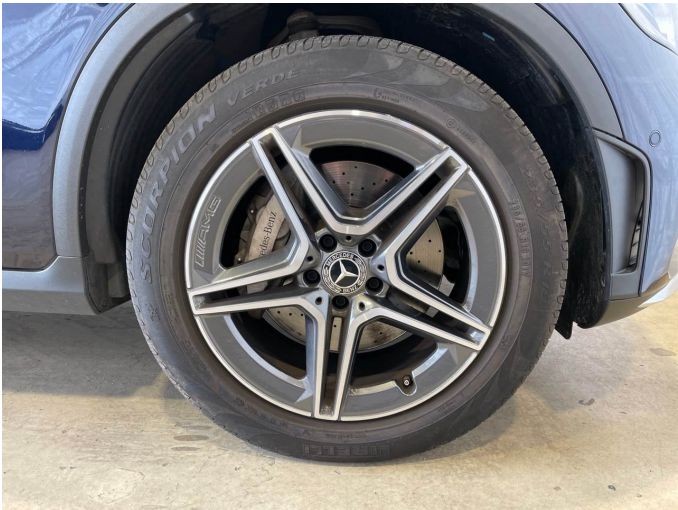
| # | Tyre size | Type of tyre | Manufacturer | Tread depth |
|---|---|---|---|---|
| 1) | 235/55 R19 101V | Summer tyres on Light alloy | Pirelli | 4mm / 4mm |
| 2) | 235/55 R19 101V | Summer tyres on Light alloy | Pirelli | 6mm / 6mm |

Figure 12: Mounted tyres

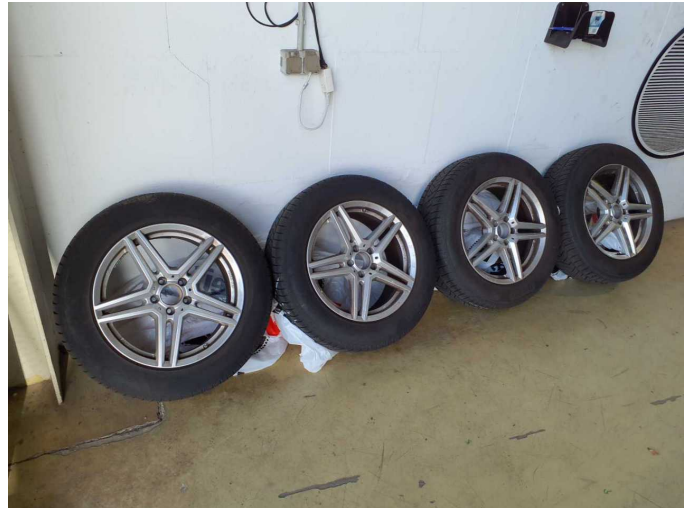
| # | Tyre size | Type of tyre | Manufacturer | Tread depth |
|---|---|---|---|---|
| 1) | 235/60 R18 107H | Winter tyres on Light alloy | Pirelli | 5mm / 5mm |
| 2) | 235/60 R18 107H | Winter tyres on Light alloy | Pirelli | 6mm / 6mm |

Figure 14: Additional tyres

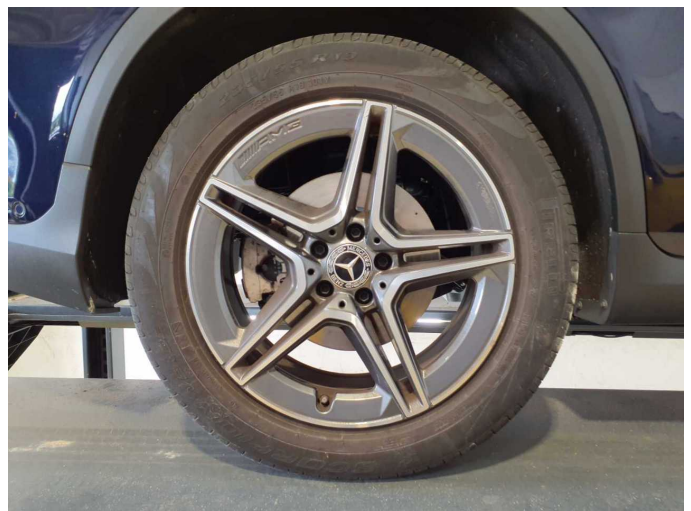
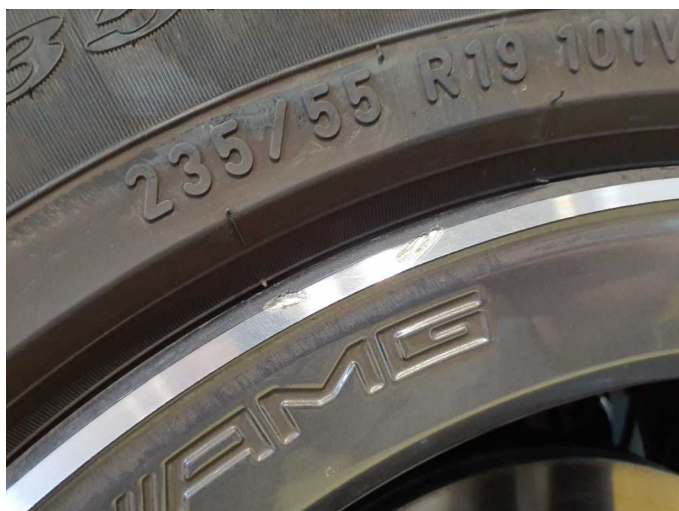
| No. | Component group | Description |
|---|---|---|
| 1 | Wheel / tyres | Alloy rim - rear right side - Scratch(es) - Loss in value |

Damage 1: Wheel / tyres: Alloy rim - rear right side - Scratch(es) - Loss in value

**Damage 1:** Wheel / tyres: Alloy rim - rear right side - Scratch(es) - Loss in value

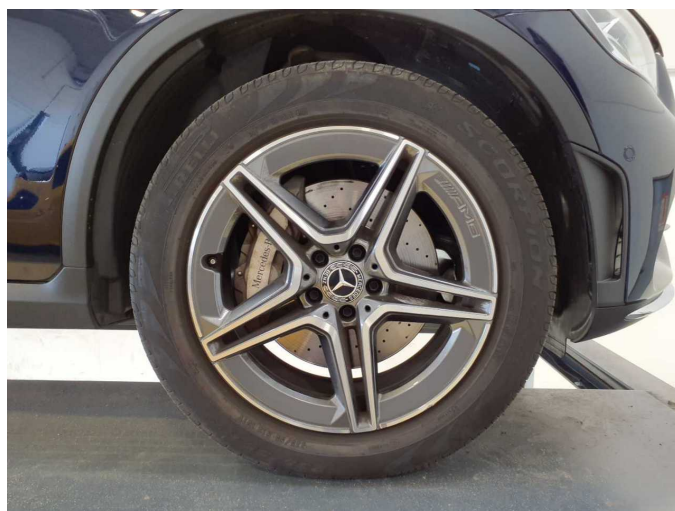
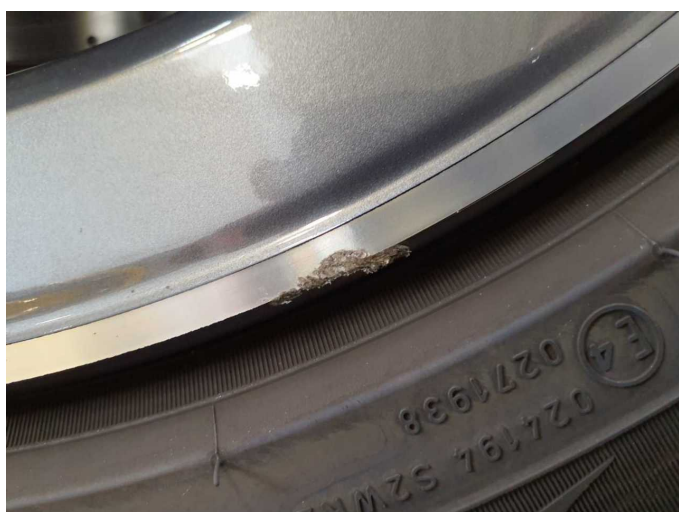
| No. | Component group | Description |
|---|---|---|
| 2 | Wheel / tyres | Alloy rim - front right side - Scratch(es) - Loss in value |

**Damage 2:** Wheel / tyres: Alloy rim - front right side - Scratch(es) - Loss in value

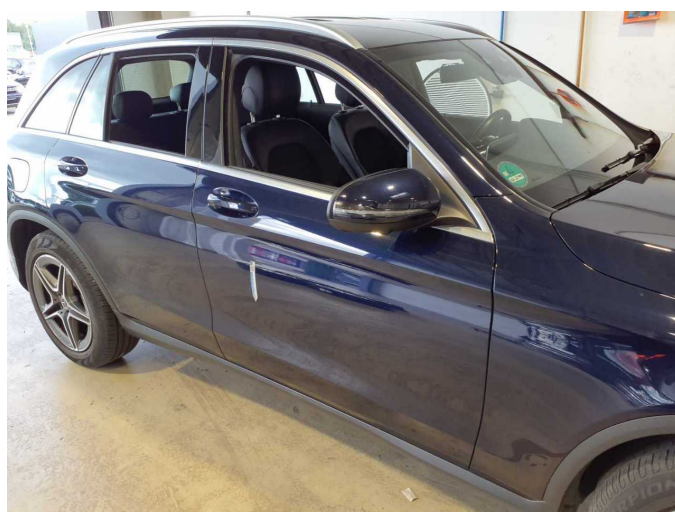
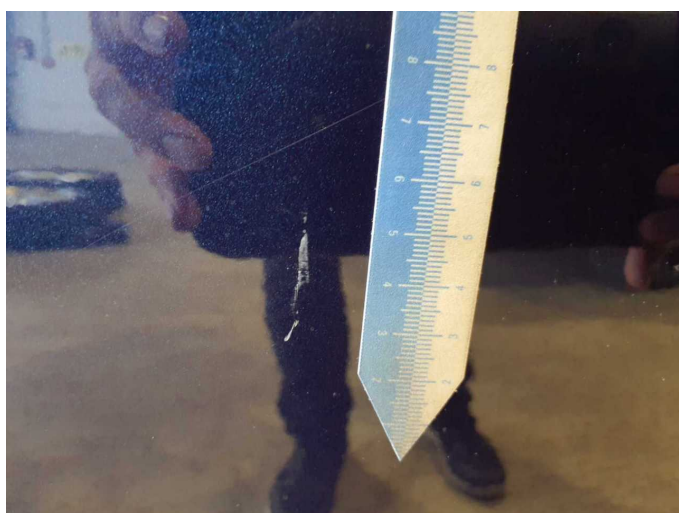
| No. | Component group | Description |
|---|---|---|
| 3 | Door - front right side | Door - Scratch(es) - Smart repair |

**Damage 3:** Door - front right side: Door - Scratch(es) - Smart repair

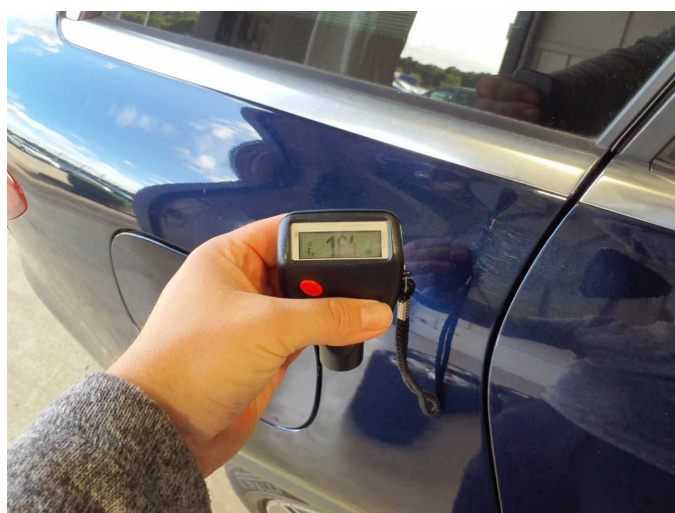
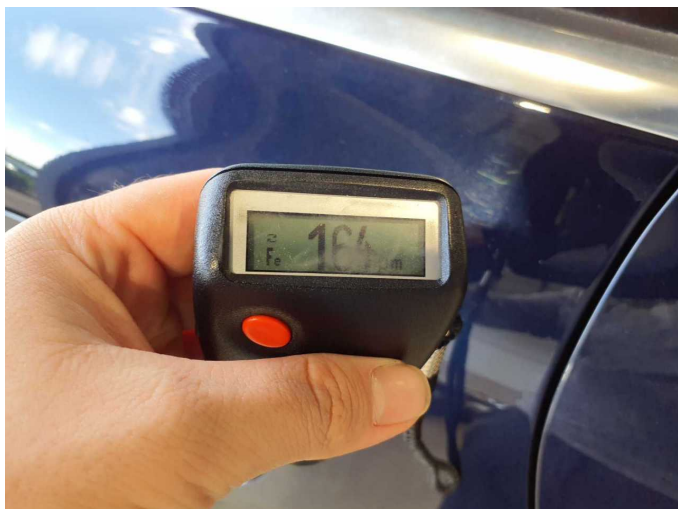
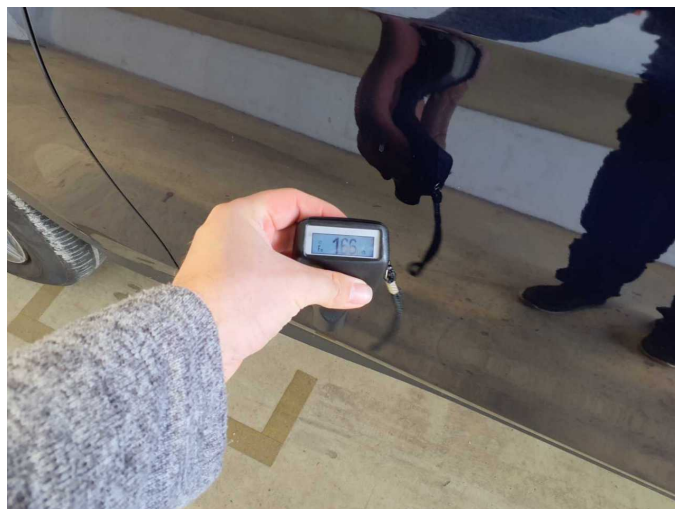
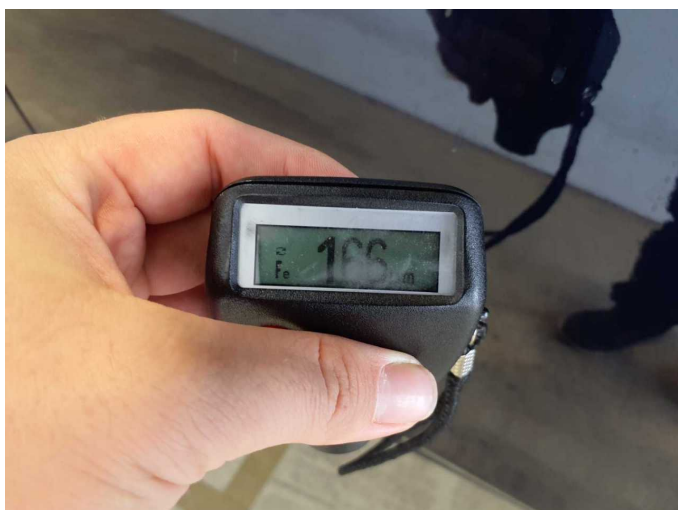
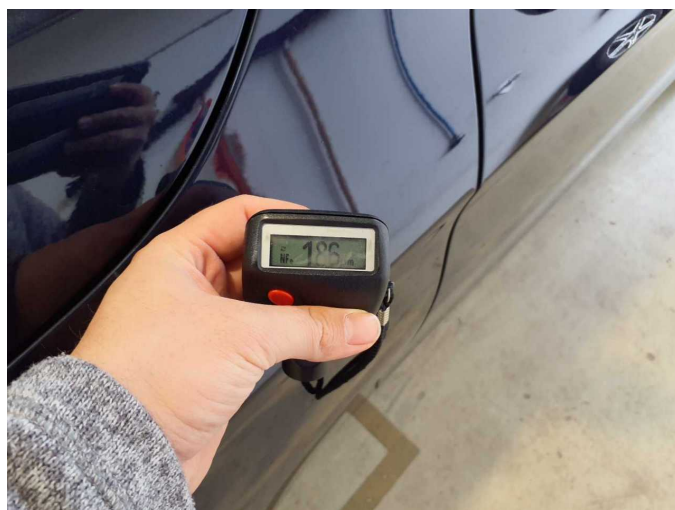
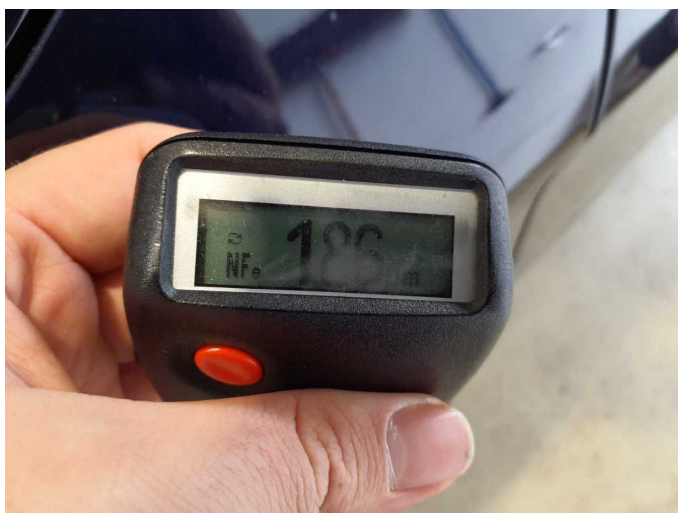
| No. | Repainting |
|---|---|
| 1 | Mudguard - left side, Side panel - rear right side, Door - front left side, Professionally carried out |

| Mudguard - left side | 186 µm | Side panel - rear right side | 164 µm |
| Door - front left side | 166 µm | | |

**Repainting 1:** Mudguard - left side, Side panel - rear right side, Door - front left side
