| Hersteller | Hyundai | Restlauf bis Service | 11 Monat(e) |
| Typ/Modell | i20 | HU (Abgelesen aus ZBI) | 05/2028 |

Zustandsbericht

Besichtigungsdatum: 17.06.2026
Protokollnummer: 46070802
Erstellt durch: Markus Böttcher
Besichtigt durch: Daniel Donath

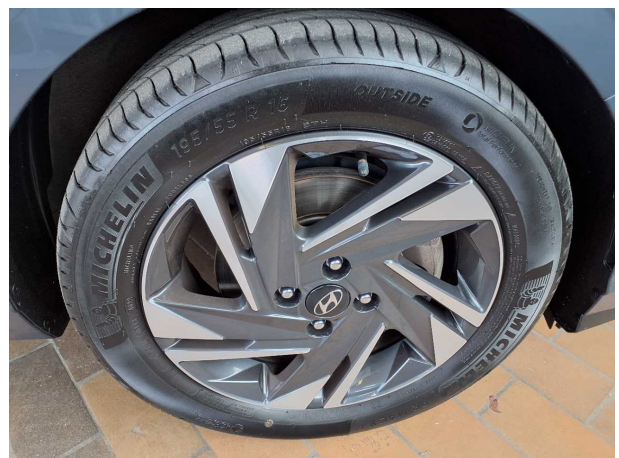
Abbildung 6: Montierte Bereifung

| Achse | Reifengröße | Hersteller | Reifentyp | Profiltiefe | Verktgl. | Zul. |
|---|---|---|---|---|---|---|
| 1 | 195/55 R16 87H | Michelin | Sommerreifen | 7mm - 7mm | i.O. | i.O. |
| 2 | 195/55 R16 87H | Michelin | Sommerreifen | 7mm - 7mm | i.O. | i.O. |

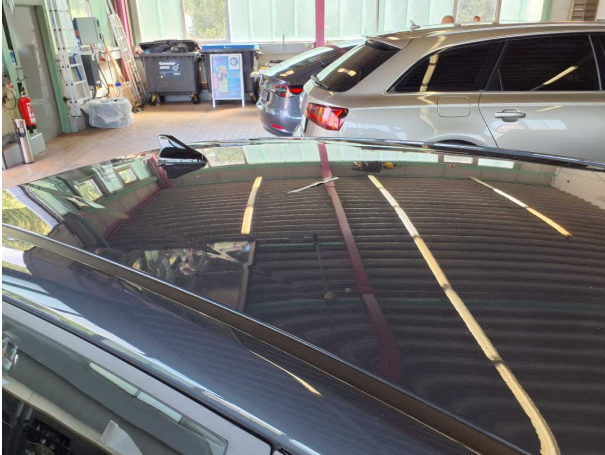
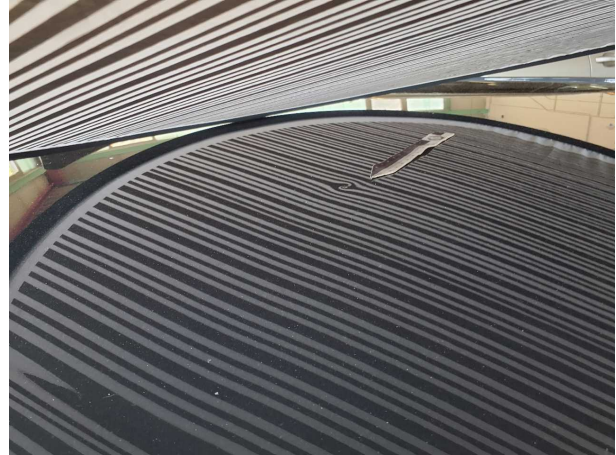
Beschädigung #2: Fahrzeugdach: Dach - Delle(n) - sanft instandsetzen

| Nr. | Bauteilgruppe | Beschreibung |
|---|---|--|
| 2 | Fahrzeugdach | Dach - Delle(n) - sanft instandsetzen |

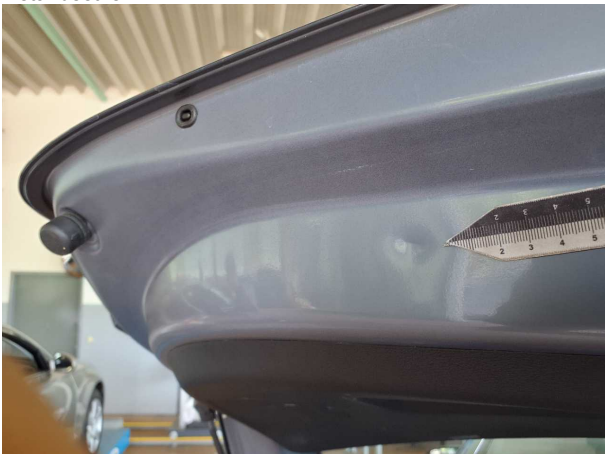
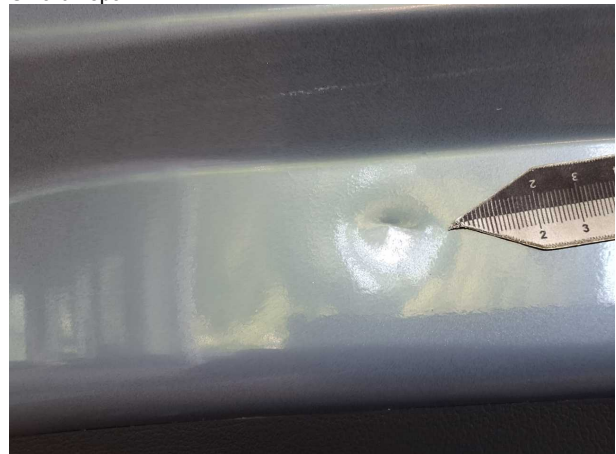
Beschädigung #3: Heckklappe/-tür: Heckklappe - Delle(n) - Smart Repair

| Nr. | Bauteilgruppe | Beschreibung |
|---|---|--|
| 3 | Heckklappe/-tür | Heckklappe - Delle(n) - Smart Repair |

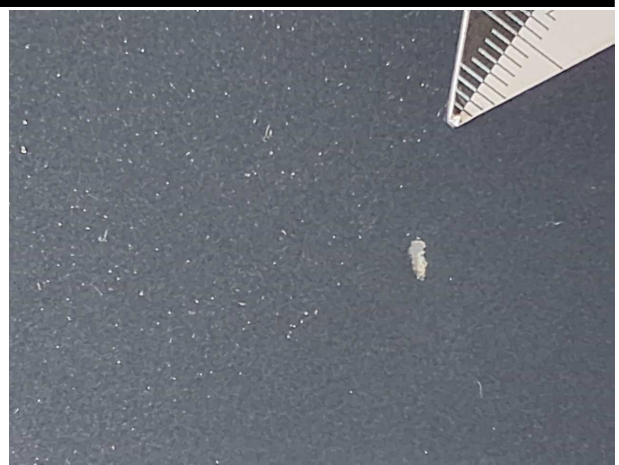
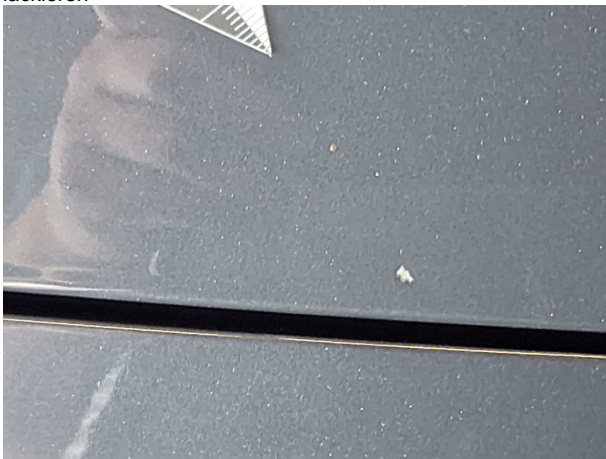
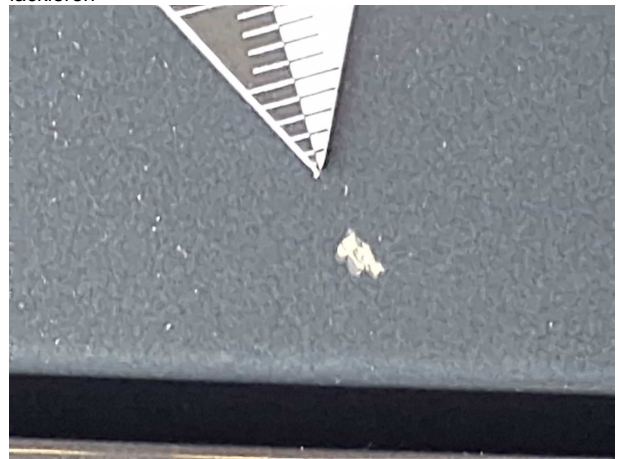
Beschädigung #4: Motorhaube: Motorhaube - Steinschlag - lackieren

| Nr. | Bauteilgruppe | Beschreibung |
|---|---|--|
| 4 | Motorhaube | Motorhaube - Steinschlag - lackieren |

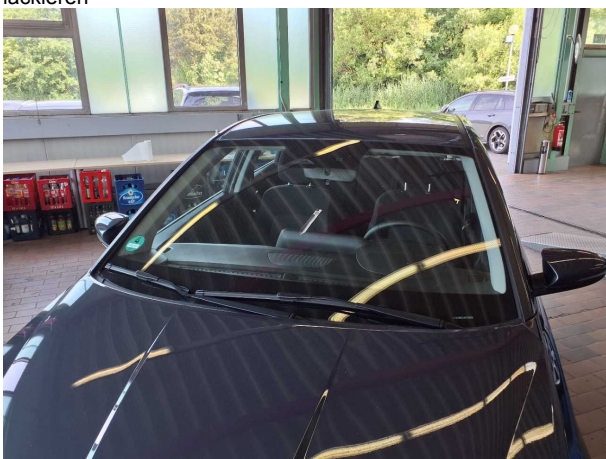
Beschädigung #5: Verglasung: Frontscheibe - Steinschlag - erneuern

| Nr. | Bauteilgruppe | Beschreibung |
|---|---|--|
| 5 | Verglasung | Frontscheibe - Steinschlag - erneuern |
