Expertise

Protocol number: 46857608  
Order No. / Reference: 26721792  
Inspection date: 3 Aug 2026

Manufacturer: Mercedes-Benz  
VIN: W1KZH1GB6PB121035

Model: E 300 de T 9G-TRONIC AMG Line

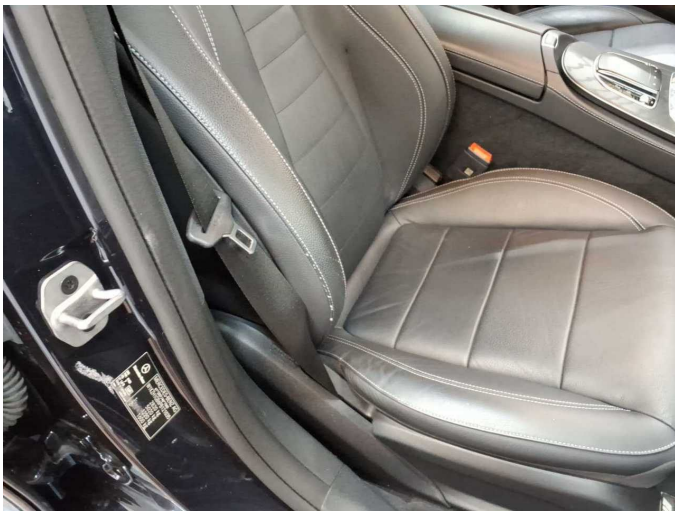
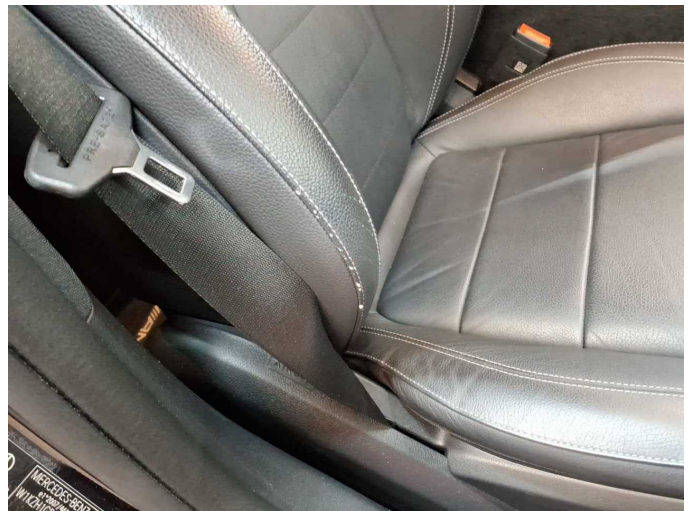
| No. | Component group | Description |
|---|---|---|
| 1 | Seat - front | Seat cover - right side - Scratch(es) - Loss in value |

**Damage 1:** Seat - front: Seat cover - right side - Scratch(es) - Loss in value

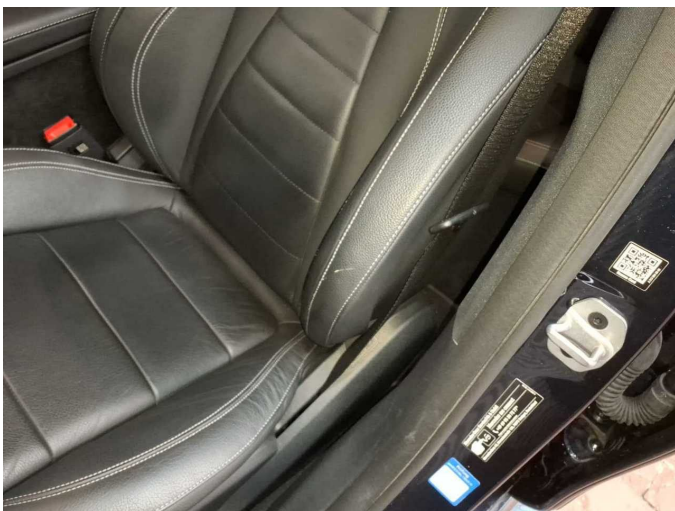
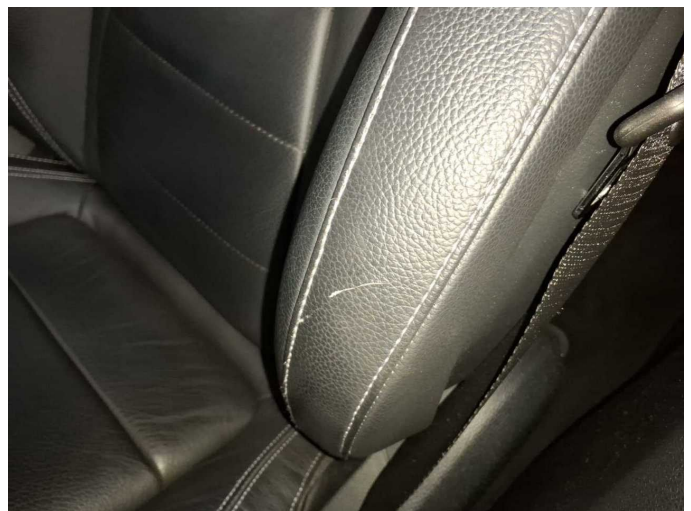
| No. | Component group | Description |
|---|---|---|
| 2 | Seat - front | Seat cover - left side - Scratch(es) - Loss in value |

**Damage 2:** Seat - front: Seat cover - left side - Scratch(es) - Loss in value

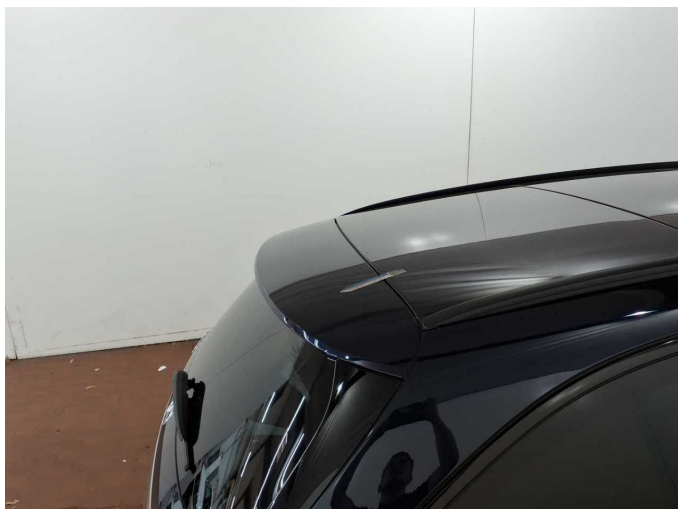
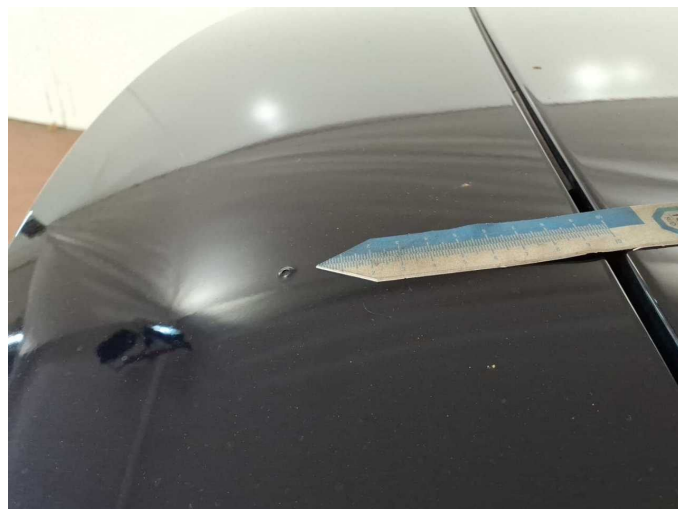
| No. | Component group | Description |
|---|---|---|
| 3 | Boot lid / rear door | Rear spoiler - Scratch(es) - Smart repair |

**Damage 3:** Boot lid / rear door: Rear spoiler - Scratch(es) - Smart repair

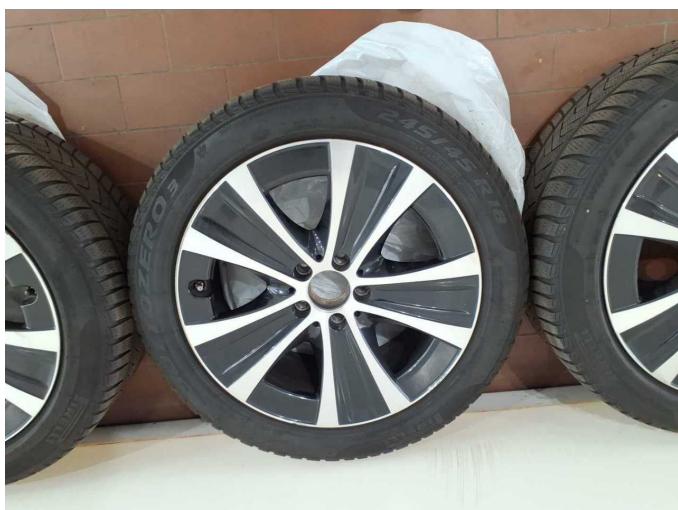
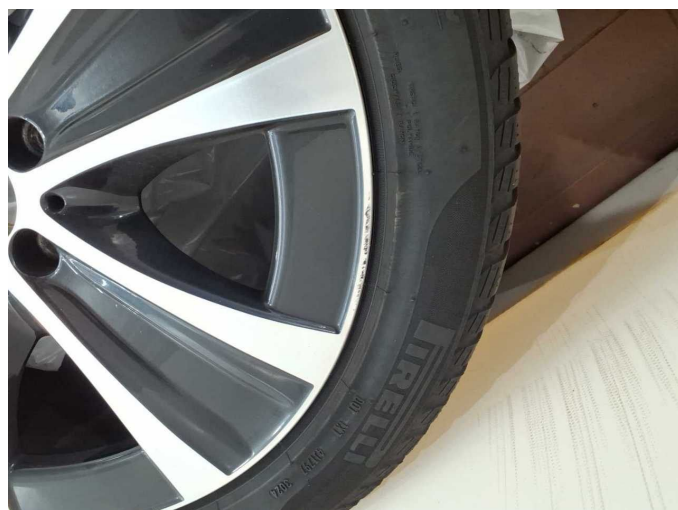
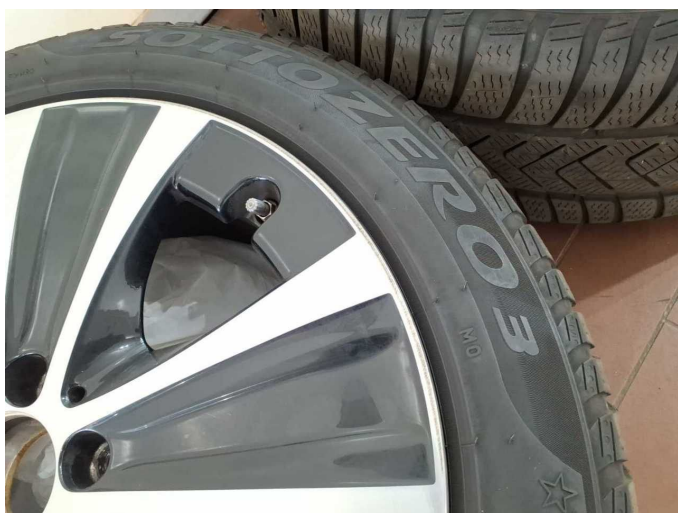
| No. | Component group | Description |
|---|---|---|
| 4 | 2nd wheel set | 1 alloy rim - Scratch(es) - Loss in value |

**Damage 4:** 2nd wheel set: 1 alloy rim - Scratch(es) - Loss in value

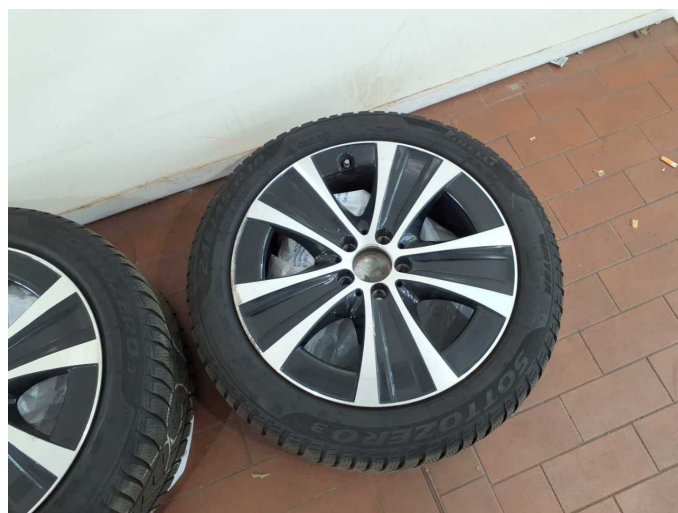
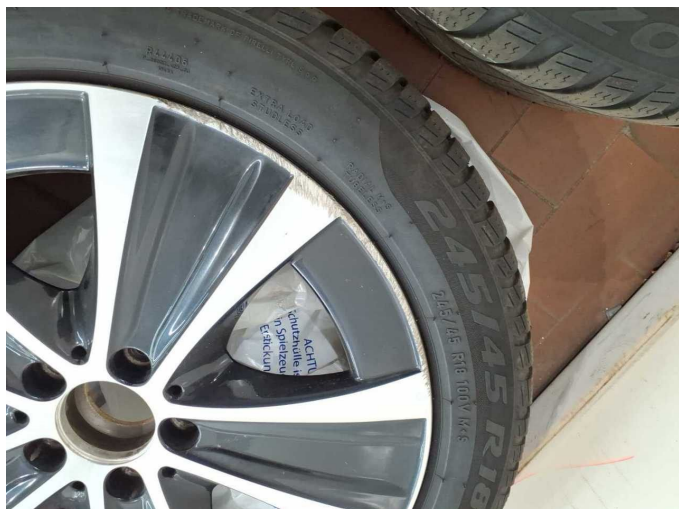
| No. | Component group | Description |
|---|---|---|
| 5 | 2nd wheel set | 1 alloy rim - Scratch(es) - Loss in value |

**Damage 5:** 2nd wheel set: 1 alloy rim - Scratch(es) - Loss in value

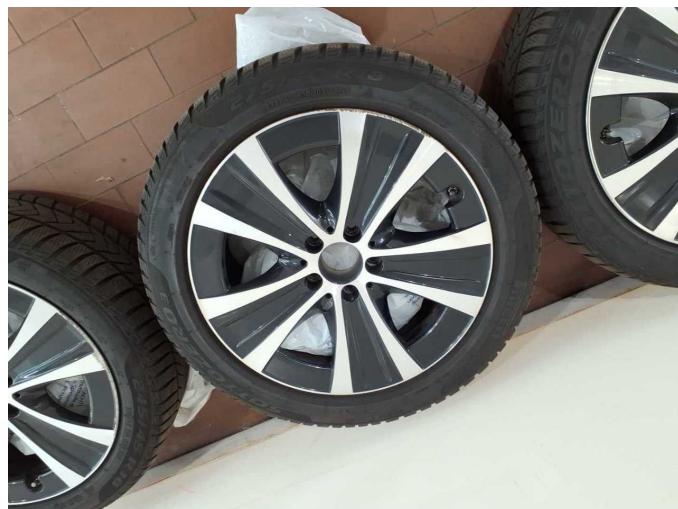
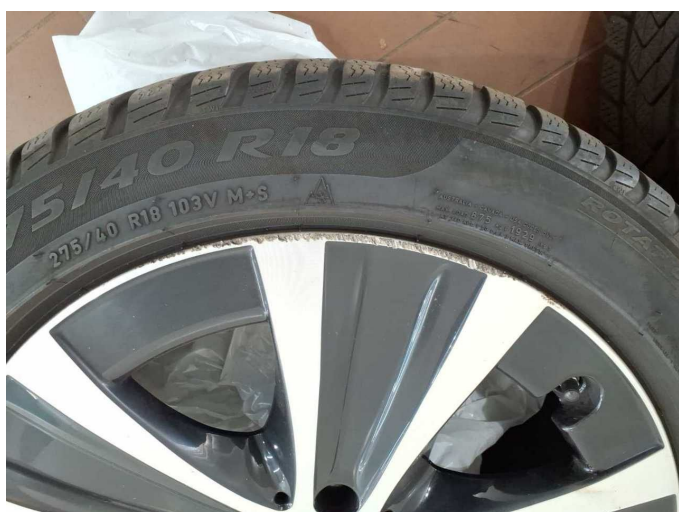
| No. | Component group | Description |
|---|---|---|
| 6 | 2nd wheel set | 1 alloy rim - Scratch(es) - Loss in value |

**Damage 6:** 2nd wheel set: 1 alloy rim - Scratch(es) - Loss in value

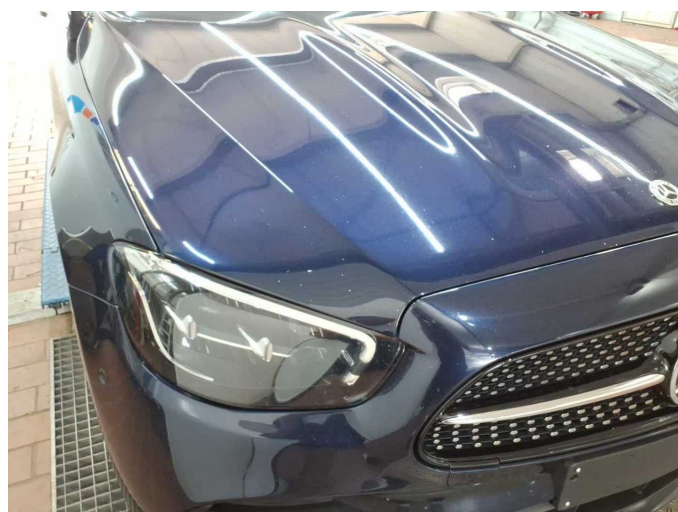
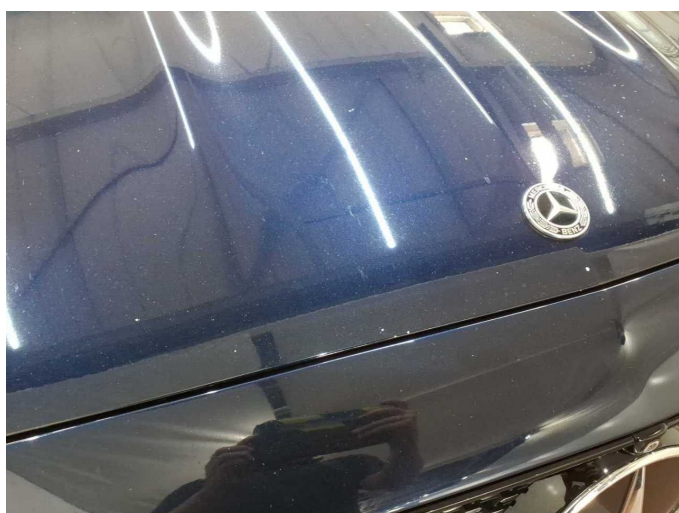
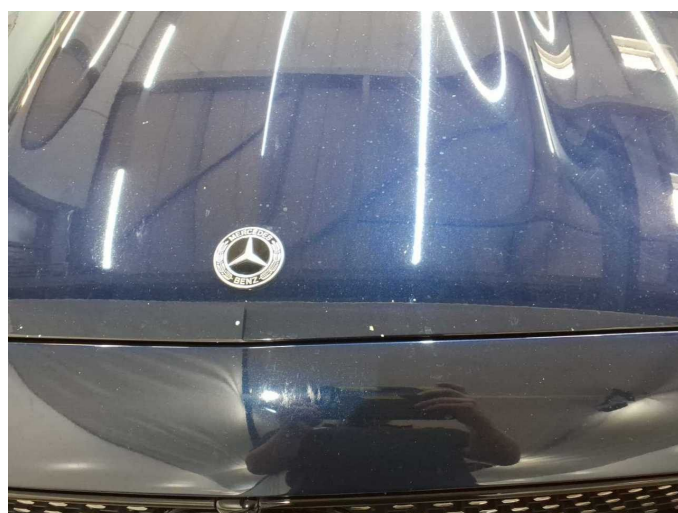
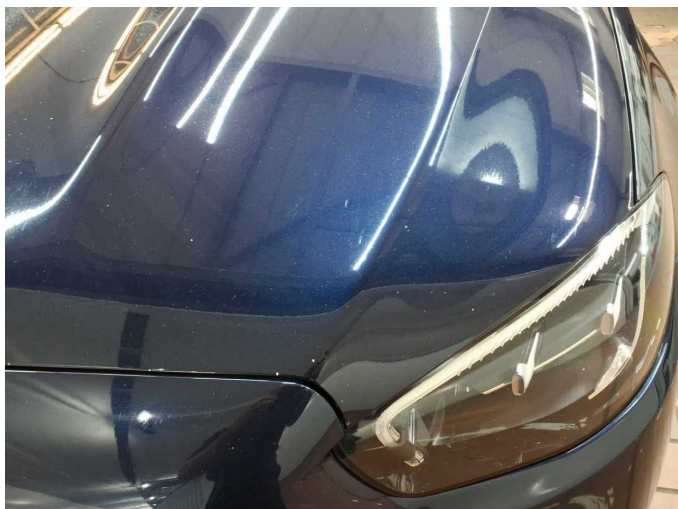
| No. | Component group | Description |
|---|---|---|
| 7 | Bonnet | Bonnet - Stone chips - Paint |

**Damage 7:** Bonnet: Bonnet - Stone chips - Paint

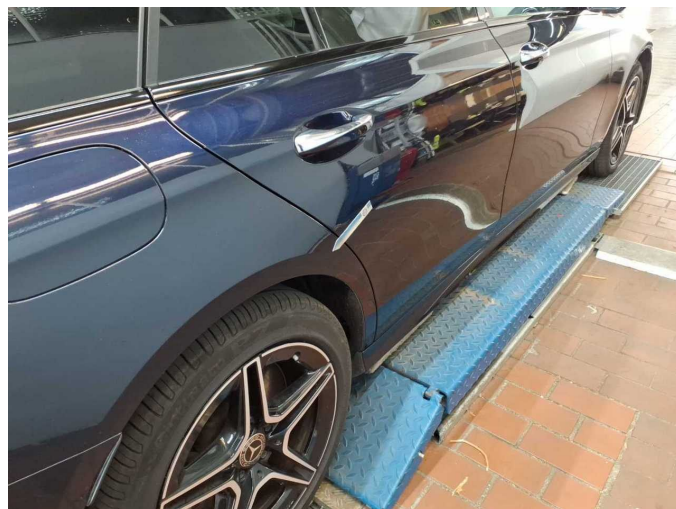
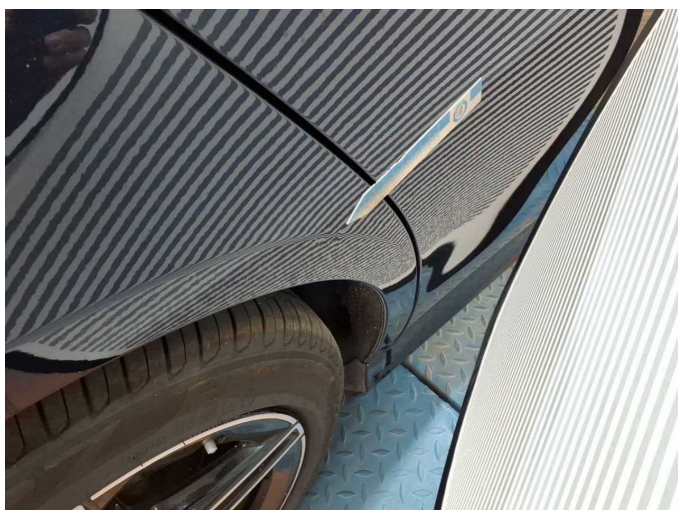
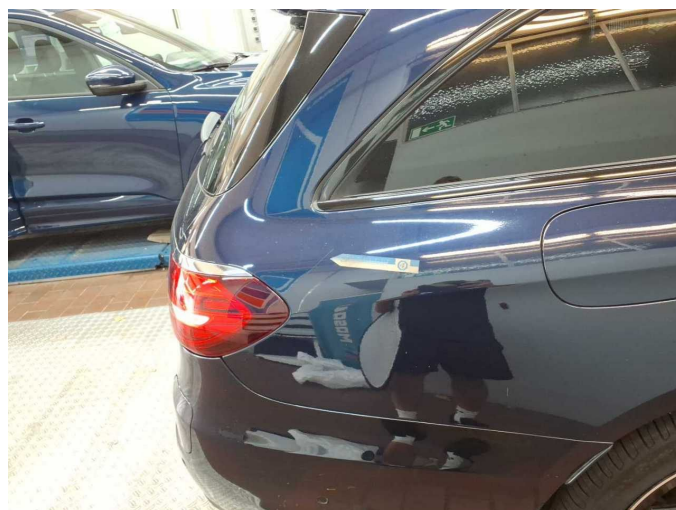
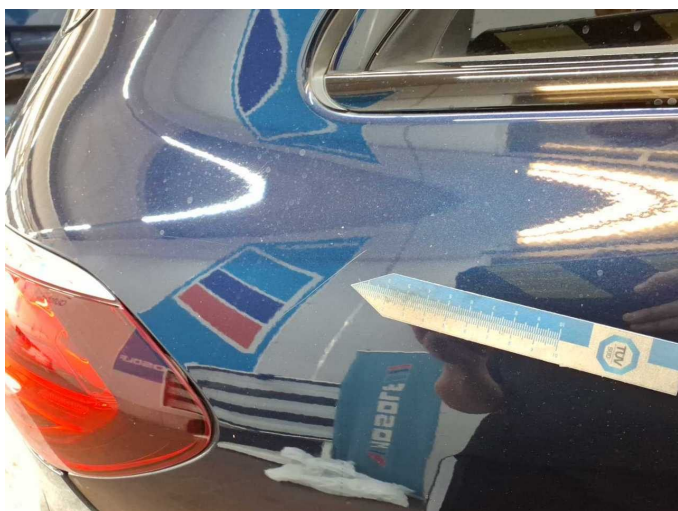
| No. | Component group | Description |
|---|---|---|
| 8 | Side panel - rear right side | Side panel (Mit Kratzer) - dent(s) - Repair and paint |

**Damage 8:** Side panel - rear right side: Side panel (Mit Kratzer) - dent(s)  
- Repair and paint

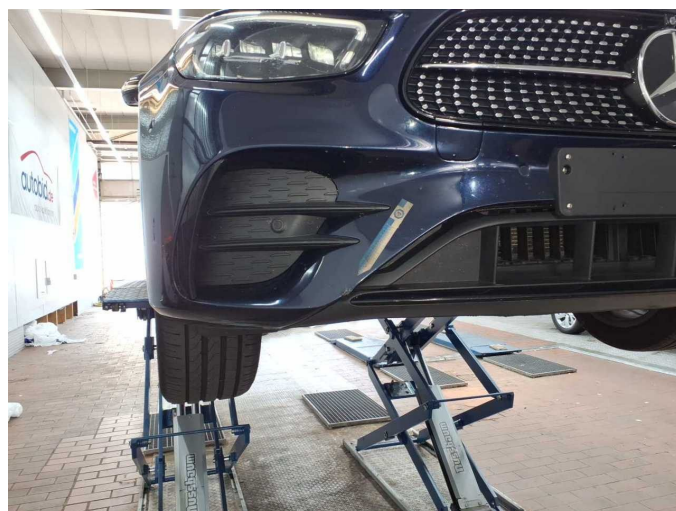
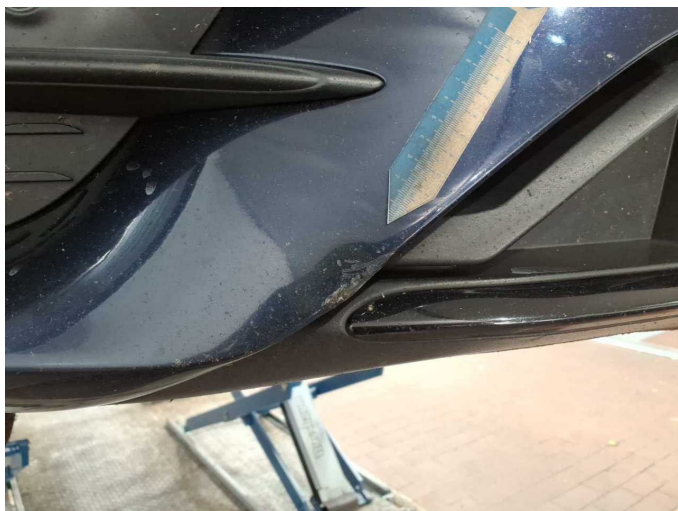
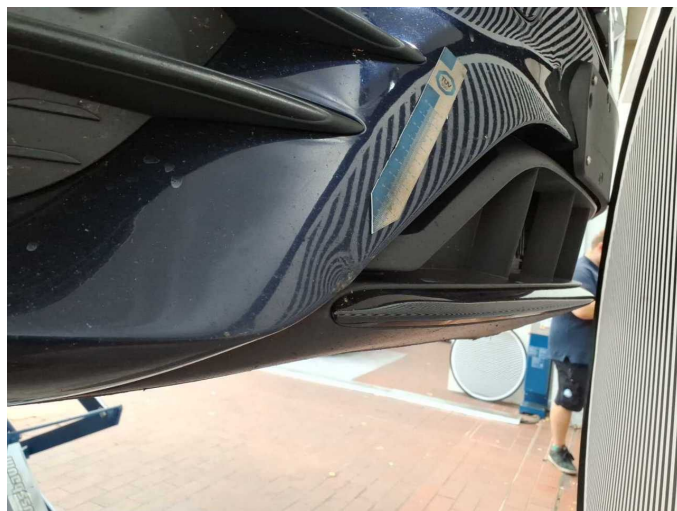
| No. | Component group | Description |
|---|---|---|
| 9 | Front bumper | Front bumper - Dent / paintcoat damage - Repair and paint |

**Damage 9:** Front bumper: Front bumper - Dent / paintcoat damage -  
Repair and paint

**Damage 9:** Front bumper: Front bumper - Dent / paintcoat damage - Repair and paint

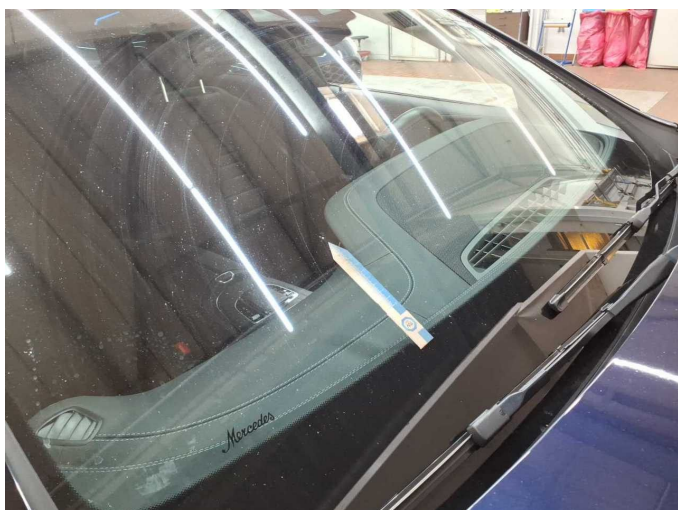
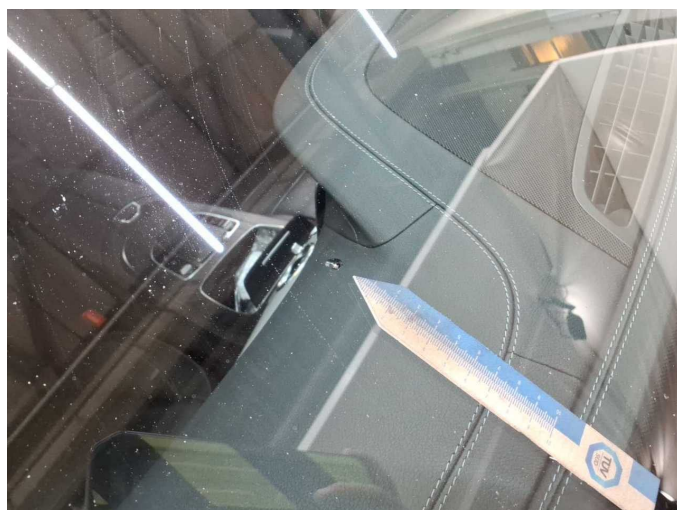
| No. | Component group | Description |
|---|---|---|
| 10 | Vehicle glazing | Windscreen - Stone chips - repair according to calculation |

**Damage 10:** Vehicle glazing: Windscreen - Stone chips - repair according to calculation

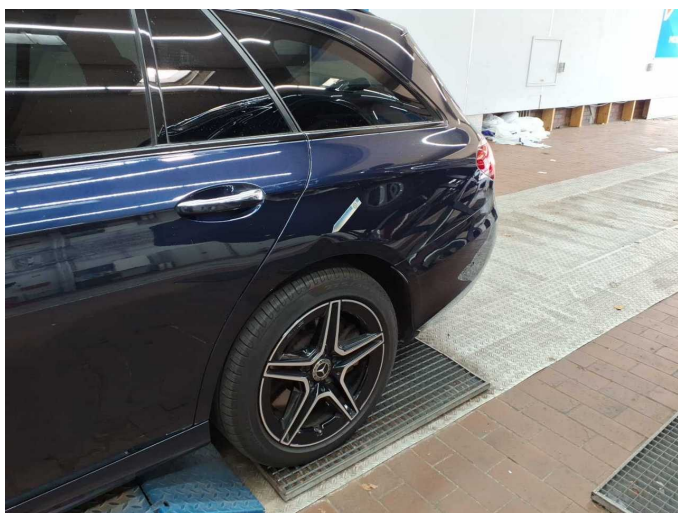
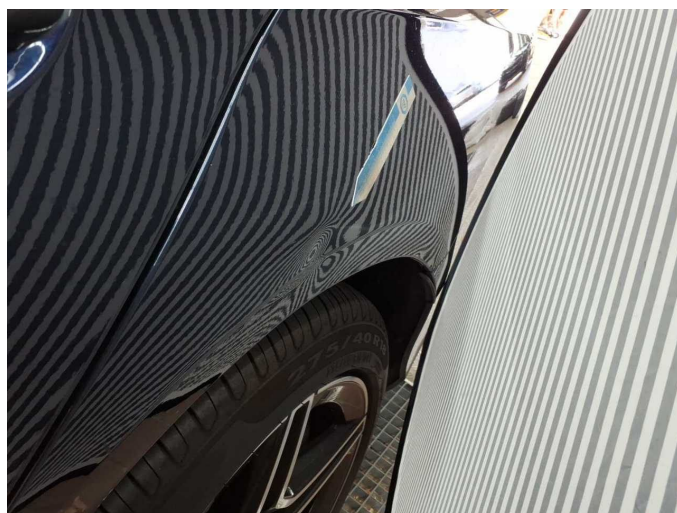
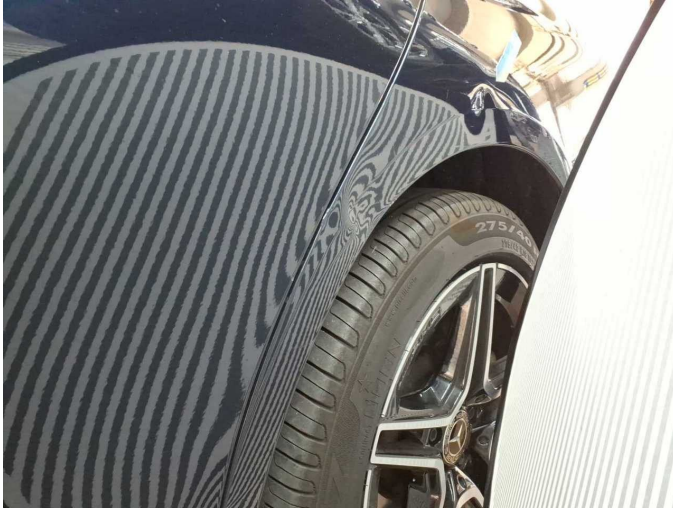
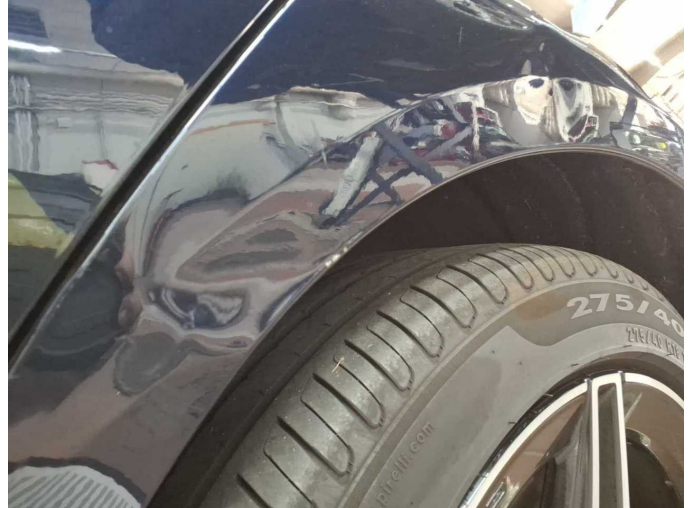
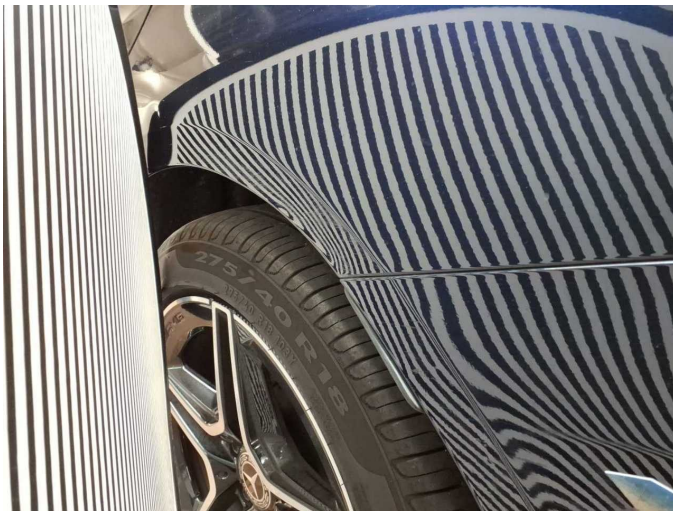
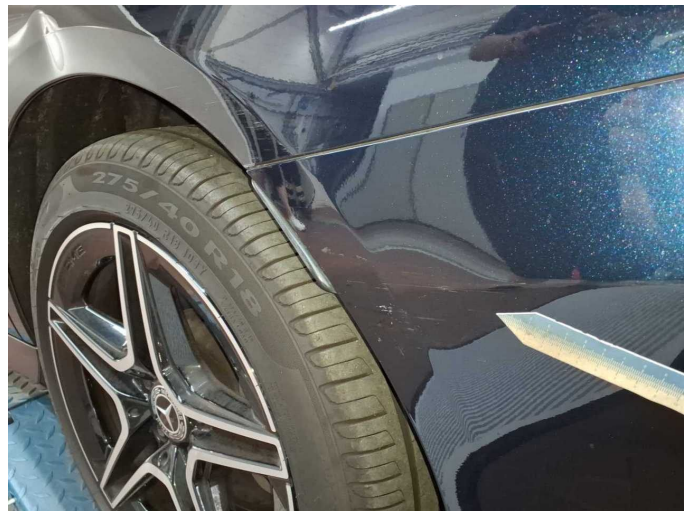
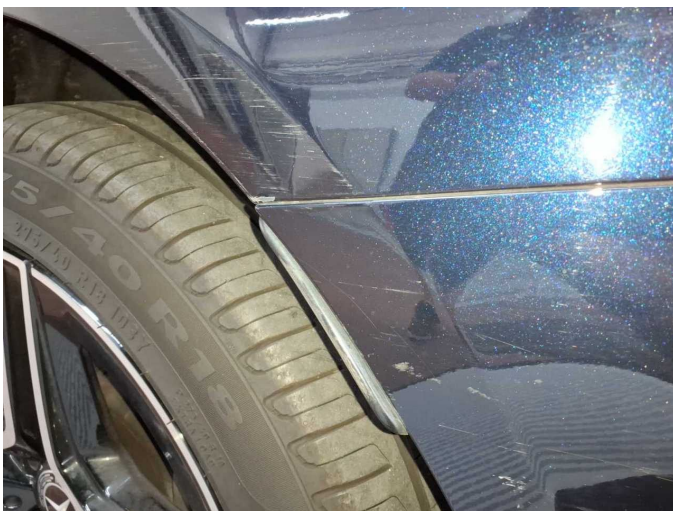
**Accident 1:** Rear, Side - left

**Accident 1: Rear, Side - left**

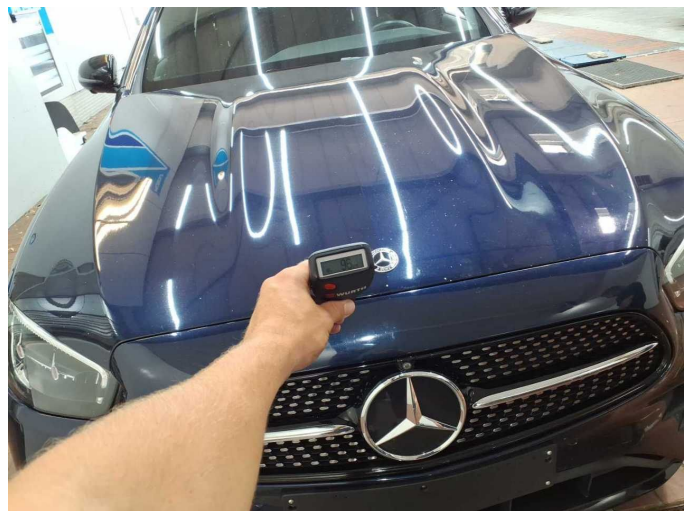
Non-repaired previous damages were found at the vehicle. The necessary repair costs are listed in the expert report or if necessary, are listed in detail in a separately enclosed repair cost calculation.

**Previous damage 1: Front**
