Expertise

Protocol number: 46196341  
Order No. / Reference: 26550322  
Inspection date: 26 Jun 2026

Manufacturer: Audi

Model: Q5 40 TDI quattro S tronic advanced

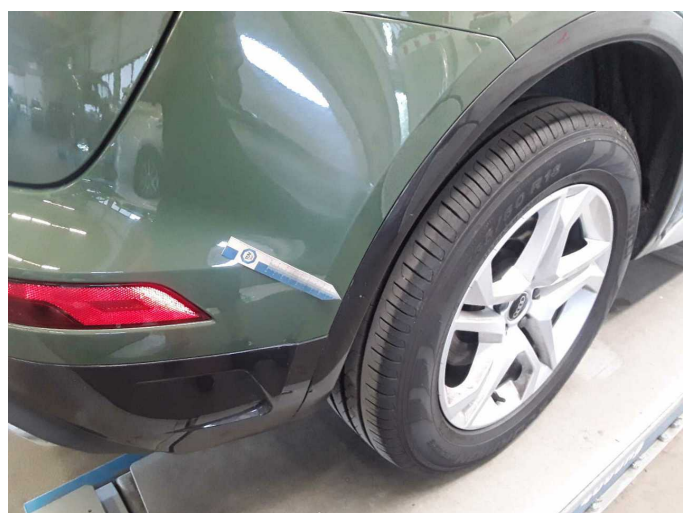
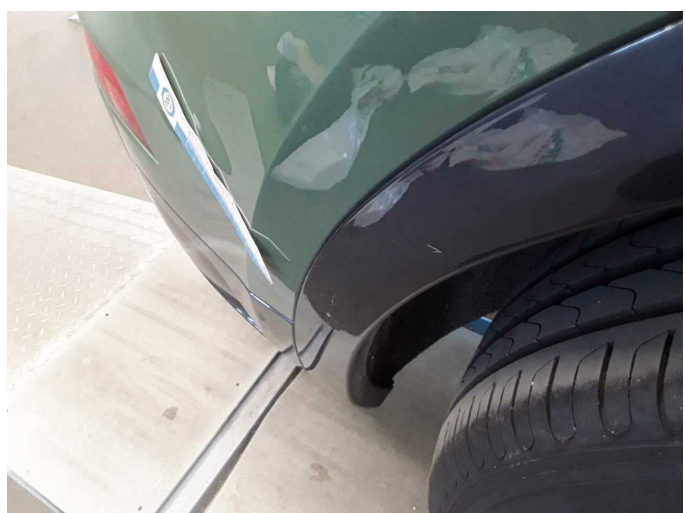
| No. | Component group | Description |
|---|---|---|
| 1 | Side panel - rear right side | Wheel arch - Scratch(es) - Smart repair |

**Damage 1:** Side panel - rear right side: Wheel arch - Scratch(es) - Smart repair

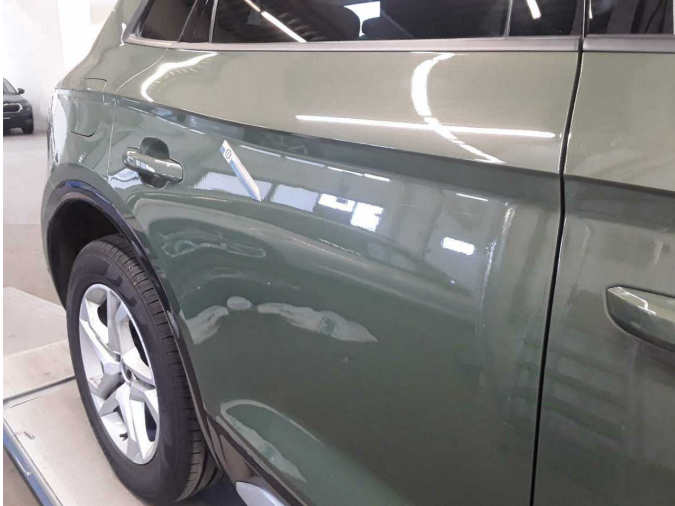
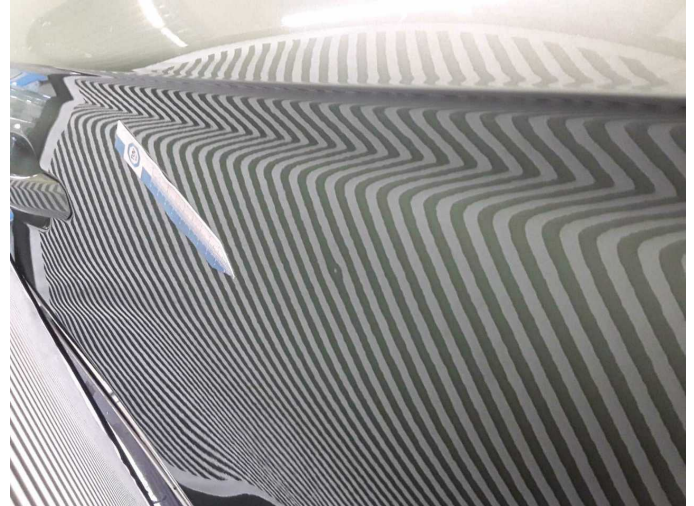
| No. | Component group | Description |
|---|---|---|
| 2 | Door - rear right side | Door - dent(s) - Smooth repair work |

**Damage 2:** Door - rear right side: Door - dent(s) - Smooth repair work

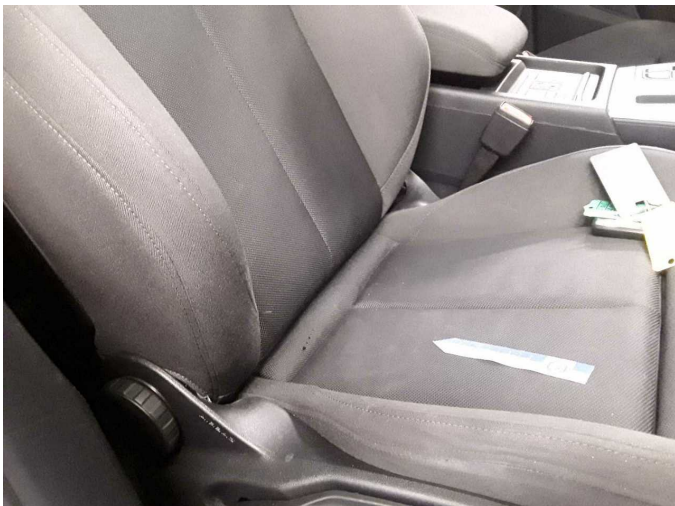
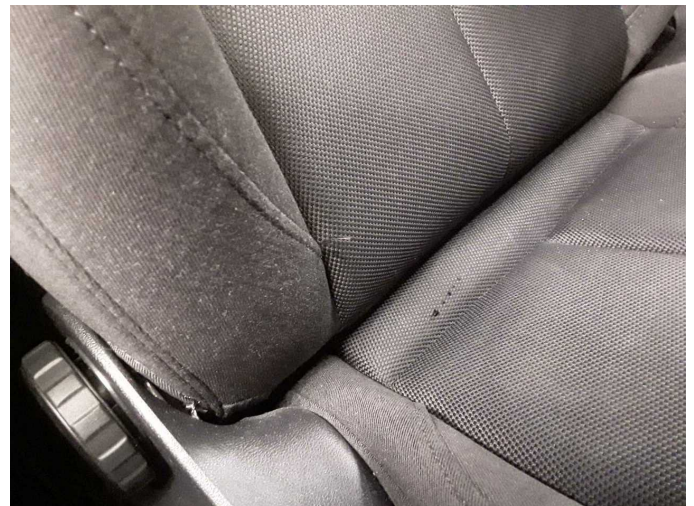
| No. | Component group | Description |
|---|---|---|
| 3 | Seat - front | Backrest cover - right side - Worn - Smart repair |

**Damage 3:** Seat - front: Backrest cover - right side - Worn - Smart repair

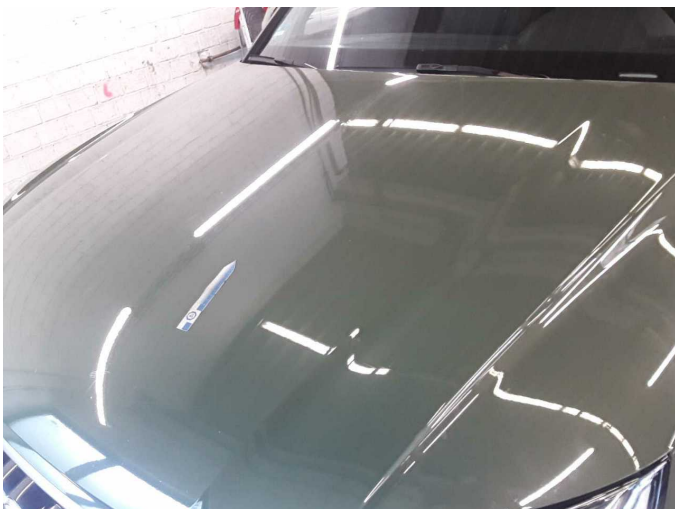
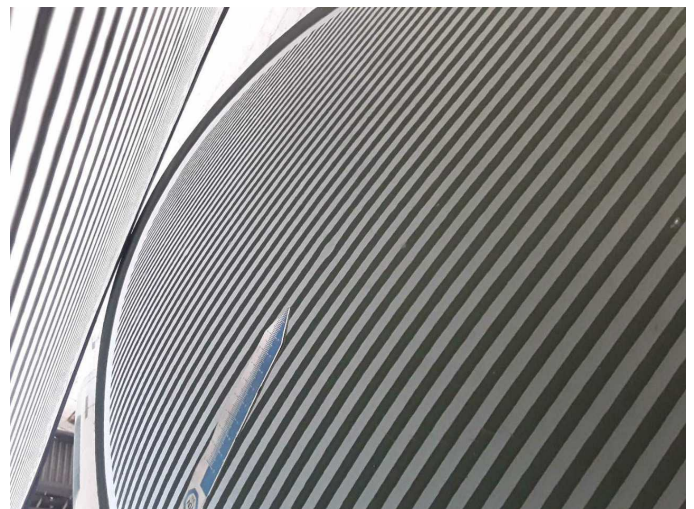
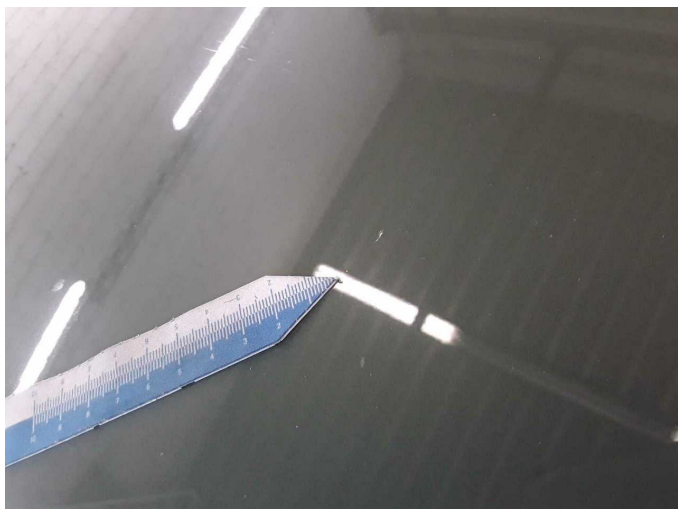
| No. | Component group | Description |
|---|---|---|
| 4 | Bonnet | Bonnet - Dent / paintcoat damage - Repair and paint |

**Damage 4:** Bonnet: Bonnet - Dent / paintcoat damage - Repair and paint

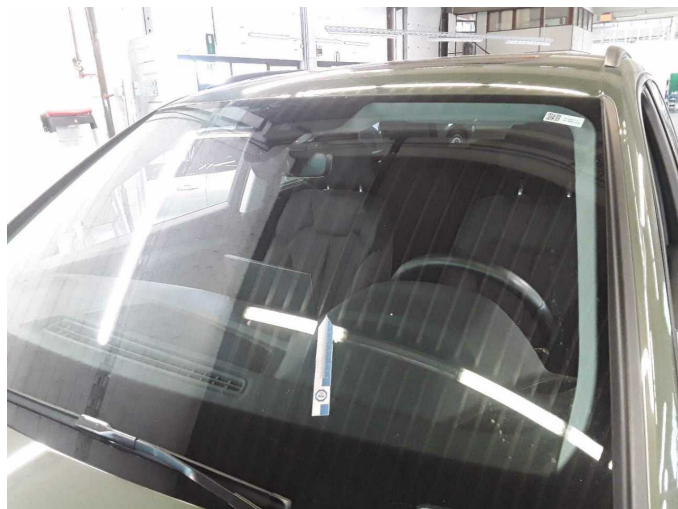
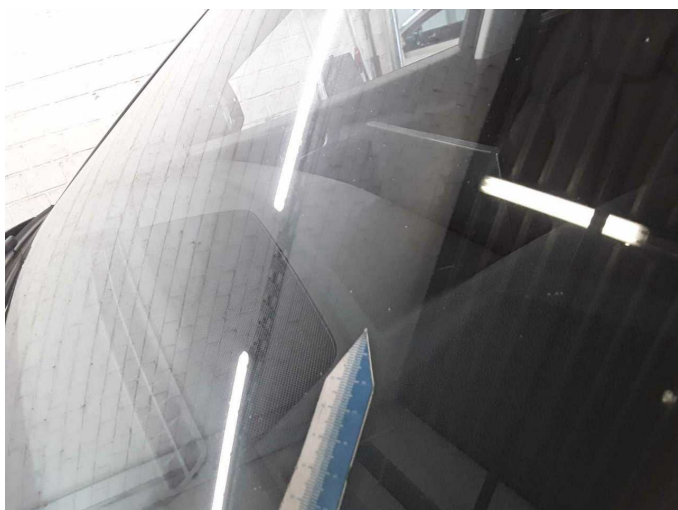
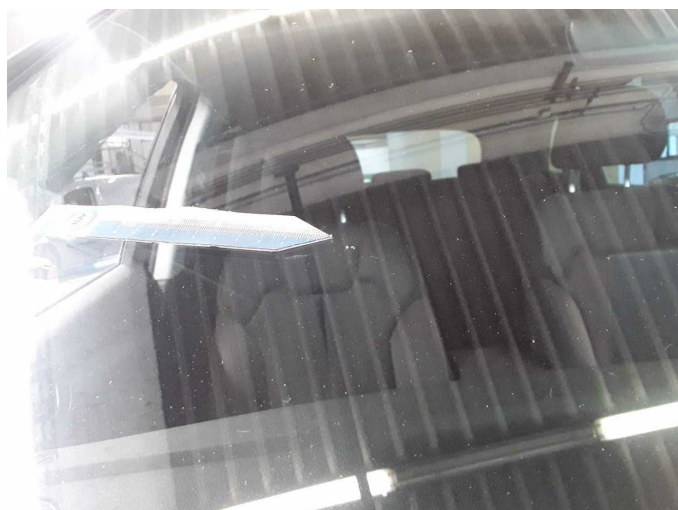
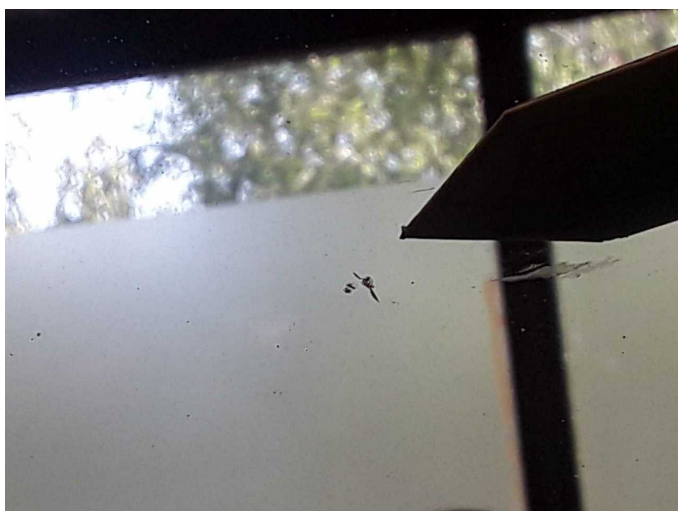
| No. | Component group | Description |
|---|---|---|
| 5 | Vehicle glazing | Windscreen (Rissbildung) - Stone chips - Replace |

**Damage 5:** Vehicle glazing: Windscreen (Rissbildung) - Stone chips - Replace
