Expertise

Protocol number: 46496921  
Order No. / Reference: 26626749  
Inspection date: 14 Jul 2026

Manufacturer: Audi  
VIN: WAUZZZF3XP1122854

Model: Q3 40 TDI quattro S tronic S line

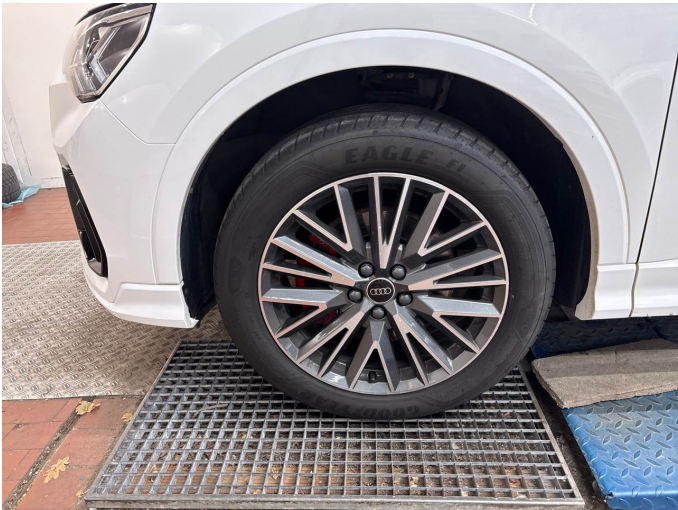
| # | Tyre size | Type of tyre | Manufacturer | Tread depth |
|---|---|---|---|---|
| 1) | 235/50 R19 99V | Summer tyres on Light alloy | Goodyear | 5mm / 5mm |
| 2) | 235/50 R19 99V | Summer tyres on Light alloy | Goodyear | 5mm / 5mm |

Figure 12: Mounted tyres

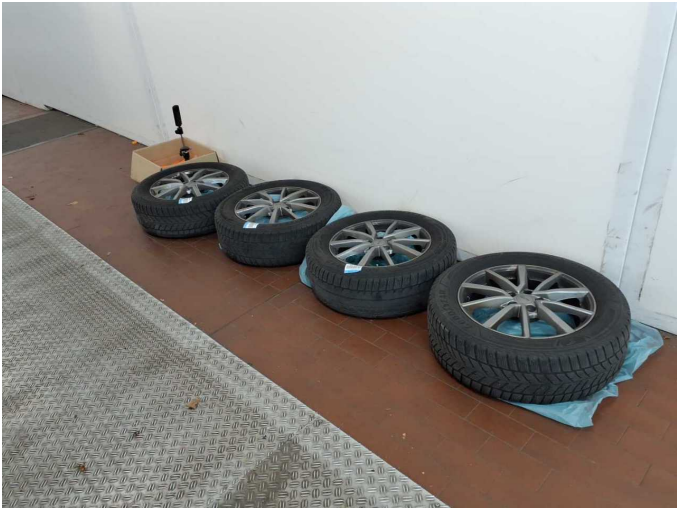
| # | Tyre size | Type of tyre | Manufacturer | Tread depth |
|---|---|---|---|---|
| 1) | 215/65 R17 99V | Winter tyres on Light alloy | Goodyear | 0mm / 0mm |
| 2) | 215/65 R17 99V | Winter tyres on Light alloy | Goodyear | 2mm / 2mm |

| No. | Component group | Description |
|---|---|---|
| 2 | 2nd wheel set | Tyres - complete set - Worn - No deduction |

Figure 16: Additional tyres

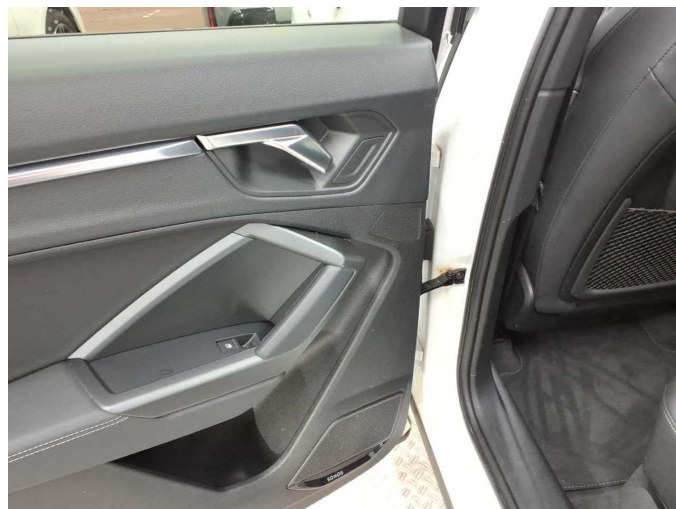
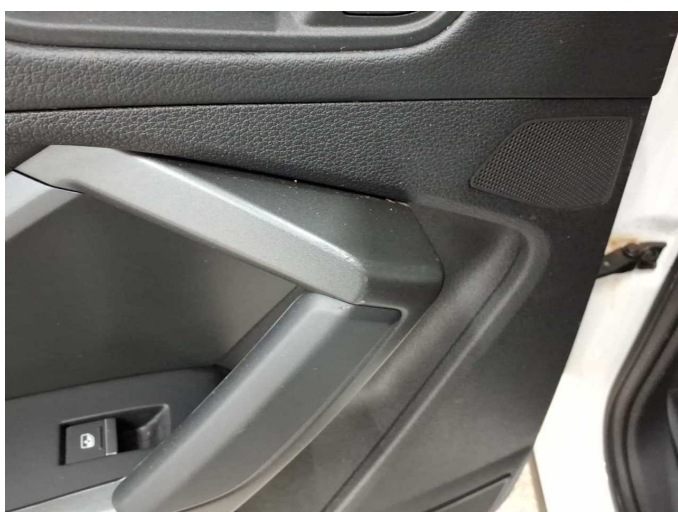
| No. | Component group | Description |
|---|---|---|
| 1 | Door - rear left side | Door handle - inside - Scratch(es) - Loss in value |

**Damage 1:** Door - rear left side: Door handle - inside - Scratch(es) - Loss in value

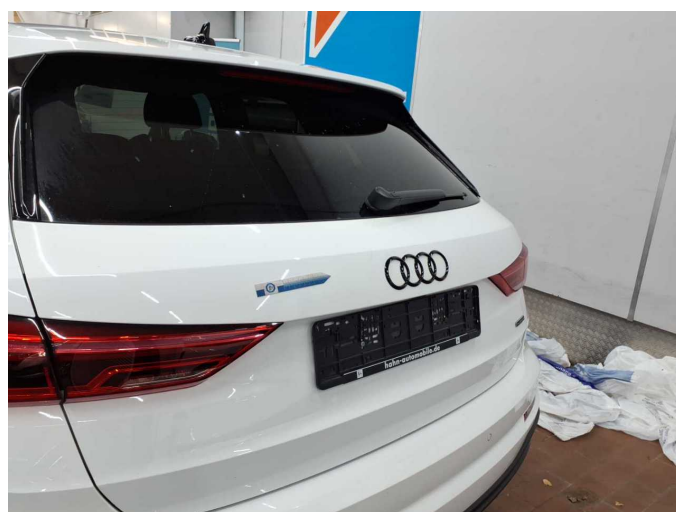
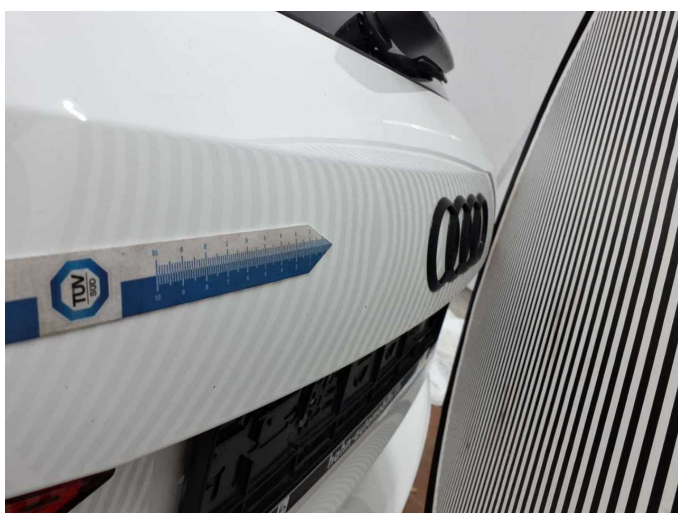
| No. | Component group | Description |
|---|---|---|
| 2 | Boot lid / rear door | Boot lid - dent(s) - Smart repair |

**Damage 2:** Boot lid / rear door: Boot lid - dent(s) - Smart repair

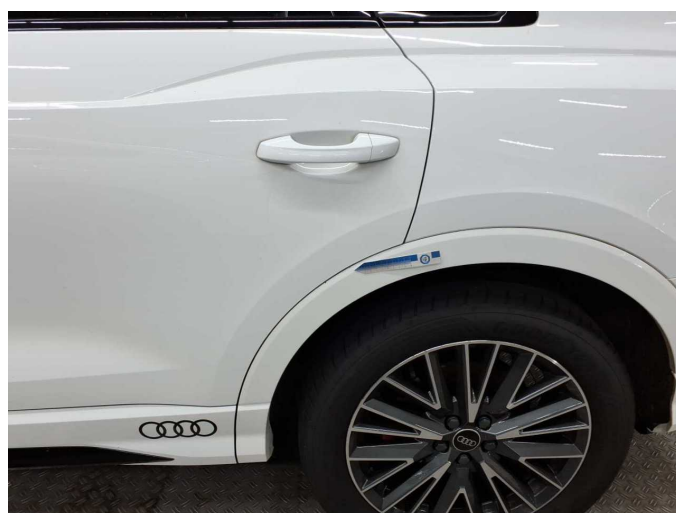
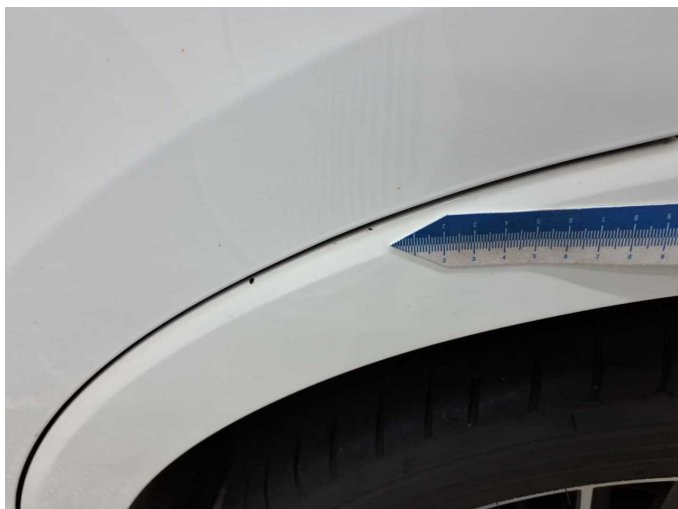
| No. | Component group | Description |
|---|---|---|
| 3 | Side panel - rear left side | Wheel well extension - Scratch(es) - Smart repair |

**Damage 3:** Side panel - rear left side: Wheel well extension - Scratch(es) - Smart repair

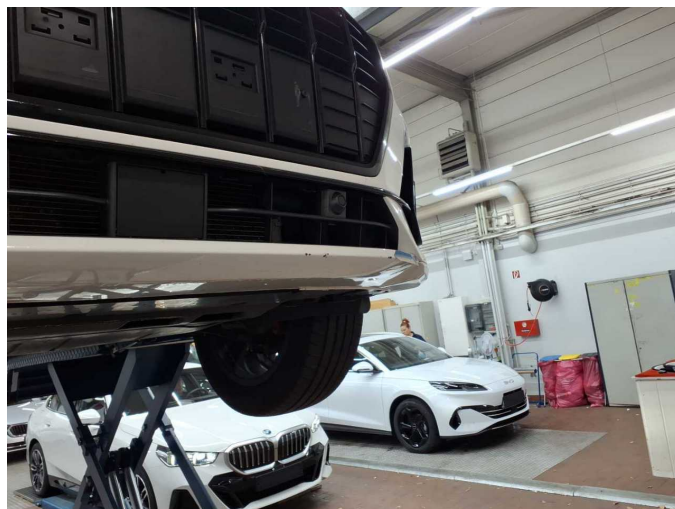
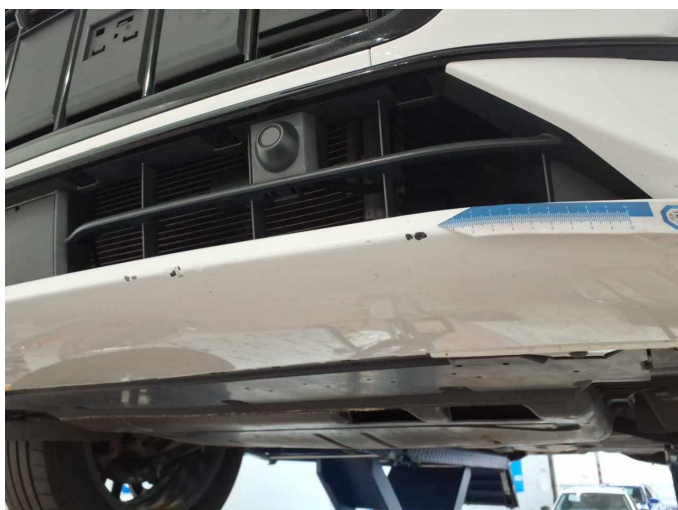
| No. | Component group | Description |
|---|---|---|
| 4 | Front bumper | Spoiler - Scratch(es) - Smart repair |

**Damage 4:** Front bumper: Spoiler - Scratch(es) - Smart repair

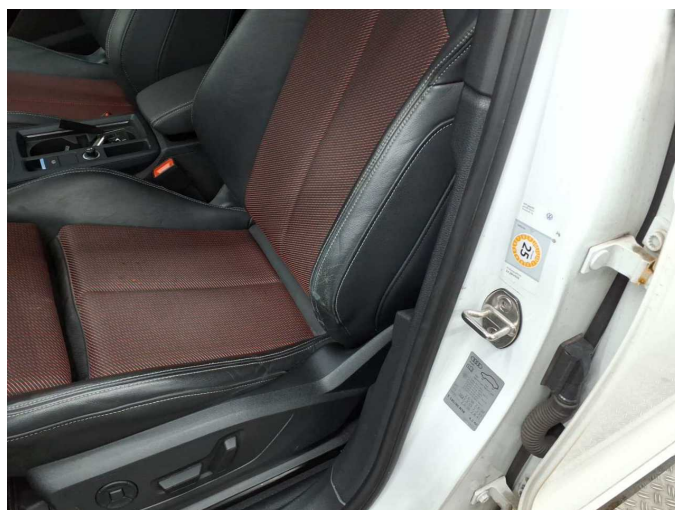
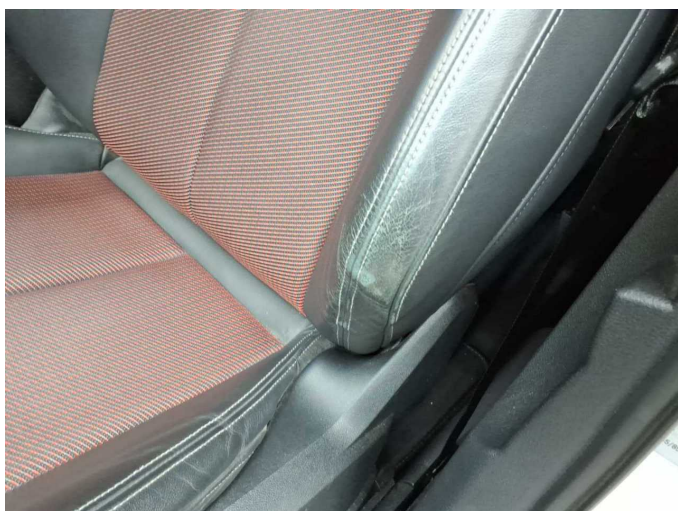
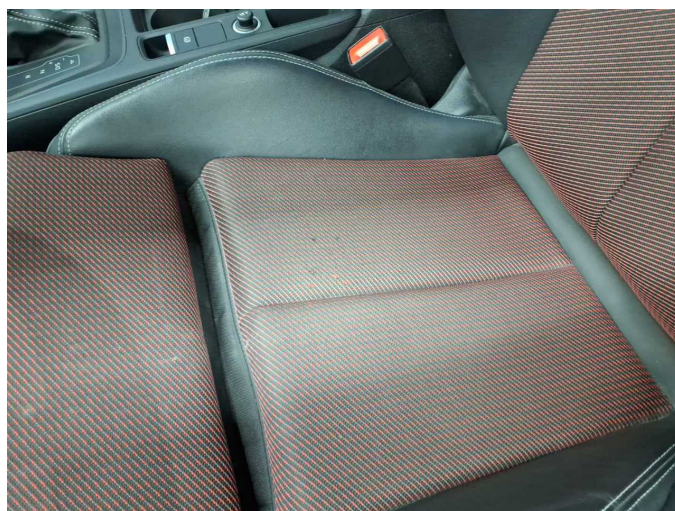
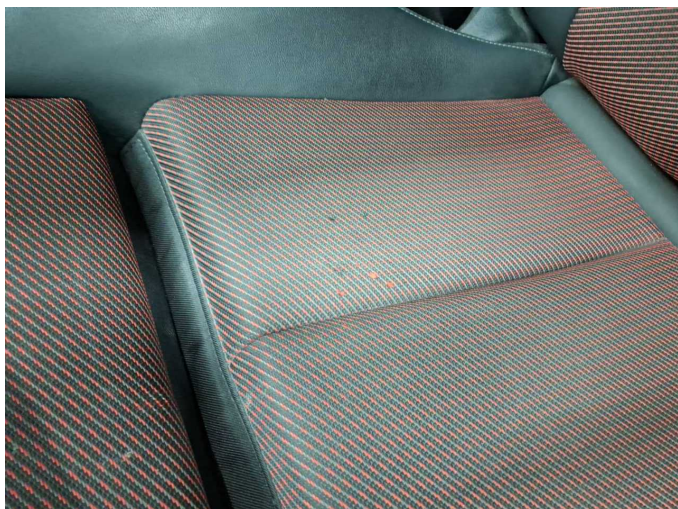
| No. | Component group | Description |
|---|---|---|
| 6 | Seat - front | Seat cover - left side - Abrasion - Loss in value |

**Damage 6:** Seat - front: Seat cover - left side - Abrasion - Loss in value

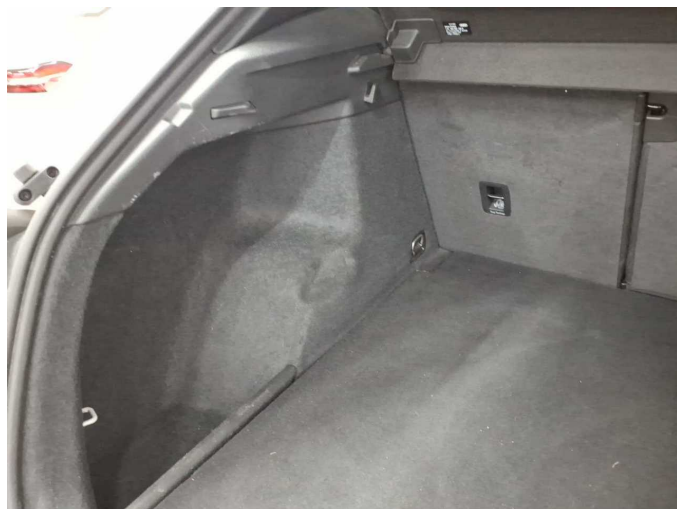
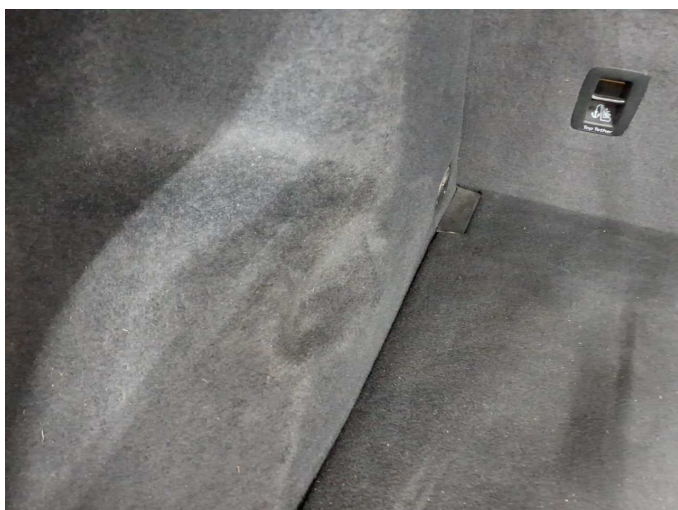
| No. | Component group | Description |
|---|---|---|
| 7 | Side panel - rear left side | Interior trim - Deformed - Replace |

**Damage 7:** Side panel - rear left side: Interior trim - Deformed - Replace

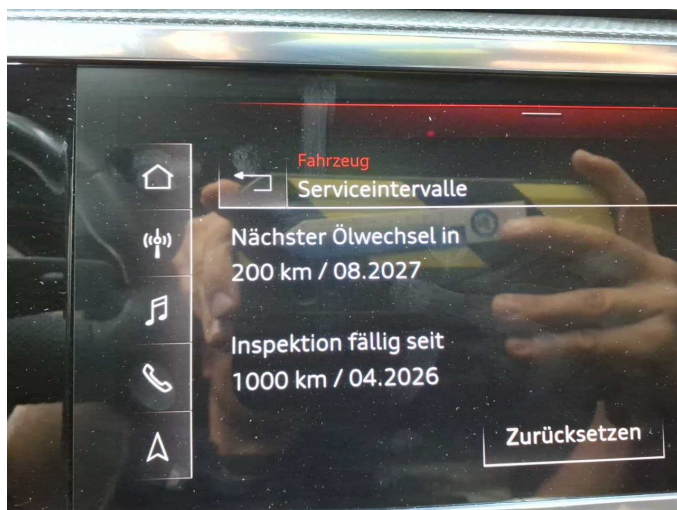
| No. | Component group | Description |
|---|---|---|
| 8 | Misc. | Inspection / maintenance - Due - Perform |

**Damage 8:** Misc.: Inspection / maintenance - Due - Perform

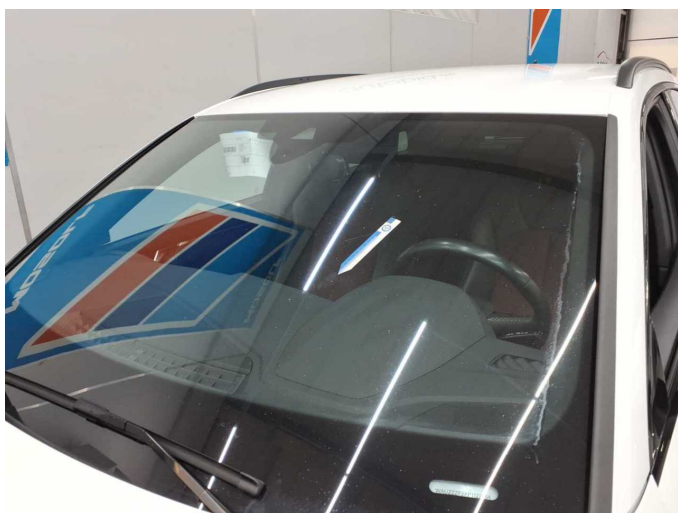
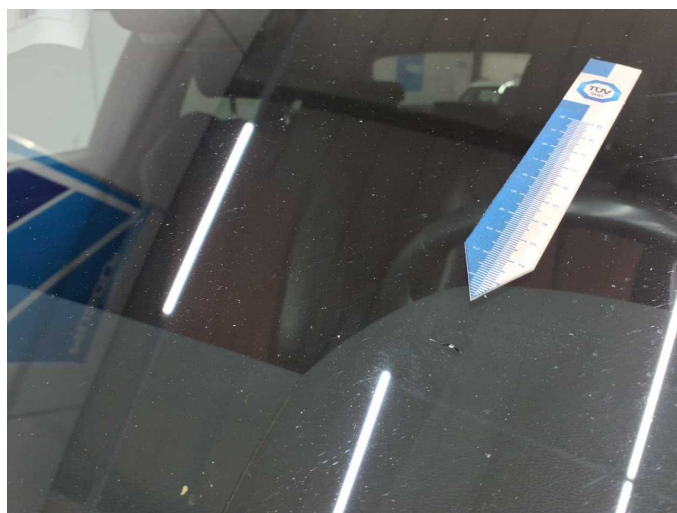
| No. | Component group | Description |
|---|---|---|
| 9 | Vehicle glazing | Windscreen - Stone chips - Replace |

**Damage 9:** Vehicle glazing: Windscreen - Stone chips - Replace

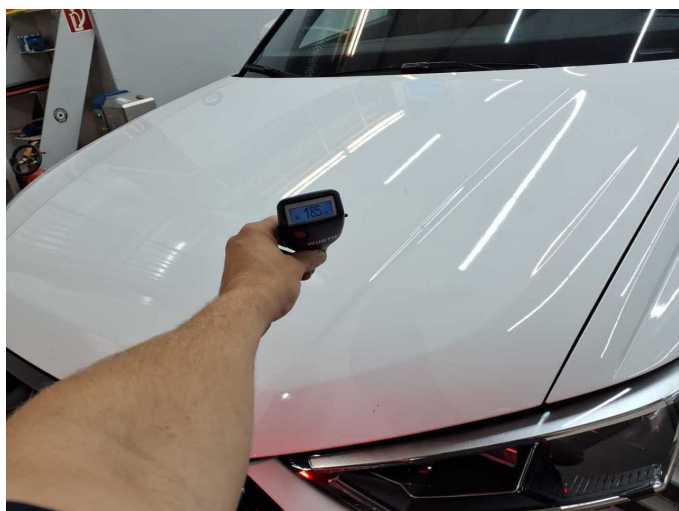
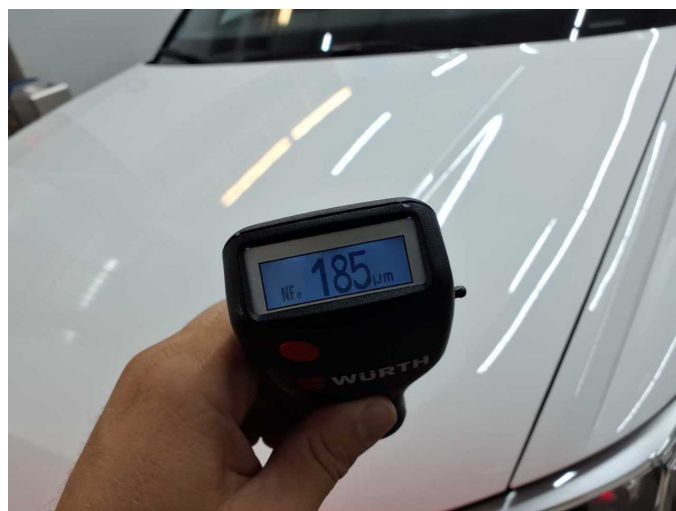
1 Bonnet, Professionally carried out, Invoice of repair done Non-existent

Bonnet 185 µm

**Repainting 1: Bonnet**
