Expertise

Protocol number: 46276935
Order No. / Reference: 26582102
Inspection date: 30 Jun 2026

Model: Tiguan Allspace 2.0 TDI SCR DSG Life

VIN: WVGZZZ5N6PM021696

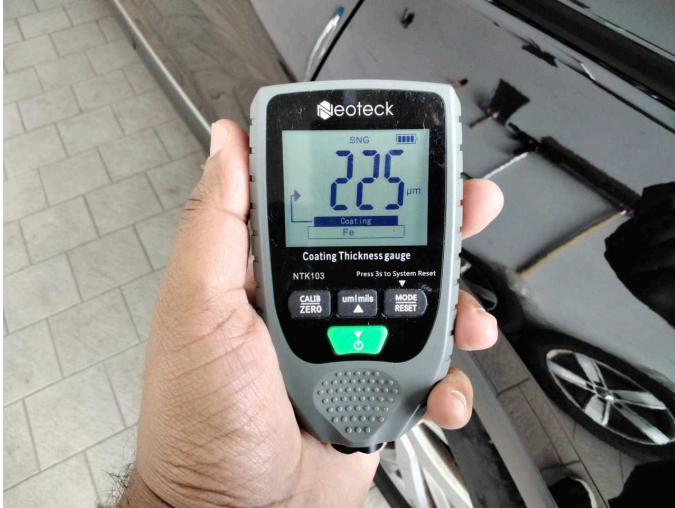
Side panel - rear left side: 225 µm
