## Expertise

Protocol number: 45911002  
Order No. / Reference: 26397913  
Inspection date: 8 Jun 2026

Model: Superb Combi 1.4 TSI iV DSG Style

VIN: TMBJW7NP8M7050689

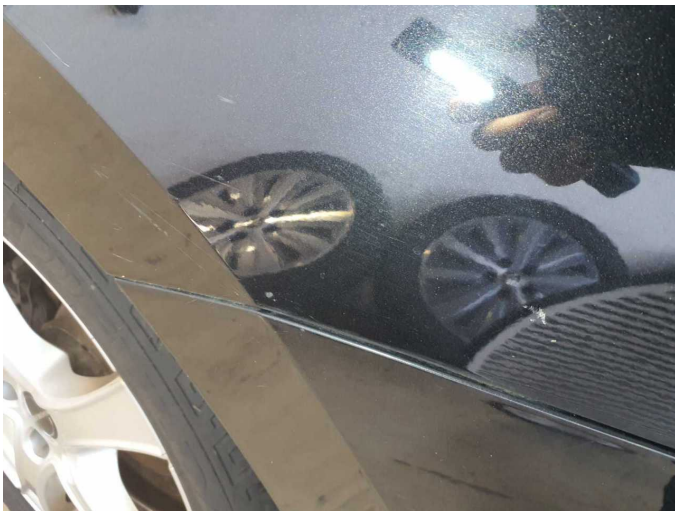
Accident 1: Side - left

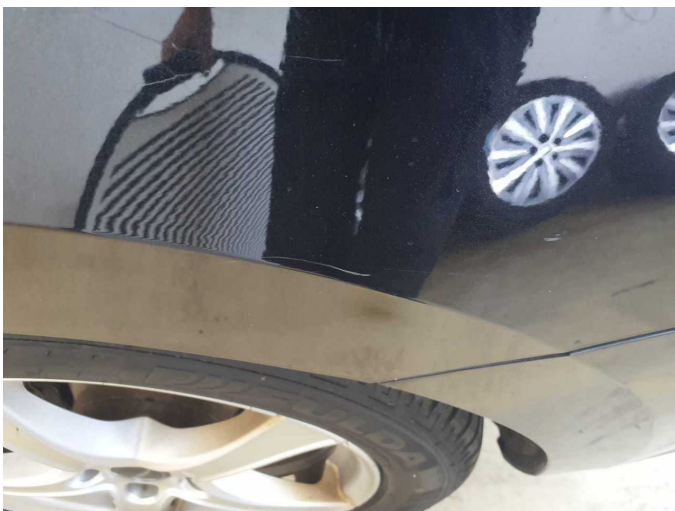
Accident 1: Side - left

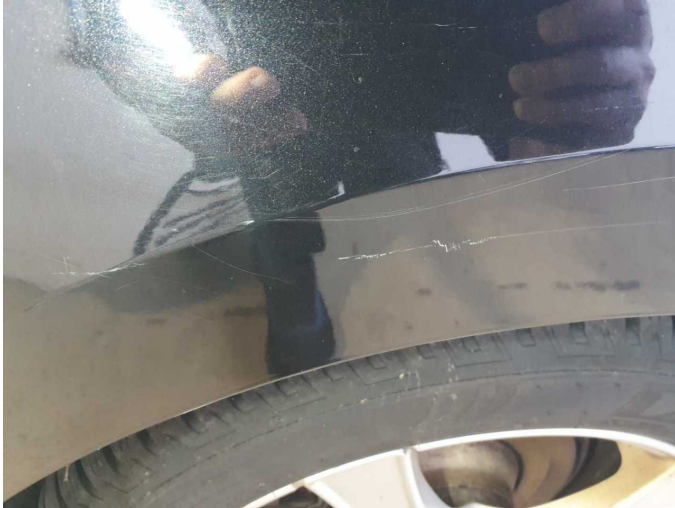
**Accident 1: Side - left**

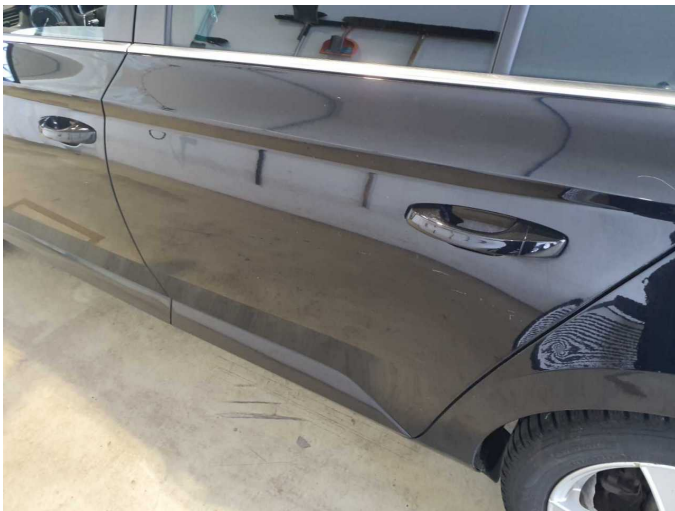
**Accident 1: Side - left**

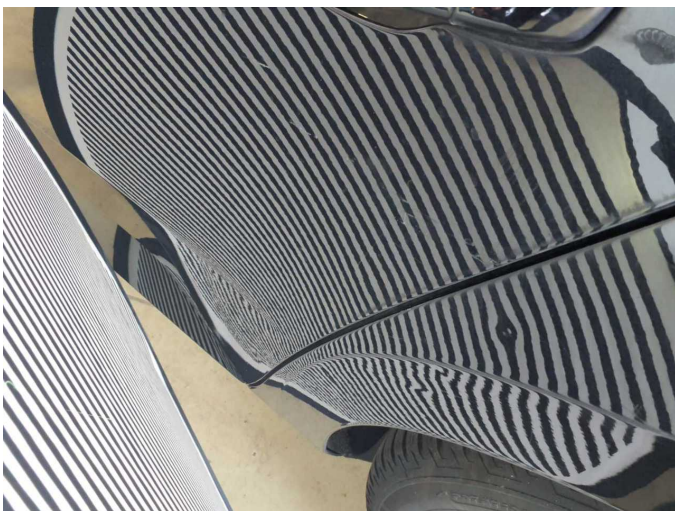
**Accident 1: Side - left**

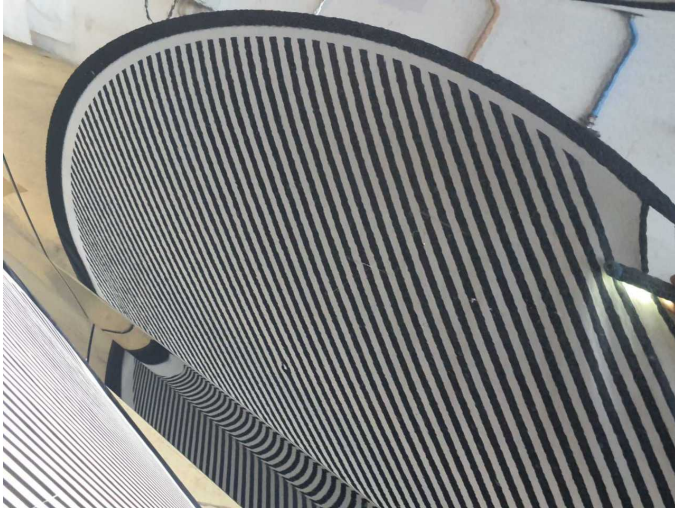
**Accident 1: Side - left**

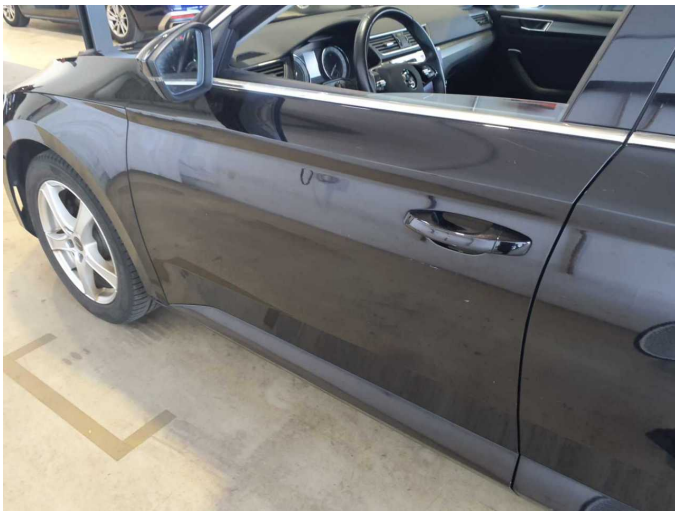
**Accident 1: Side - left**

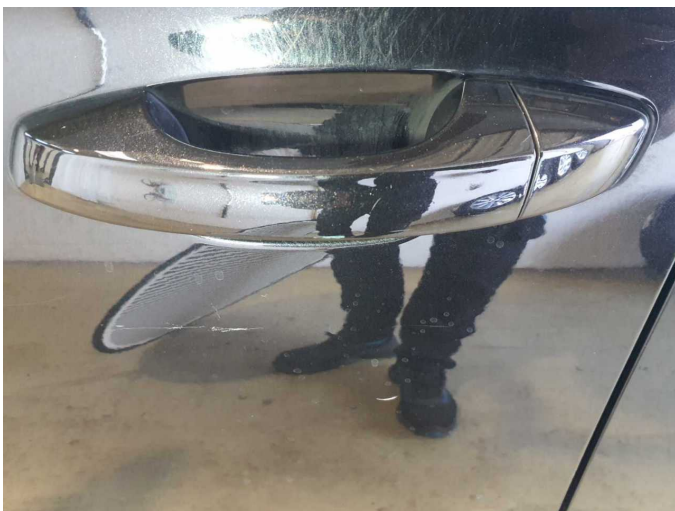
**Accident 1: Side - left**

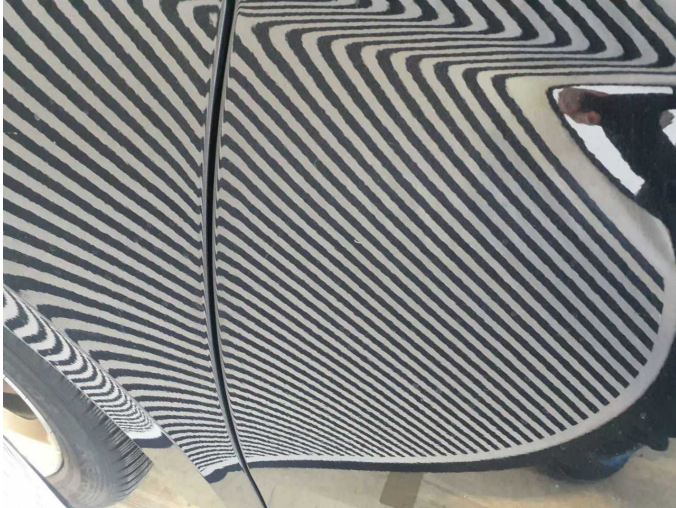
Accident 1: Side - left

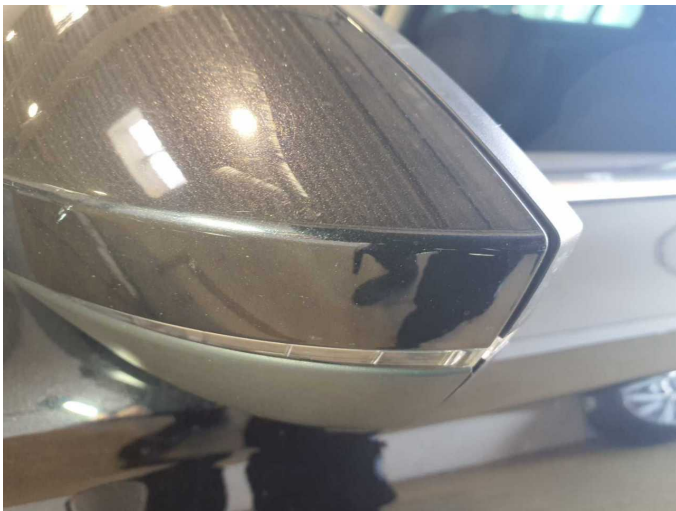
Accident 1: Side - left

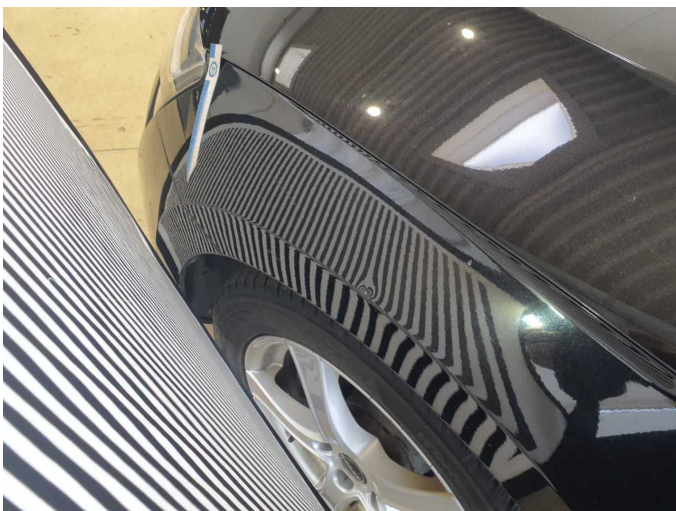
Accident 1: Side - left

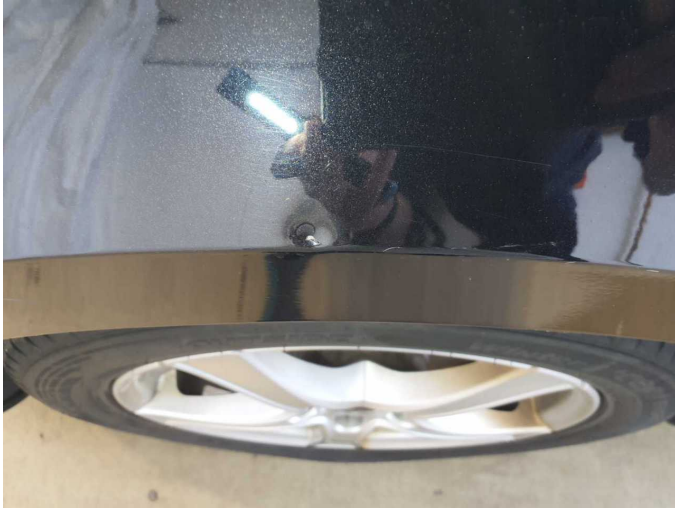
**Accident 1: Side - left**
