Expertise

Protocol number: 46289191
Order No. / Reference: 26627660
Inspection date: 2 Jul 2026

Manufacturer: Opel

Model: Insignia Sports Tourer 2.0 Diesel Aut. Business Edition

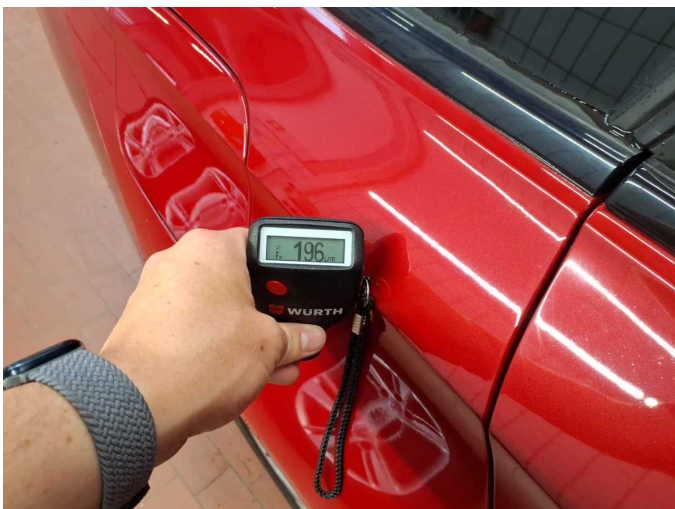
Repainting 3: Side panel - rear right side
