## Expertise

Protocol number: 45529990  
Order No. / Reference: 26335487  
Inspection date: 19 May 2026

Manufacturer: Skoda

Model: Kodiaq 2.0 TDI 4x4 DSG Style

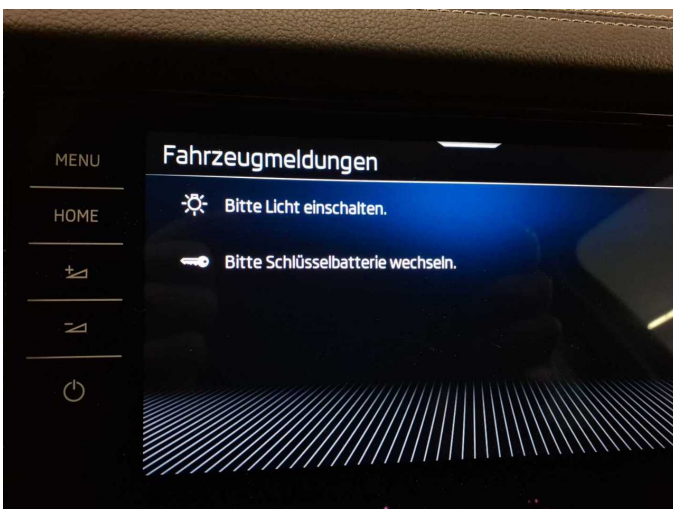
**Damage 1:** Equipment: Vehicle key with remote control (Batterie) - Due - Replace
