Expertise

Protocol number: 46872489  
Order No. / Reference: 26754769  
Inspection date: 4 Aug 2026

Manufacturer: Ford

Model: Focus Turnier 2.0 EcoBlue Start-Stopp-System Aut.  
COOL&CONNECT

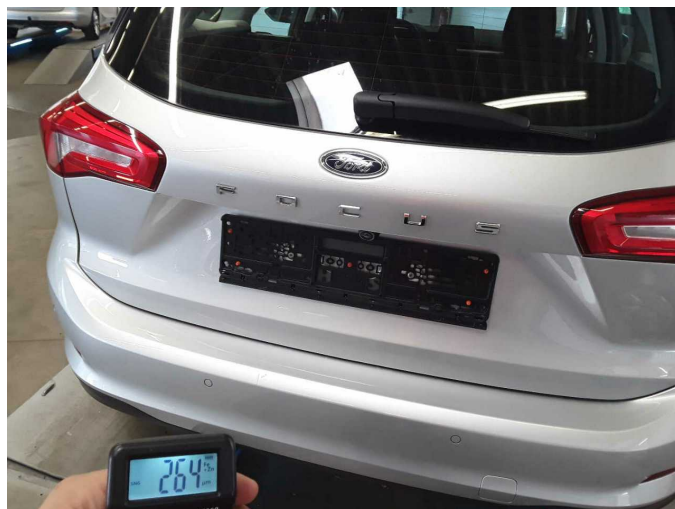
Boot lid / rear door: 264 µm

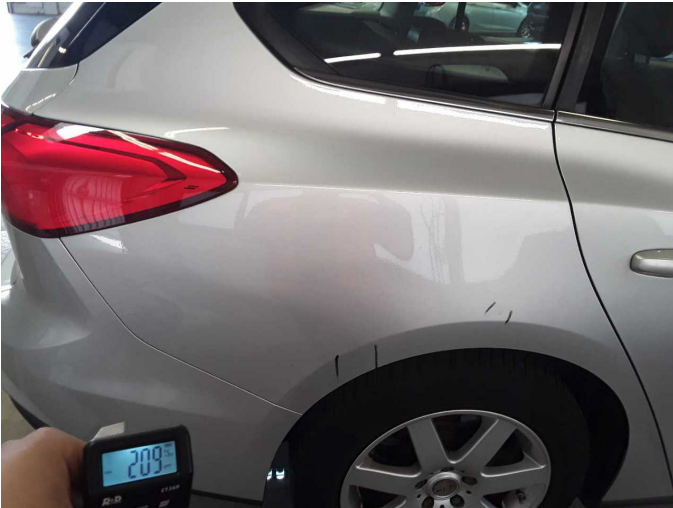
Side panel - rear right side: 209 µm
