## Expertise

Protocol number: 46238637  
Order No. / Reference: 26350006  
Inspection date: 26 Jun 2026

Manufacturer: Ford

Model: e-Transit 350 L3H3 Lkw HA Basis

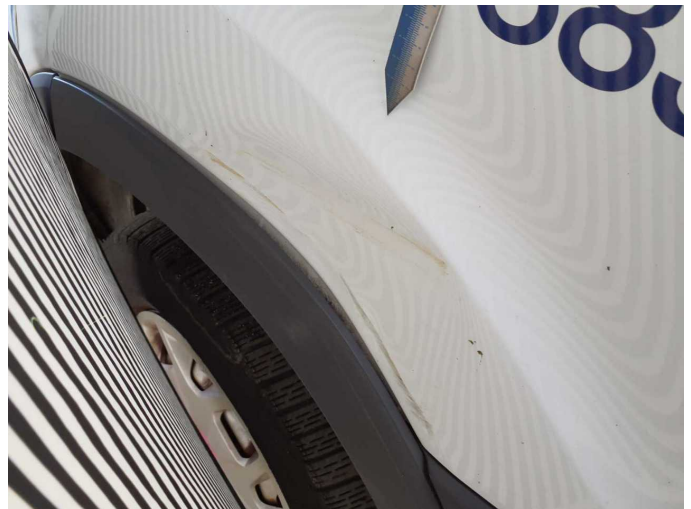
**Accident 1:** Front, Side right

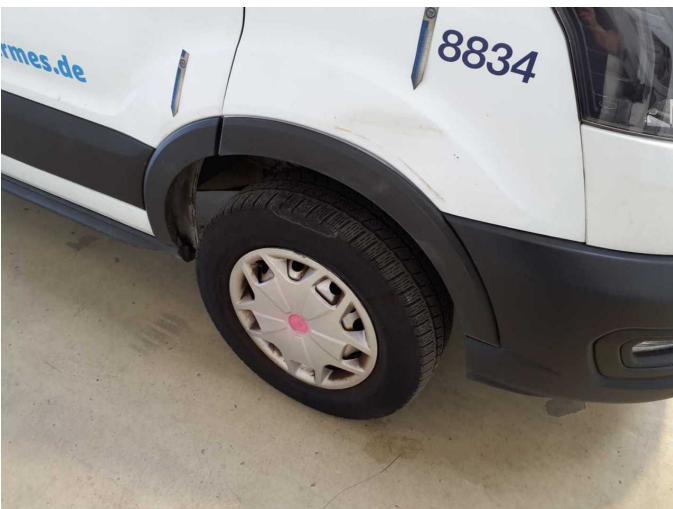
**Accident 1:** Front, Side right

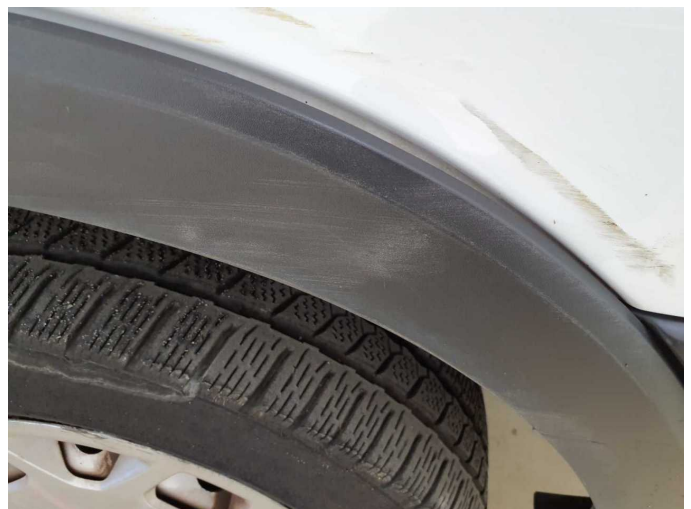
**Accident 1:** Front, Side right

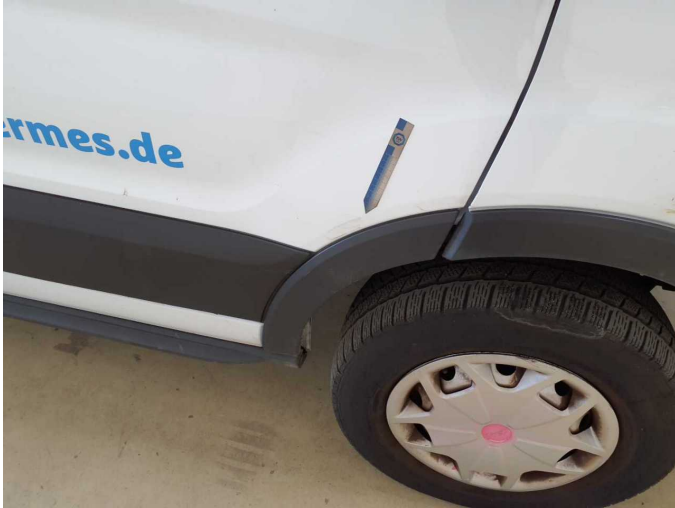
Accident 1: Front, Side right

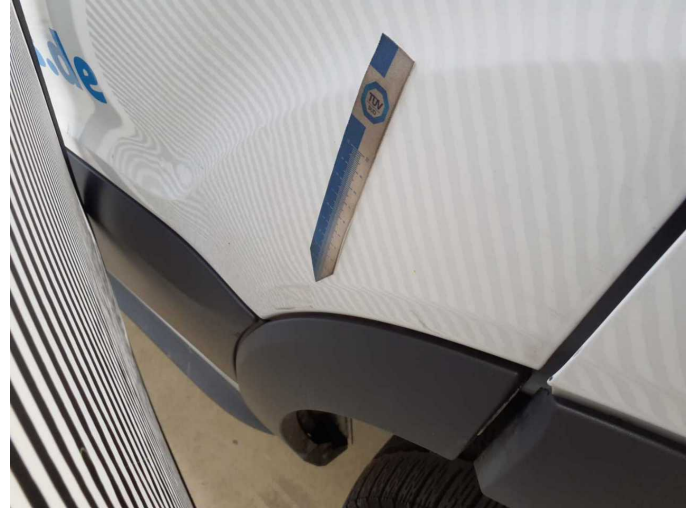
Accident 1: Front, Side right

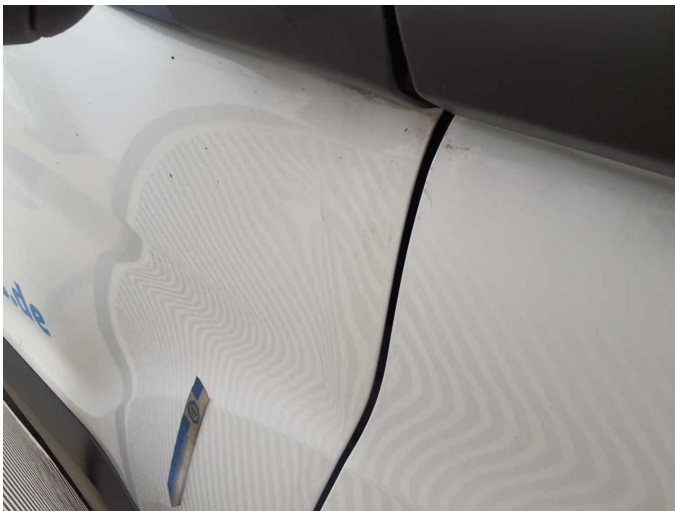
Accident 1: Front, Side right

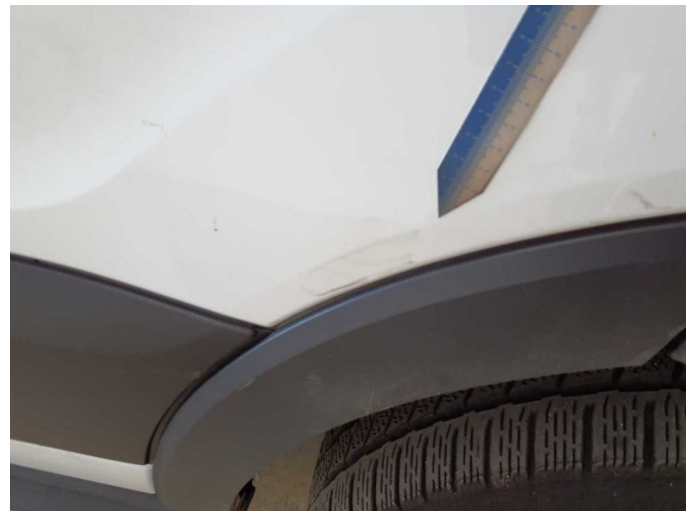
Accident 1: Front, Side right

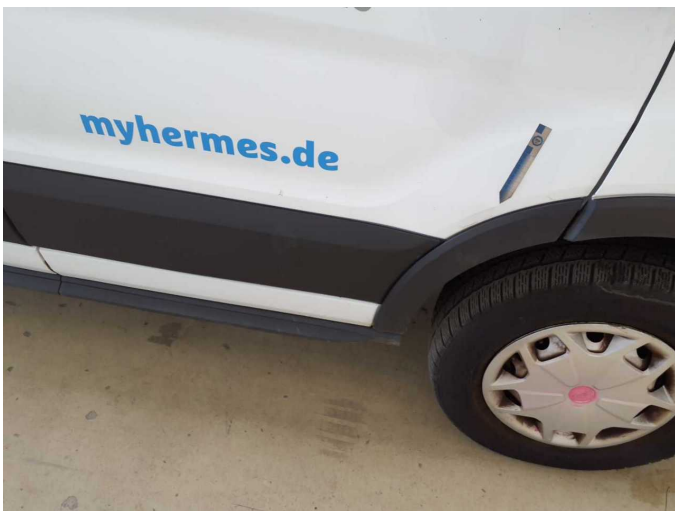
Accident 1: Front, Side right

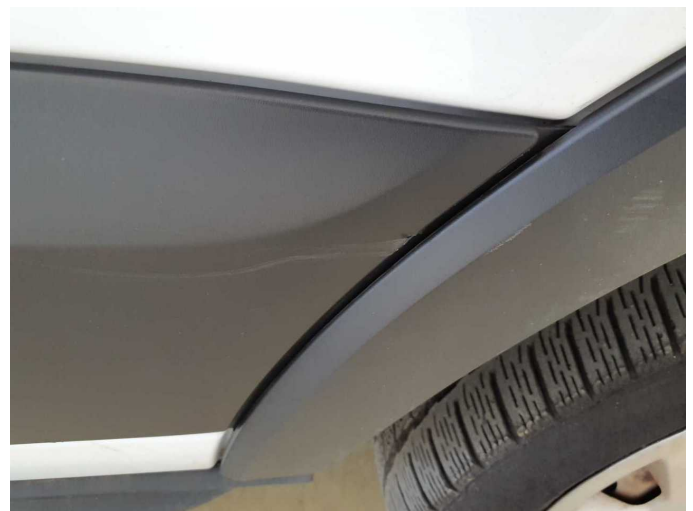
Accident 1: Front, Side right

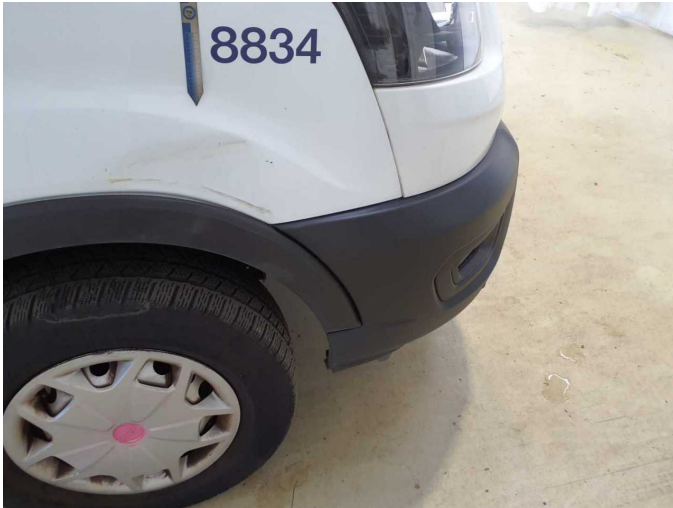
Accident 1: Front, Side right

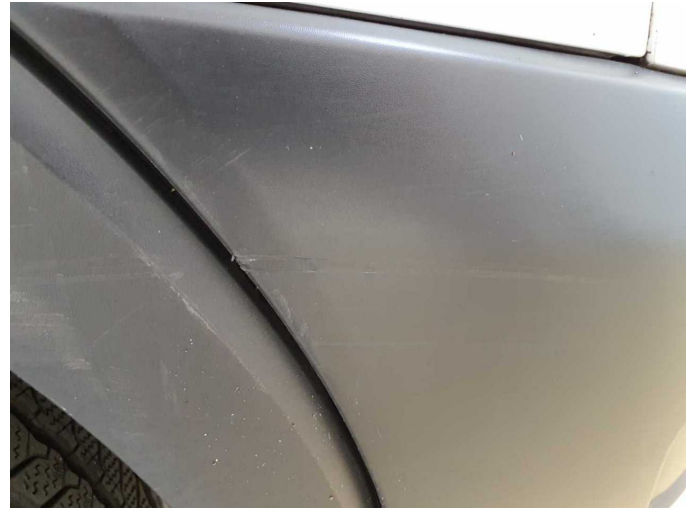
Accident 1: Front, Side right

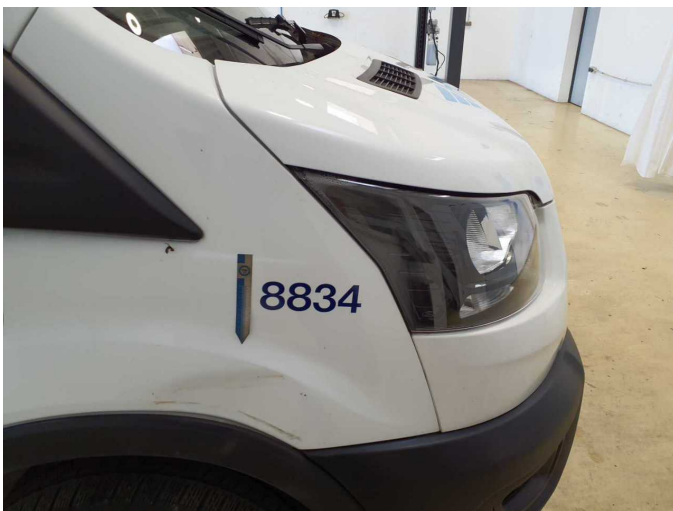
Accident 1: Front, Side right

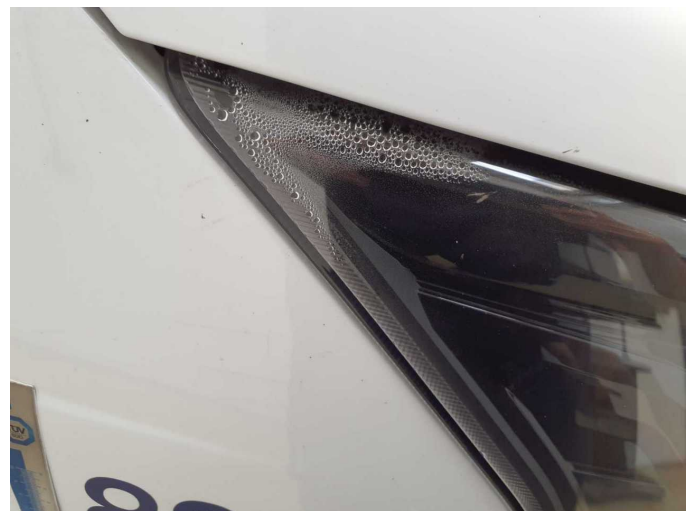
Accident 1: Front, Side right

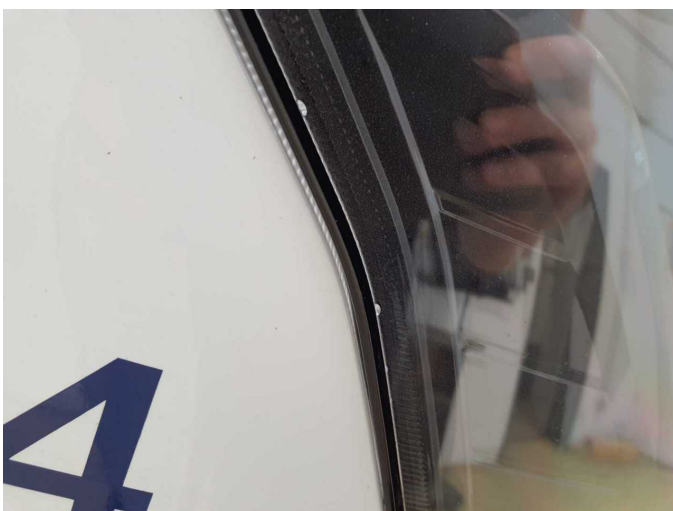
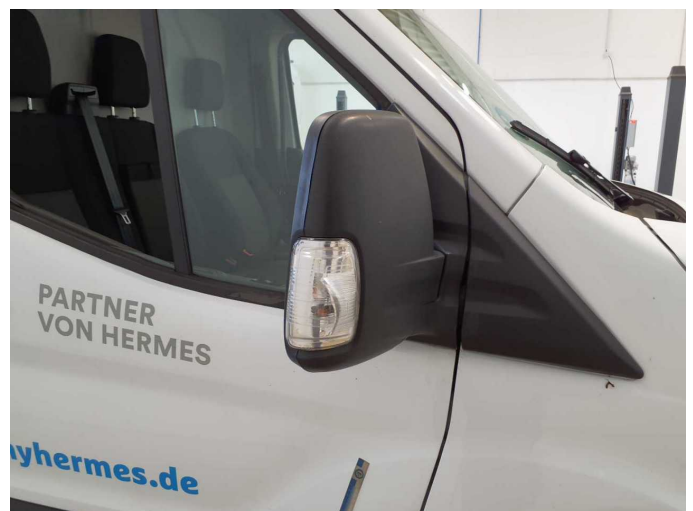
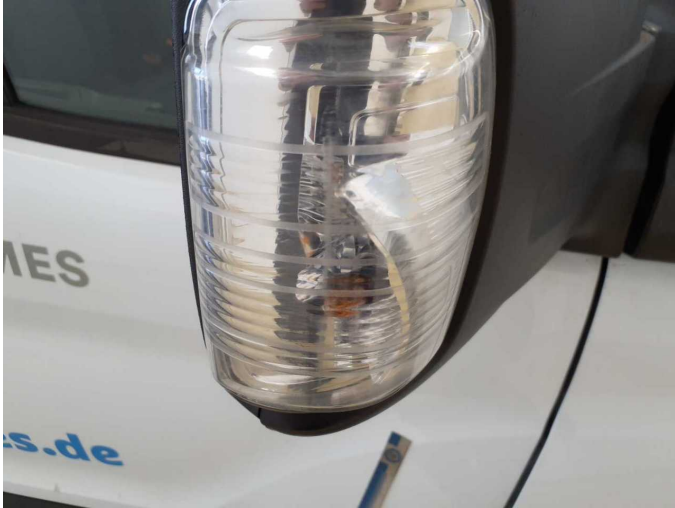
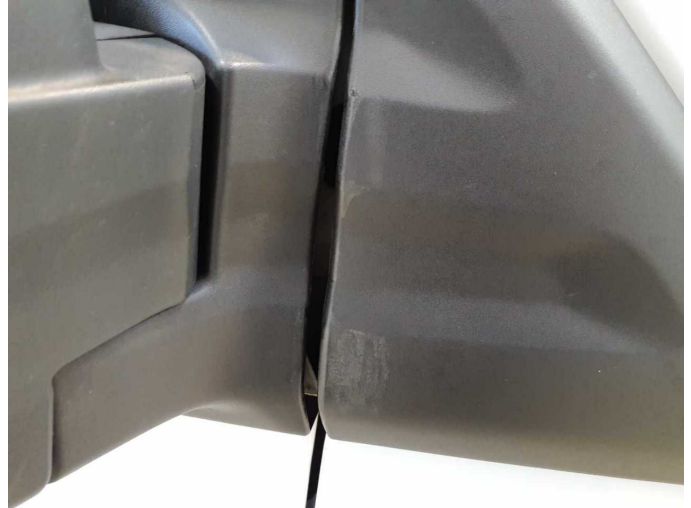
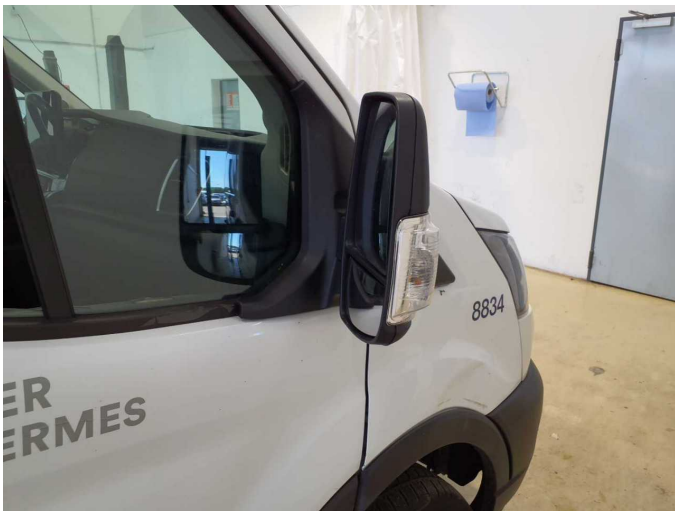
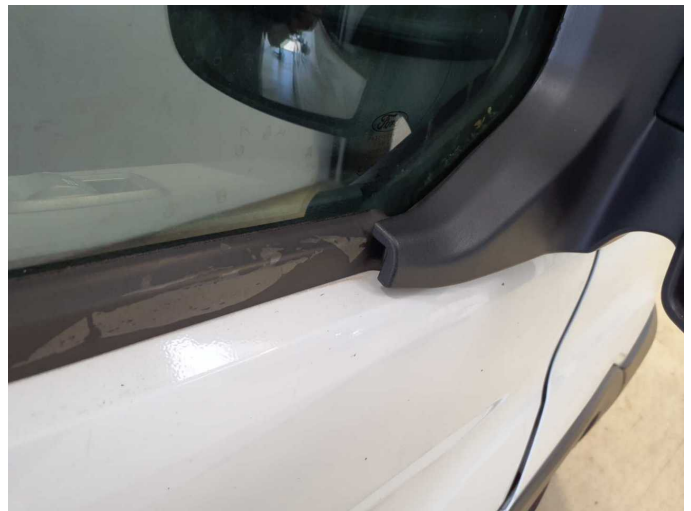
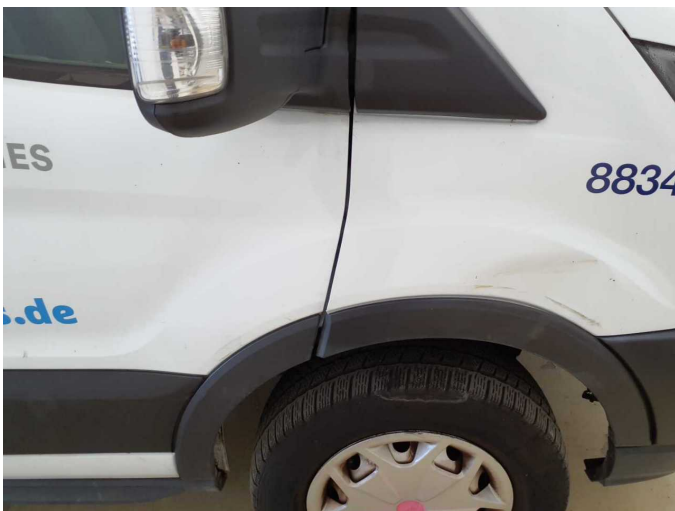
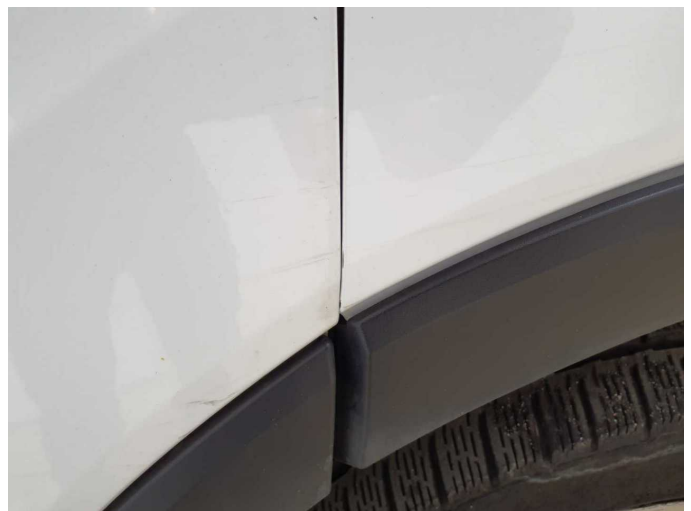
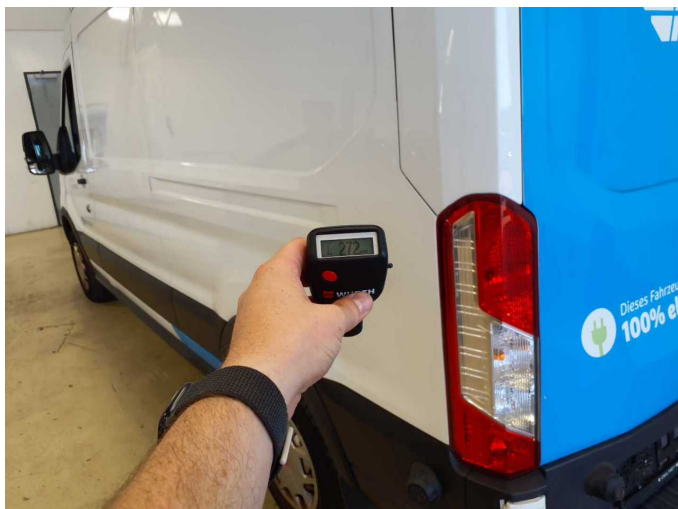
Accident 1: Front, Side right

**Accident 1:** Front, Side right

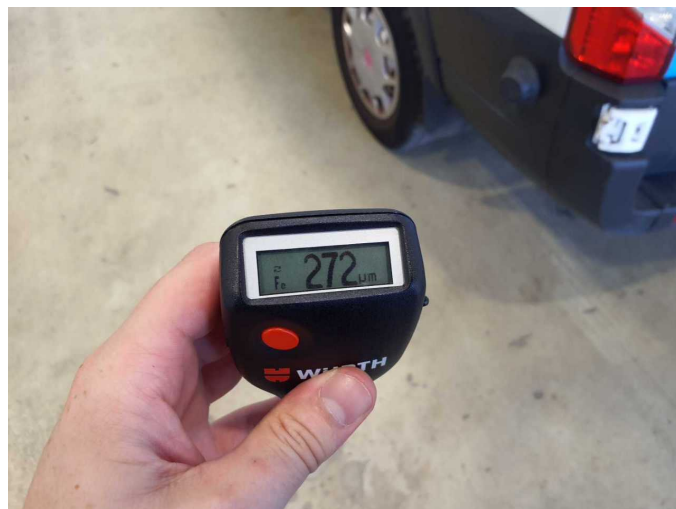
Repainting 1: Side panel - rear left side
