Expertise

Protocol number: 45861342
Order No. / Reference: 26476003
Inspection date: 9 Jun 2026

Model: S-Max 2.5 Duratec FHEV TITANIUM

VIN: WF0JXXWPCHPC17726

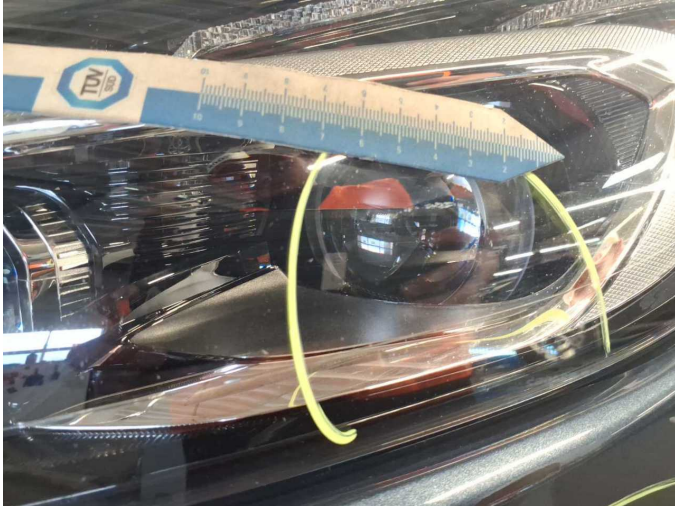
1 Bonnet, Professionally carried out, Invoice of repair done Non-existent

Accident 1: Front

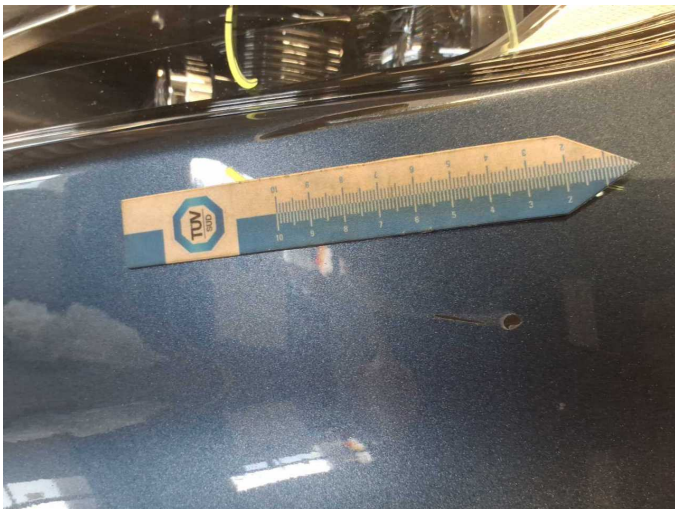
Accident 1: Front

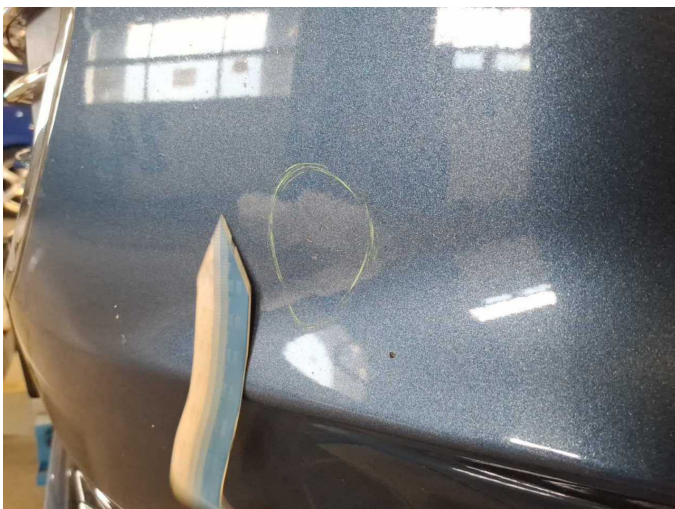
Accident 1: Front

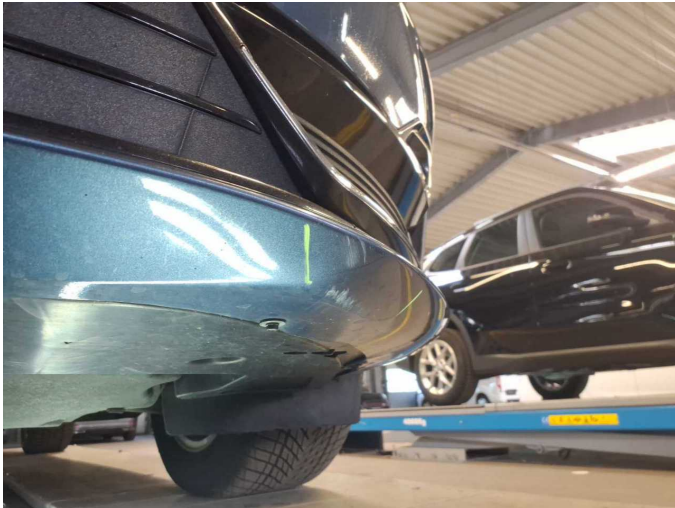
Accident 1: Front
