Expertise

Protocol number: 46550588  
Order No. / Reference: 26566618  
Inspection date: 15 Jul 2026

Manufacturer: Ford

Model: Kuga 2.5 Duratec PHEV TITANIUM X

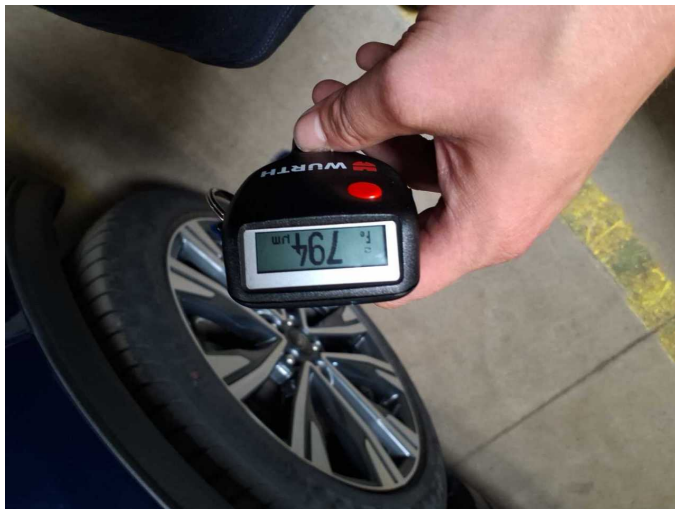
| No. | Repainting |
|---|---|
| 2 | Side panel - rear left side, Professionally carried out, Invoice of repair done Non-existent |

**Repainting 2:** Side panel - rear left side

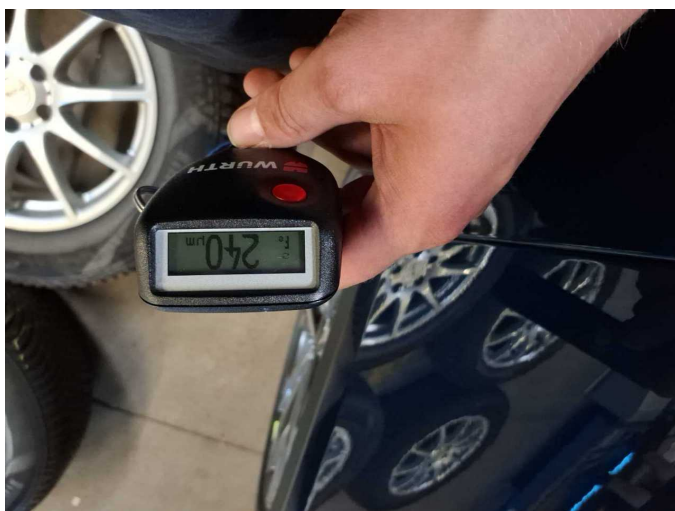
| No. | Repainting |
|---|---|
| 3 | Side panel - rear right side, Professionally carried out, Invoice of repair done Non-existent |

**Repainting 3:** Side panel - rear right side

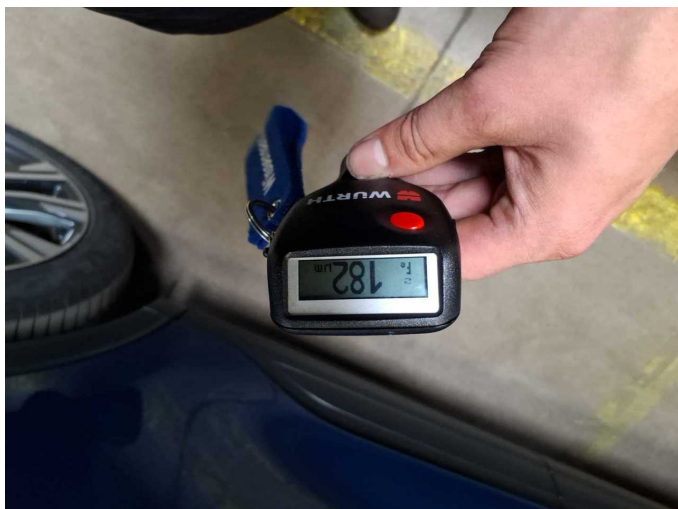
**Repainting 3:** Side panel - rear right side

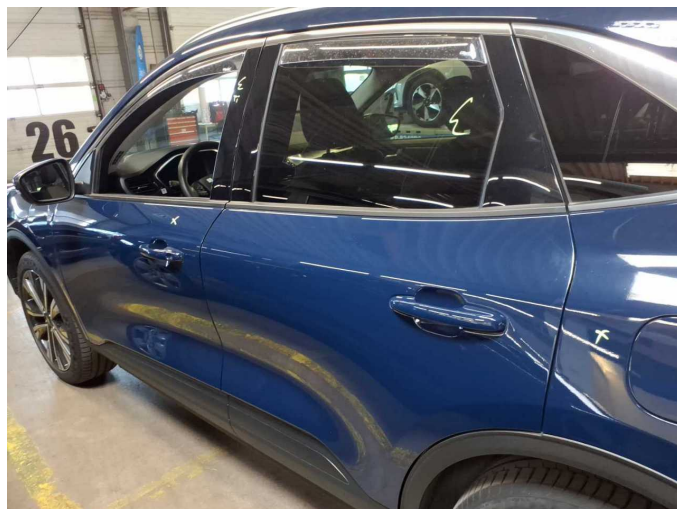
**Repainting 4:** Door - rear left side

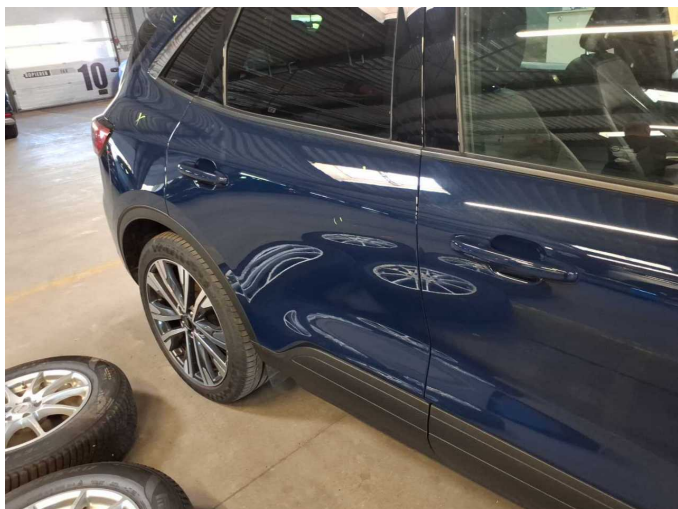
**Repainting 6:** Door - rear right side

**Repainting 6: Door - rear right side**

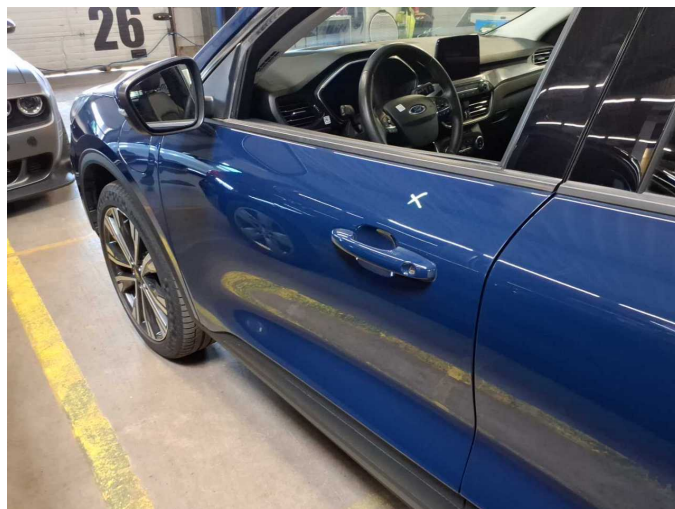
**Repainting 7: Door - front left side**

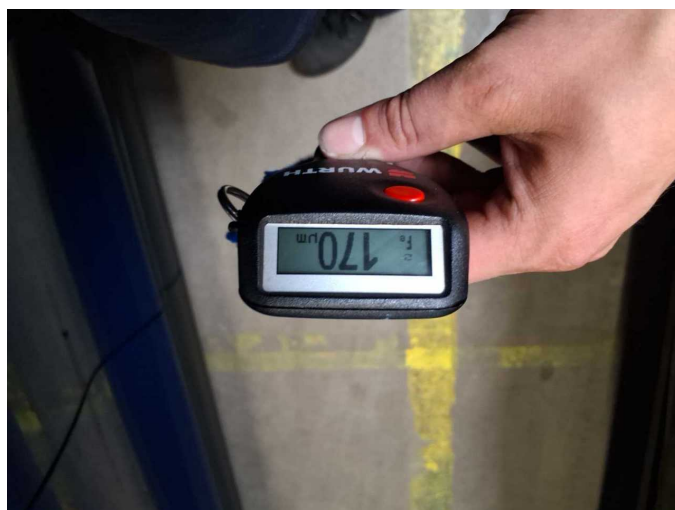
**Repainting 7: Door - front left side**

**Roof rail - left side: 170 µm**

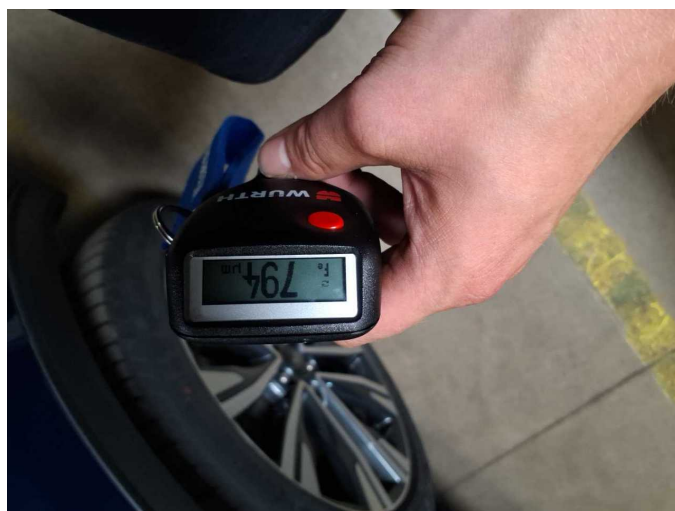
**Roof rail - right side: 186 µm**

**Side panel - rear left side: 794 µm**

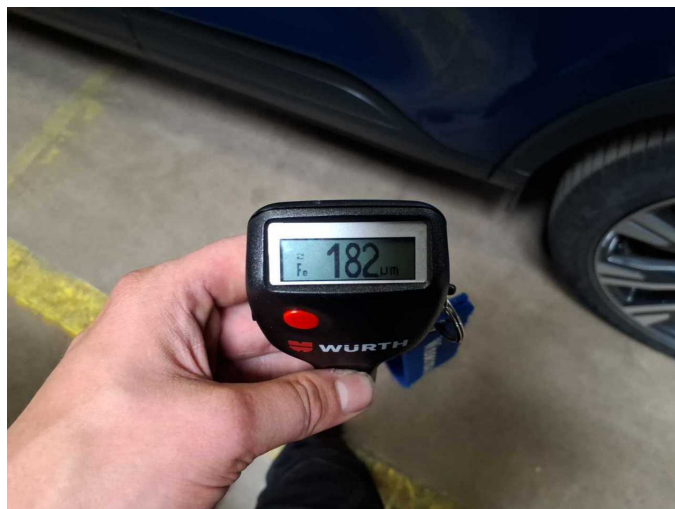
Side panel - rear right side: 240 µm

Door - rear left side: 182 µm

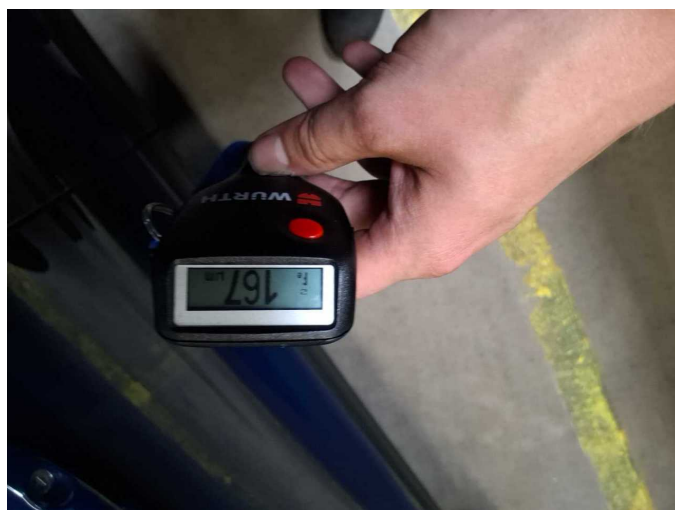
Door - rear right side: 252 µm

Door - front left side: 167 µm
