Expertise

Protocol number: 46460485  
Order No. / Reference: 26577733  
Inspection date: 10 Jul 2026

Model: Zafira Life 2.0 D M Aut. Tourer

VIN: VXEEVHZ7NZ010644

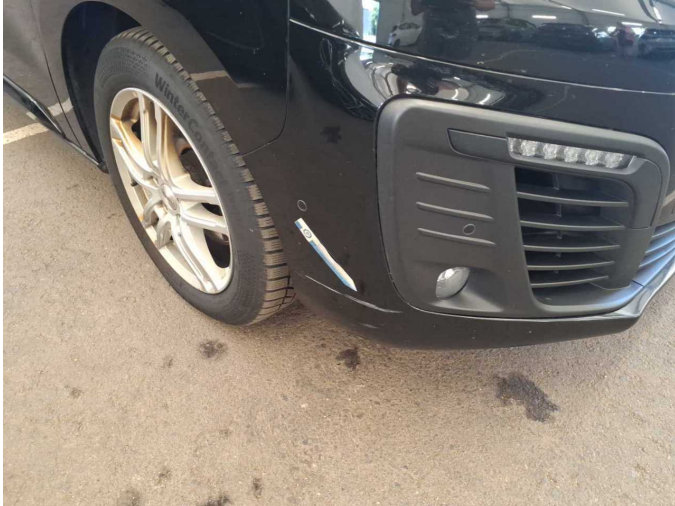
| No. | Component group | Description |
|---|---|---|
| 9 | Front bumper | Front bumper - Scratched - Repair and paint |

**Damage 9:** Front bumper: Front bumper - Scratched - Repair and paint

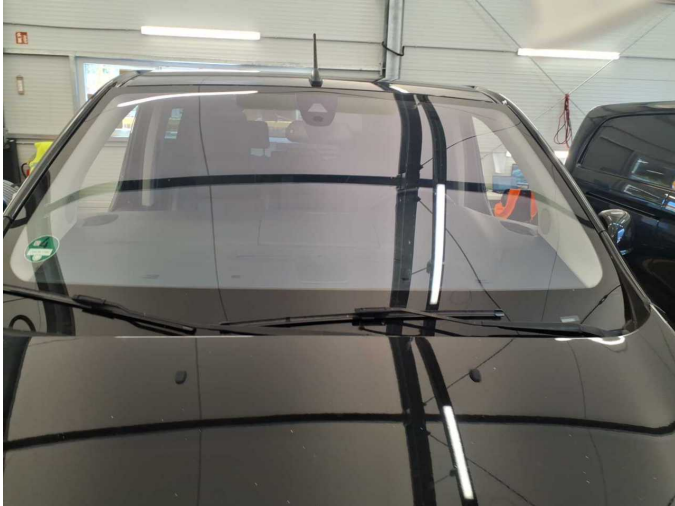
**Wear and tear 2:** Vehicle glazing: Windscreen - Stone chips - No deduction
