Expertise

Protocol number: 46371487  
Order No. / Reference: 26534020-1  
Inspection date: 30 Jun 2026

Manufacturer: Opel

Model: Zafira Life 2.0 D M Aut. Elegance

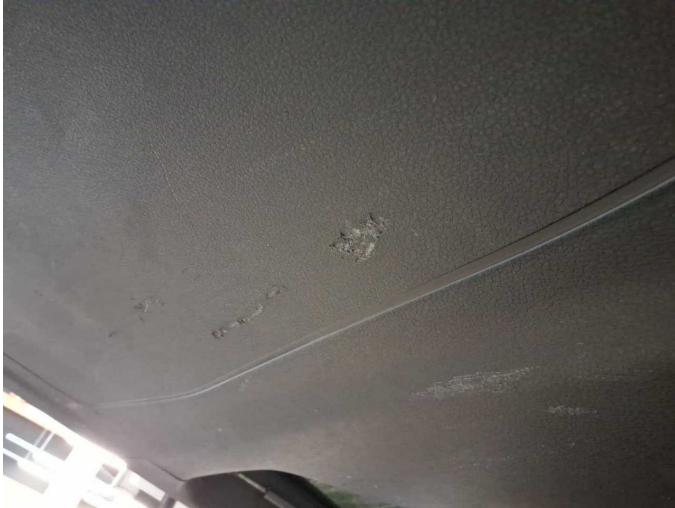
**Damage 6:** Trim / covers: Boot lid - interior trim - Scratch(es) - Loss in value

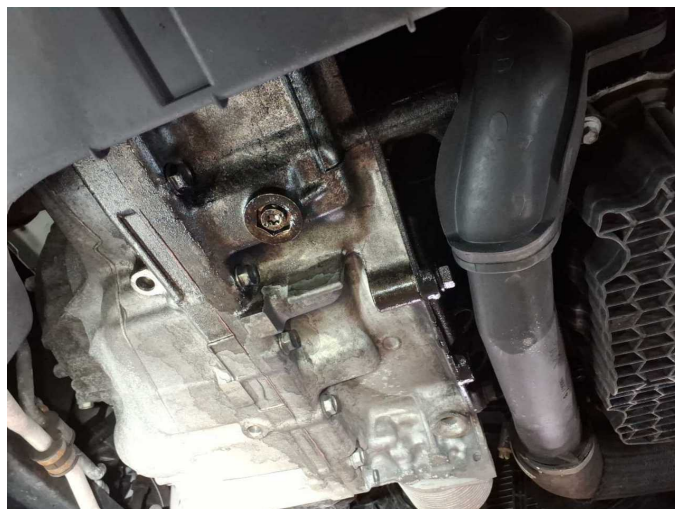
| No. | Component group | Description |
|---|---|---|
| 11 | Engine | Engine (+ Getriebe, Umweltbelastung) - Leaking - Perform diagnosis |

**Damage 11:** Engine: Engine (+ Getriebe, Umweltbelastung) - Leaking - Perform diagnosis

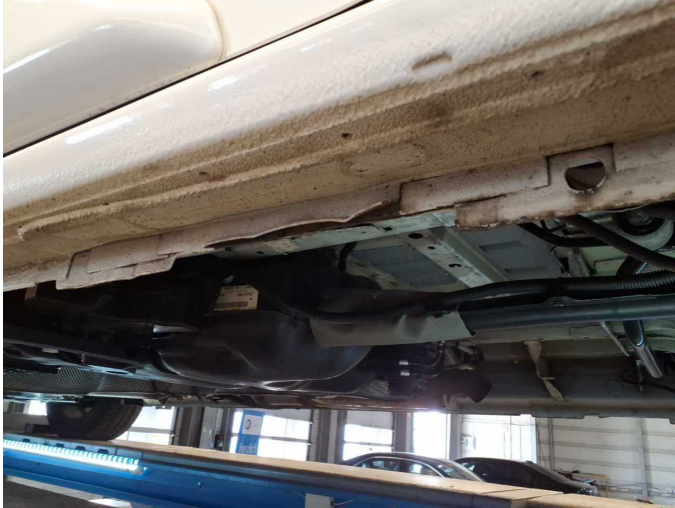
| No. | Component group | Description |
|---|---|---|
| 13 | Sill - left side | Sill - Deformed - Smart repair |

**Damage 13:** Sill - left side: Sill - Deformed - Smart repair

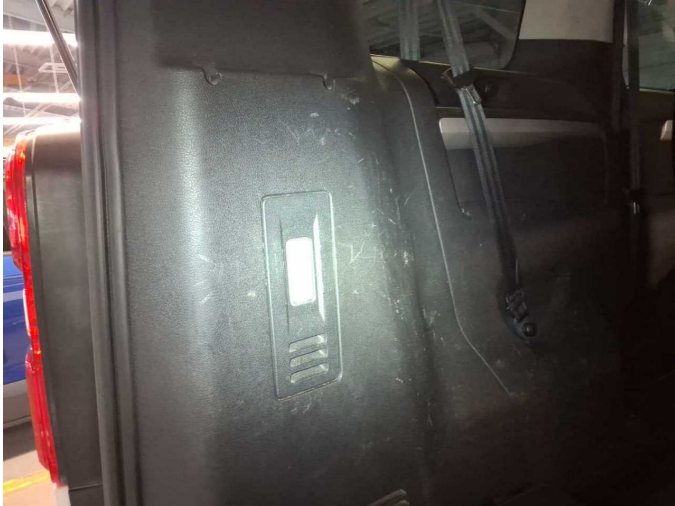
**Damage 15:** Side panel - rear left side: Interior trim - Scratched - Loss in value

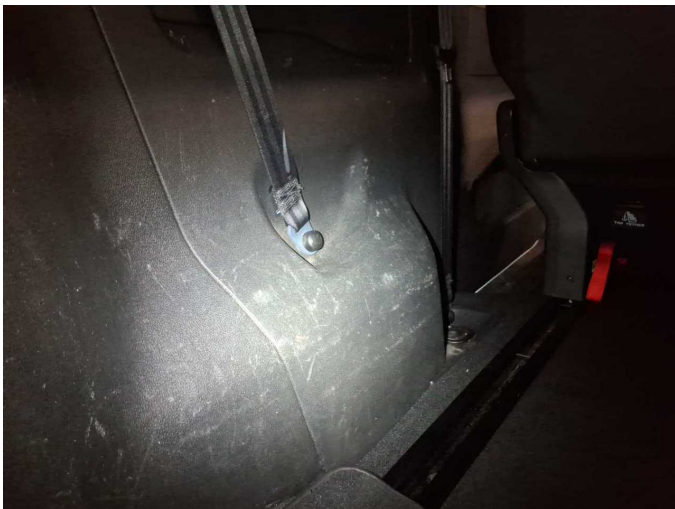
**Damage 15:** Side panel - rear left side: Interior trim - Scratched - Loss in value

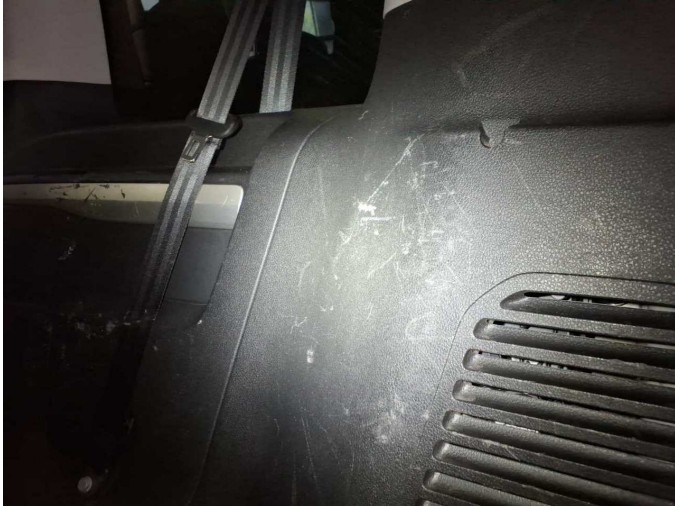
**Damage 21:** Side panel - rear right side: Interior trim - Scratched - Replace

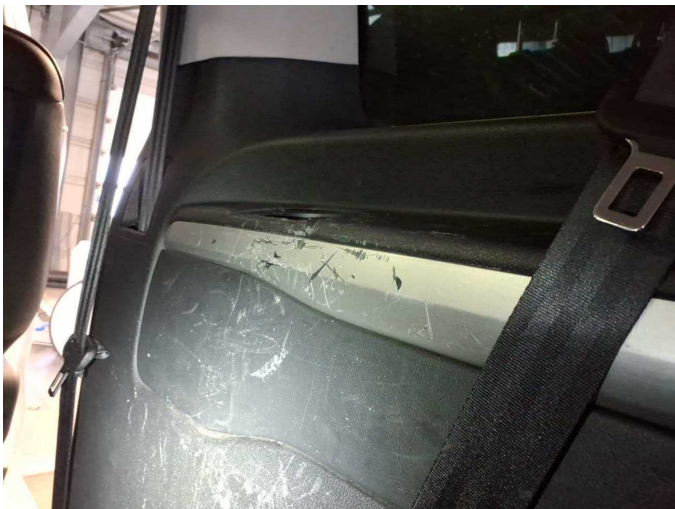
**Damage 21:** Side panel - rear right side: Interior trim - Scratched - Replace

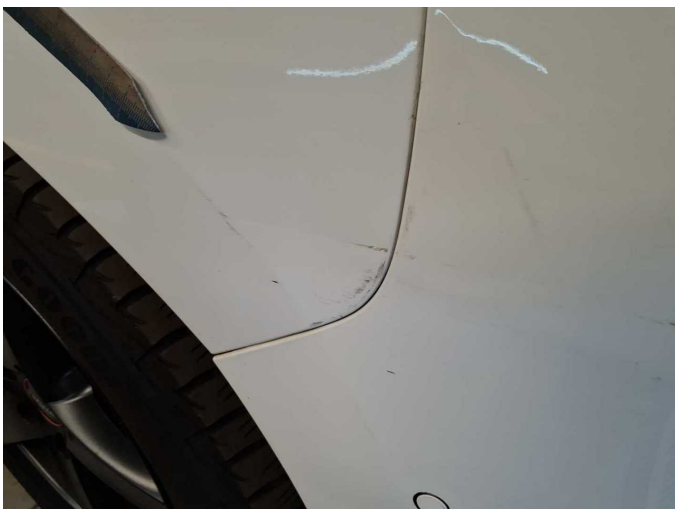
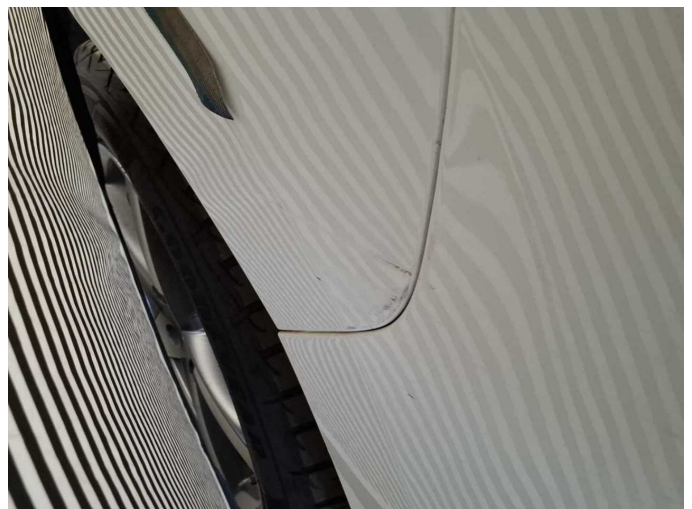
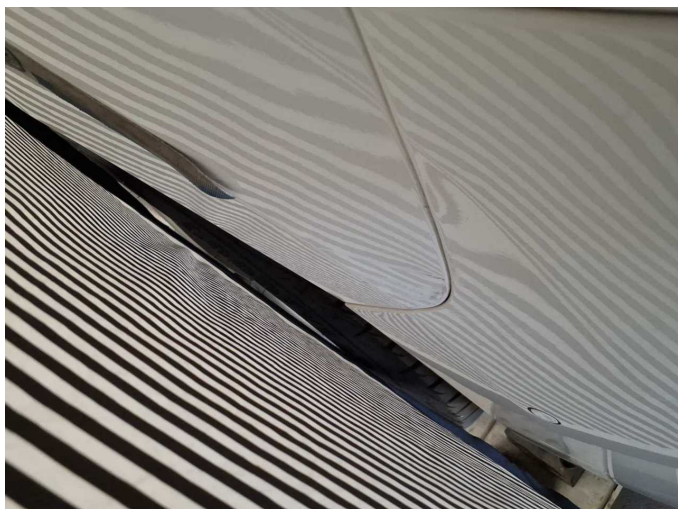
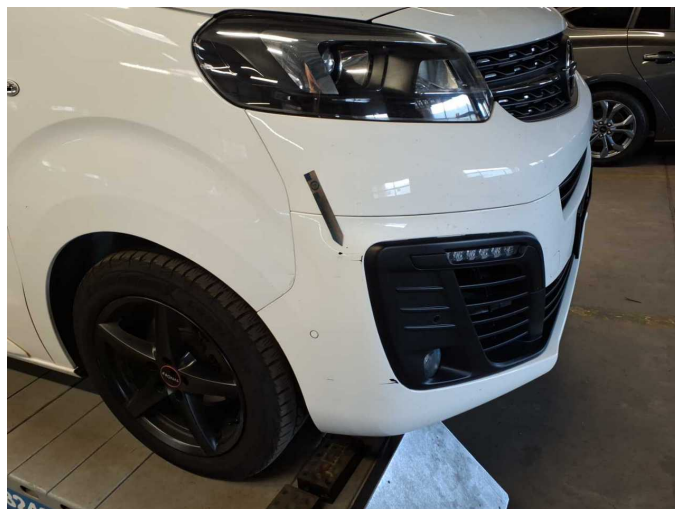
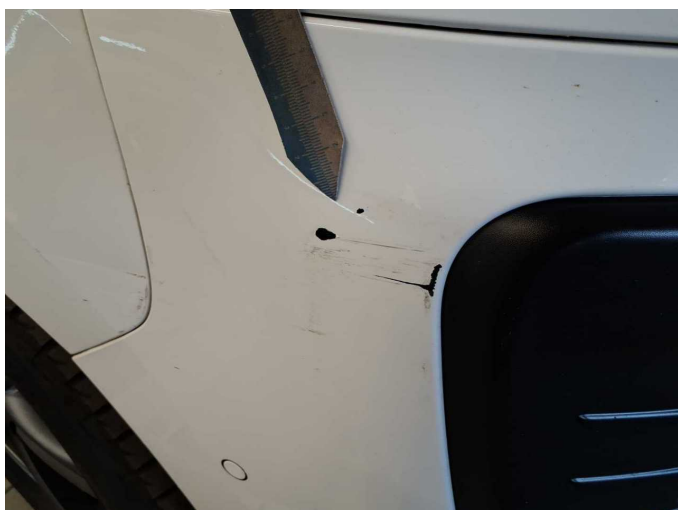
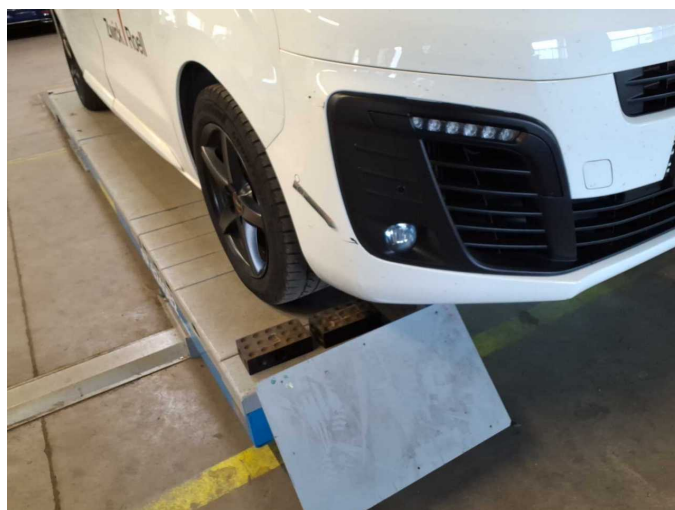
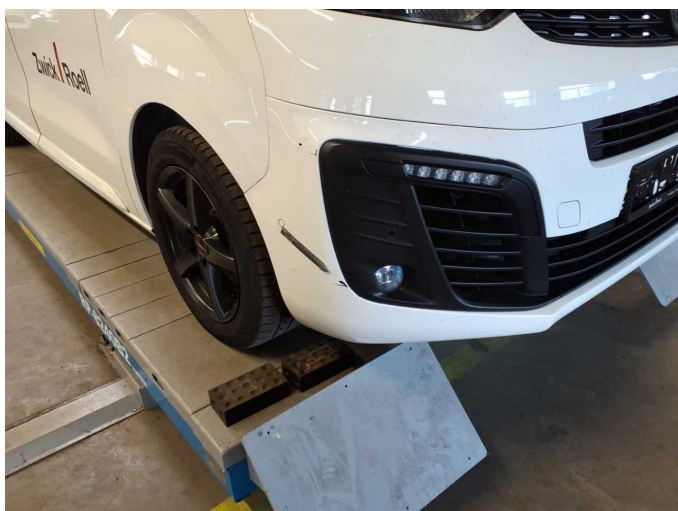
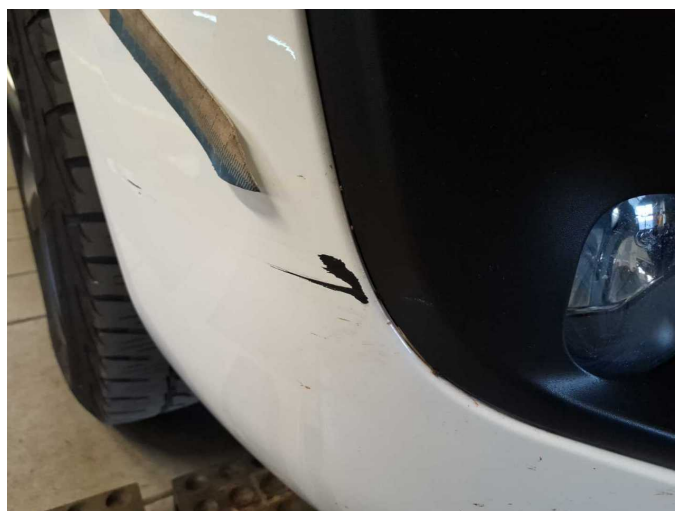
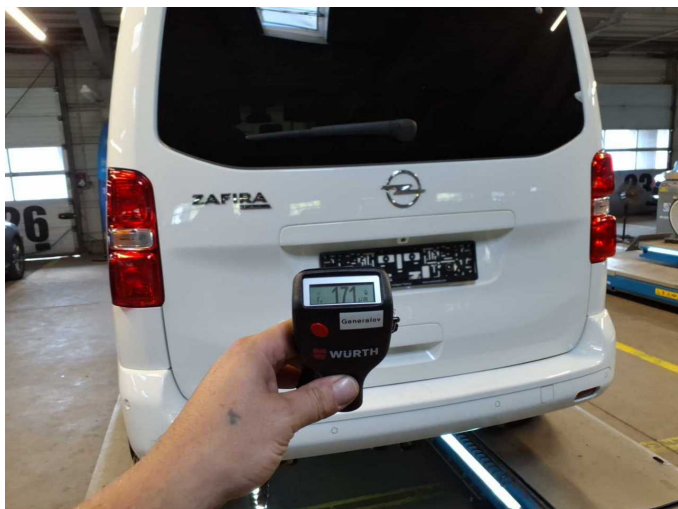
**Accident 1:** Front, Side right
