Expertise

Protocol number: 46103260
Order No. / Reference: 26496030
Inspection date: 23 Jun 2026

Manufacturer: Volkswagen

Model: Multivan Kurz 1,4 OPF eHybrid Life

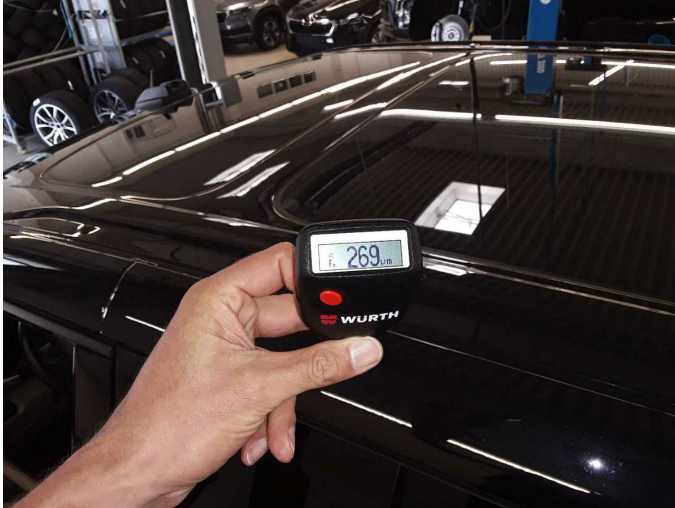
Roof: 269 µm

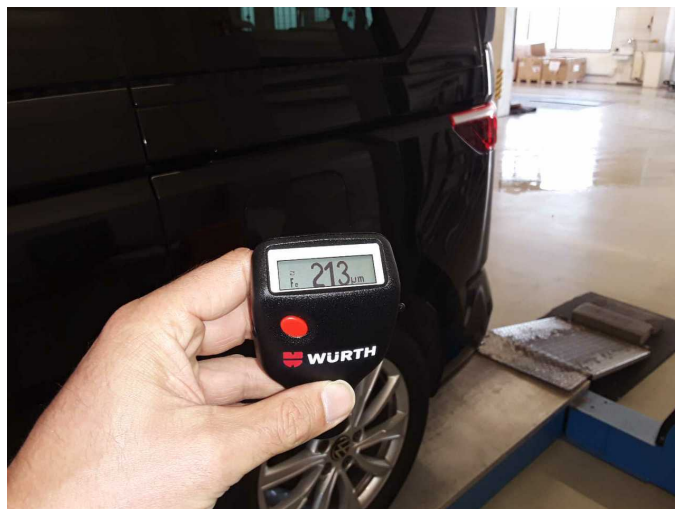
Side panel - rear left side: 213 µm
