Expertise

Protocol number: 46377225  
Order No. / Reference: 26397414  
Inspection date: 7 Jul 2026

Manufacturer: Volkswagen

Model: Tiguan Allspace 2.0 TDI SCR DSG Life

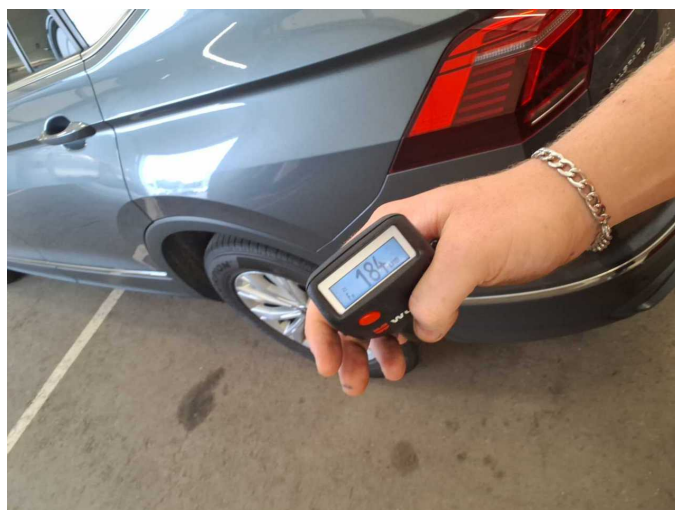
**Repainting 1:** Side panel - rear left side
