Expertise

Protocol number: 46171143
Order No. / Reference: 26530177
Inspection date: 24 Jun 2026

Manufacturer: Volkswagen

Model: T7 Multivan 2,0 TDI SCR Kurz Life

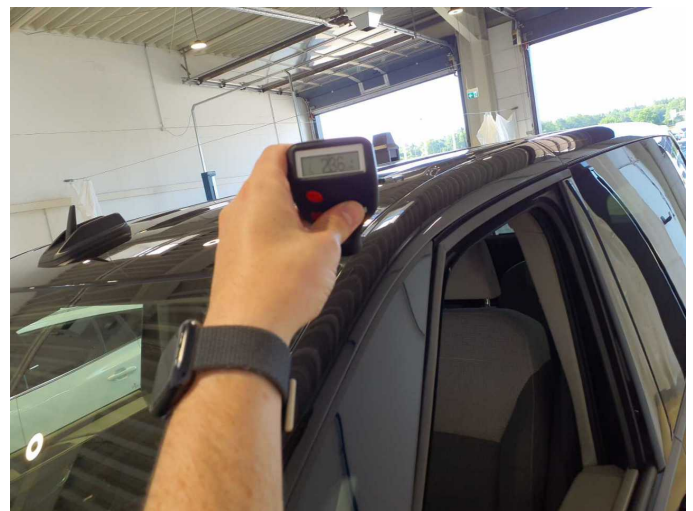
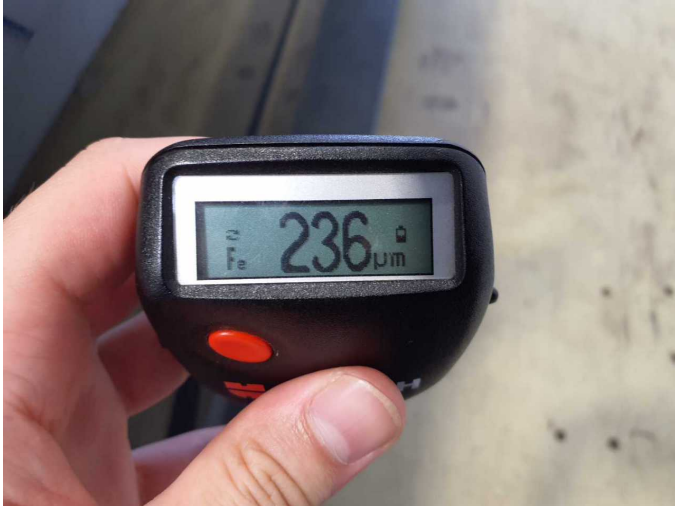
Repainting 1: Roof
