## Expertise

Protocol number: 46164297  
Order No. / Reference: 26469639  
Inspection date: 24 Jun 2026

Manufacturer: Ford

Model: Transit 350 L3H2 Lkw VA Autm. Trend

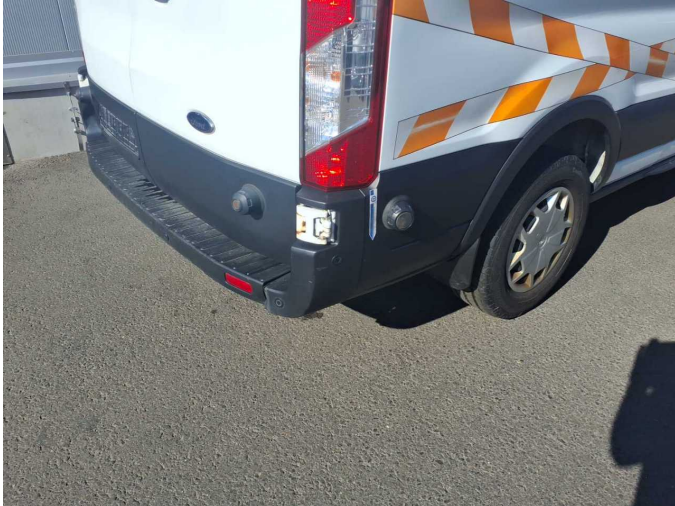
**Accident 1:** Rear, Side right

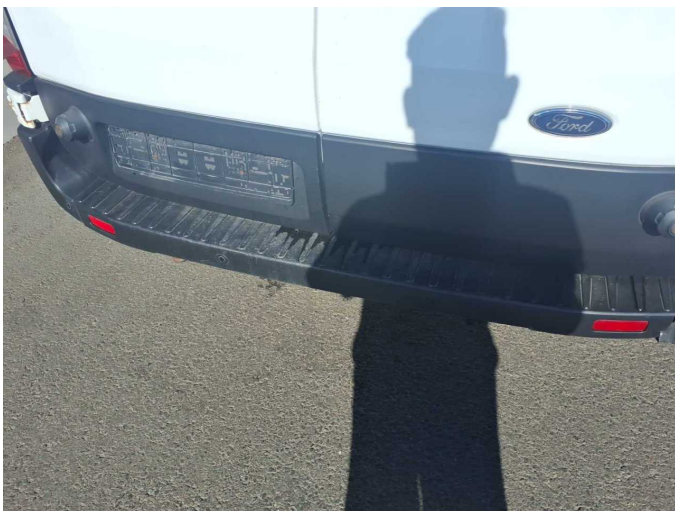
**Accident 1:** Rear, Side right
