Expertise

Protocol number: 46222926  
Order No. / Reference: 26598375  
Inspection date: 26 Jun 2026

Manufacturer: Opel

Model: Astra Sports Tourer 1.5 D Automatik Ultimate

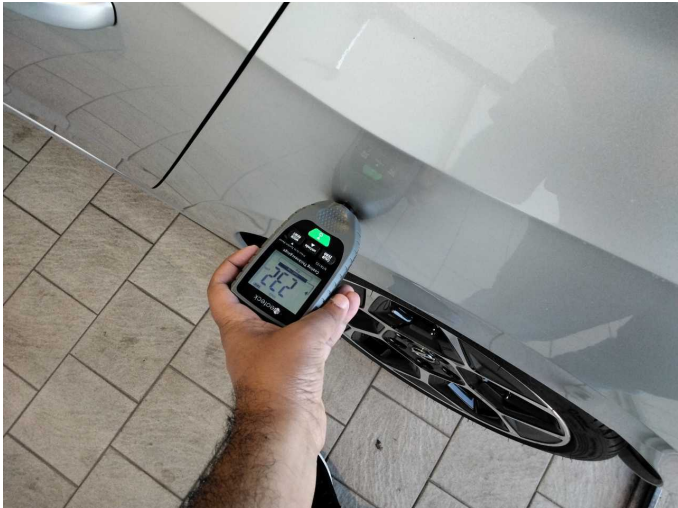
Side panel - rear left side: 232 µm

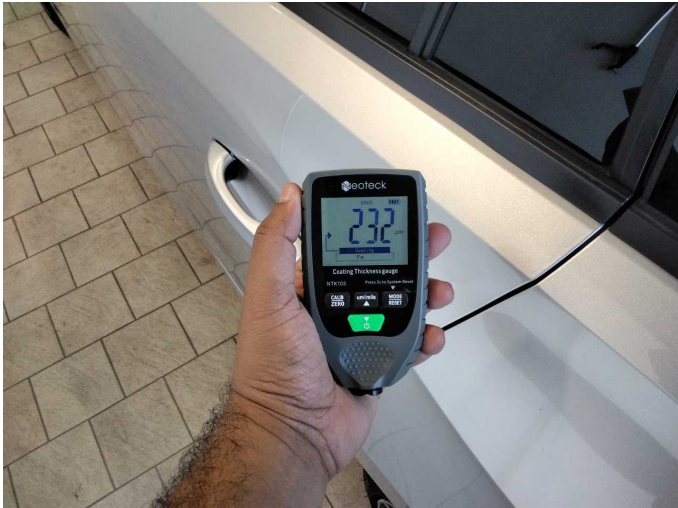
Side panel - rear left side: 232 µm

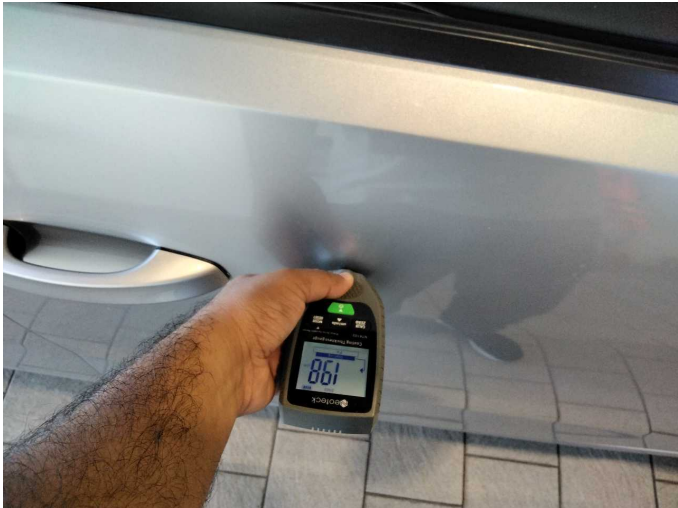
Door - front right side: 198 µm

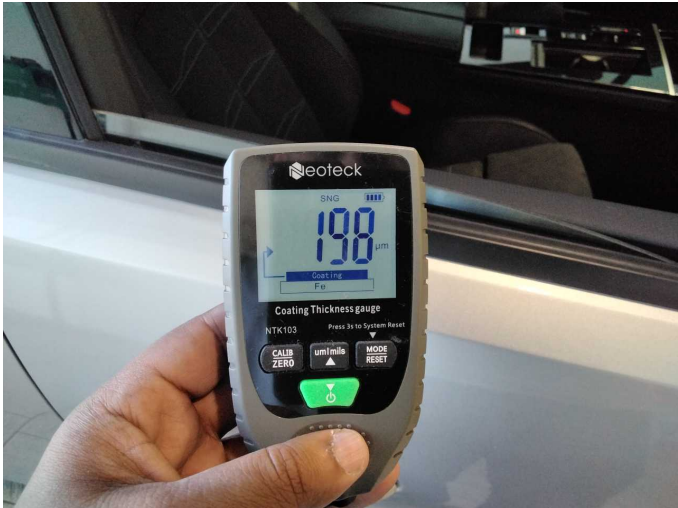
Door - front right side: 198 µm
