Expertise

Protocol number: 46360171
Order No. / Reference: 26490095
Inspection date: 6 Jul 2026

Manufacturer: Ford

Model: Kuga 2.5 Duratec FHEV TITANIUM

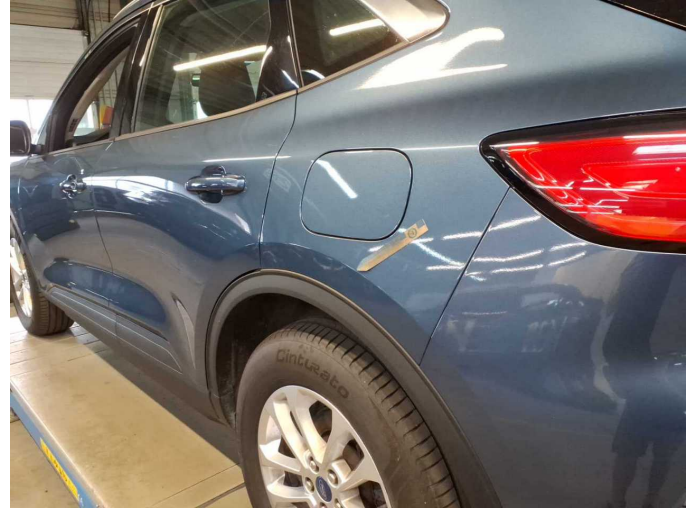
Damage 1: Side panel - rear left side: Side panel - dent(s) - Smooth repair work

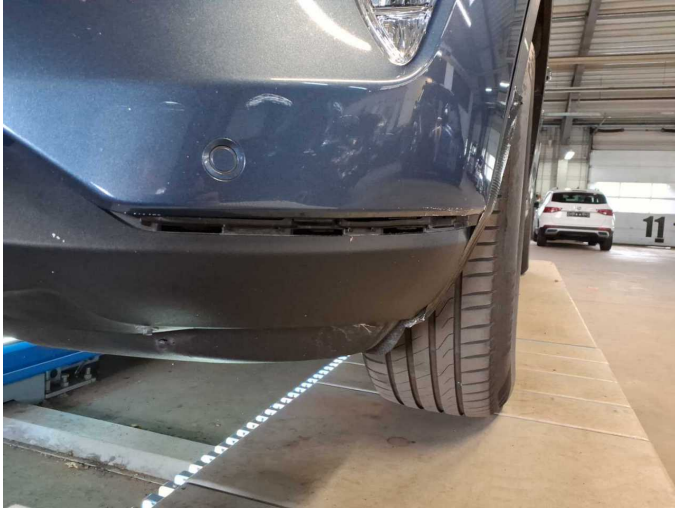
Accident 1: Front, Side - left

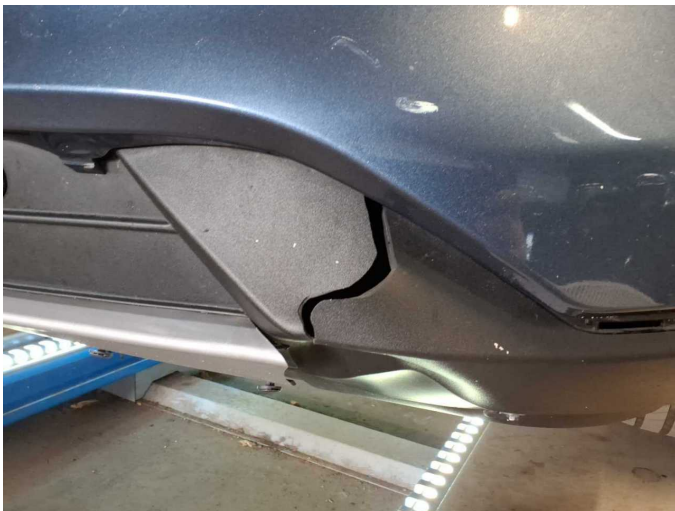
Accident 1: Front, Side - left

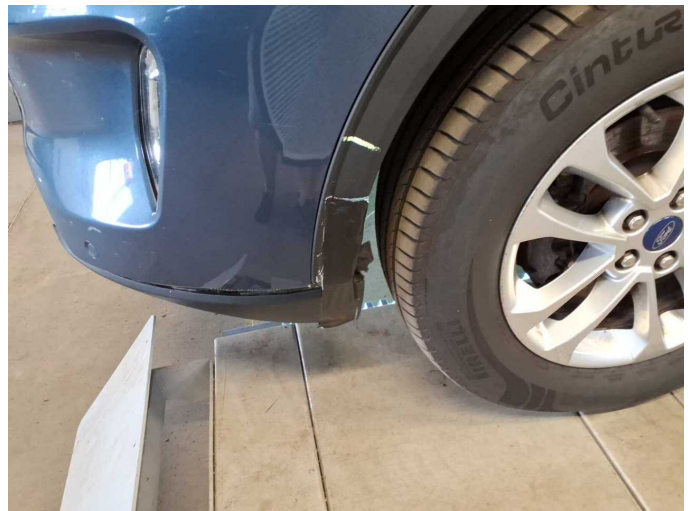
Accident 1: Front, Side - left

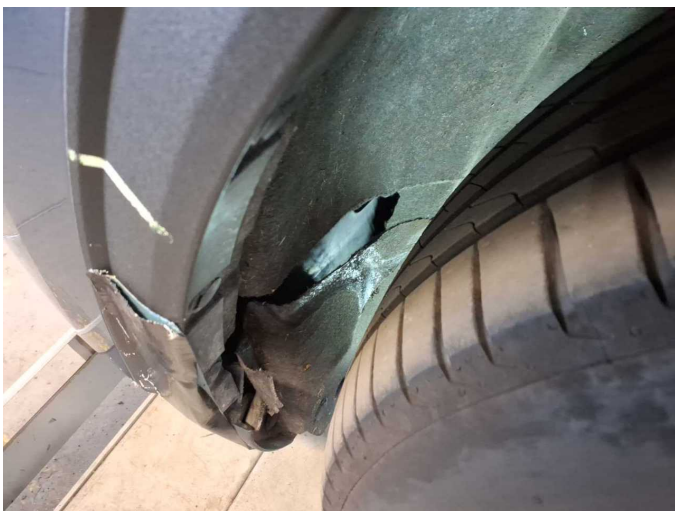
Accident 1: Front, Side - left

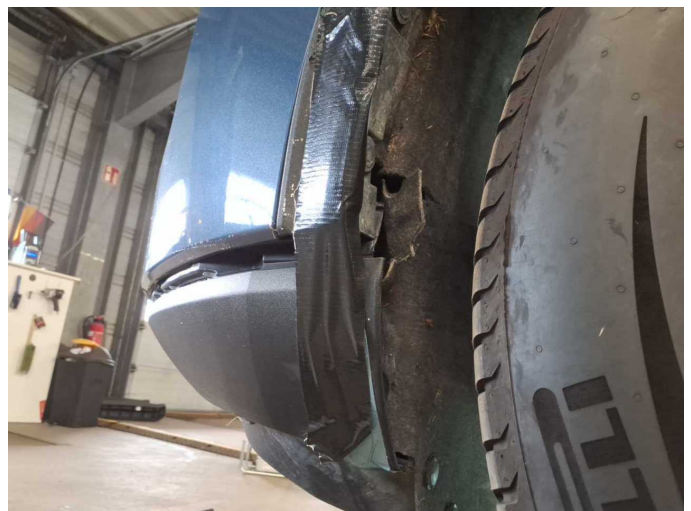
Accident 1: Front, Side - left

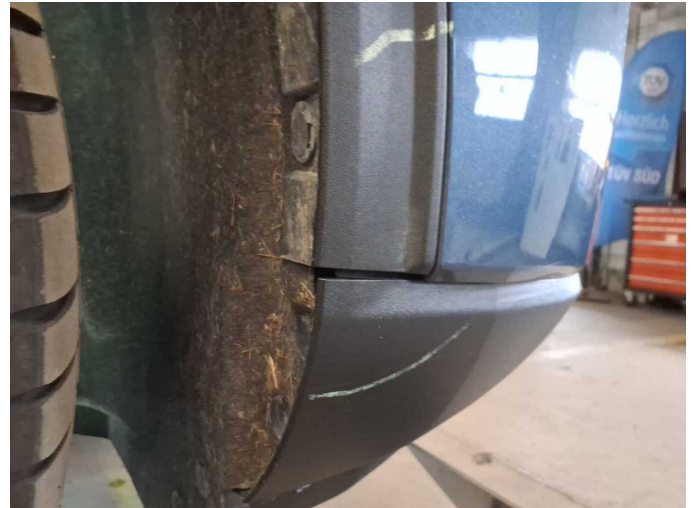
Accident 1: Front, Side - left

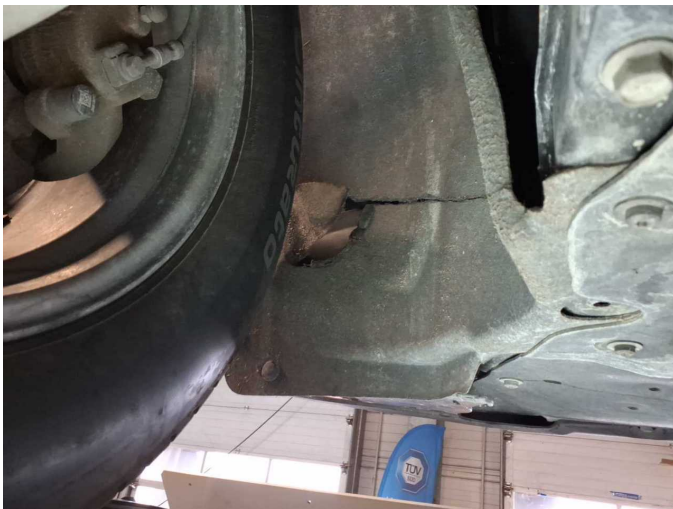
Accident 1: Front, Side - left

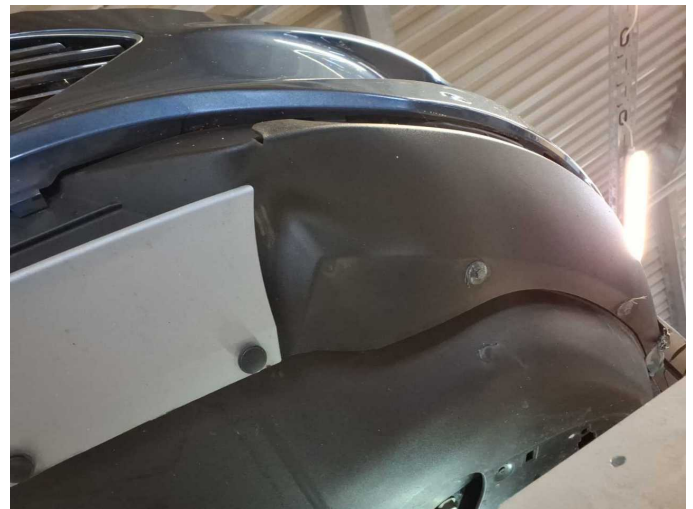
Accident 1: Front, Side - left
