Expertise

Protocol number: 46801774  
Order No. / Reference: 26775488  
Inspection date: 29 Jul 2026

Manufacturer: Skoda  
VIN: TMBLN9NSXN8510006

Model: Kodiahq 2.0 TDI 4x4 DSG Style

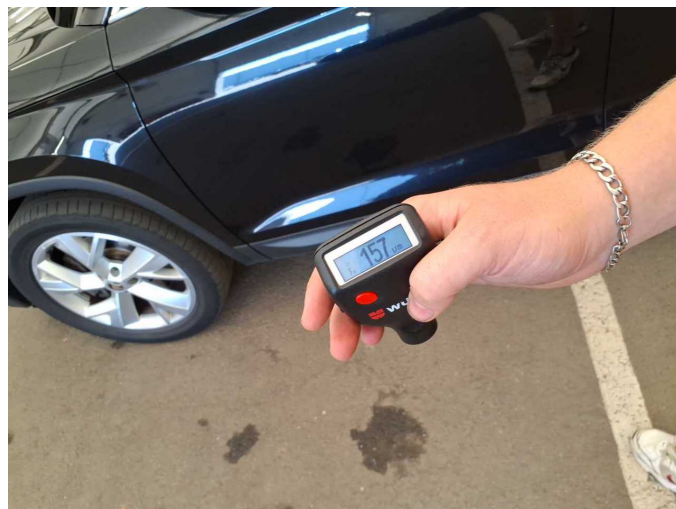
**Repainting 3:** Door - front left side
