Expertise

Protocol number: 46311703
Order No. / Reference: 26412168
Inspection date: 1 Jul 2026

Model: Focus Turnier 1.0 EcoBoost Start-Stopp-System TITANIUM

VIN: WF0PXXGCHPNG35445

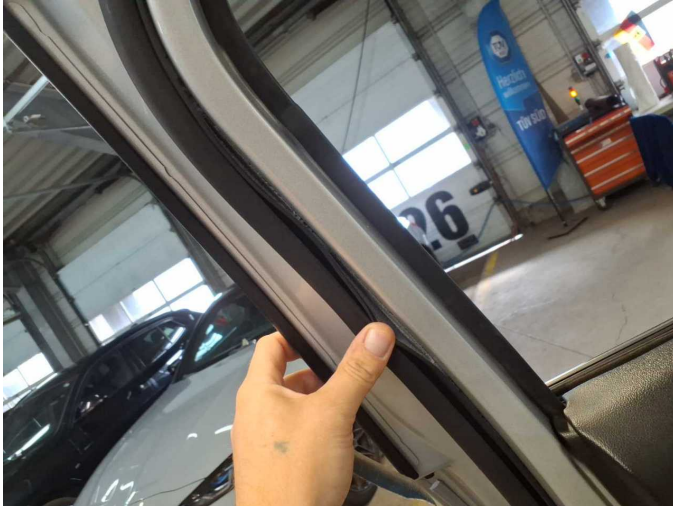
Damage 3: Door - front left side: Door seal - Loose - Repair

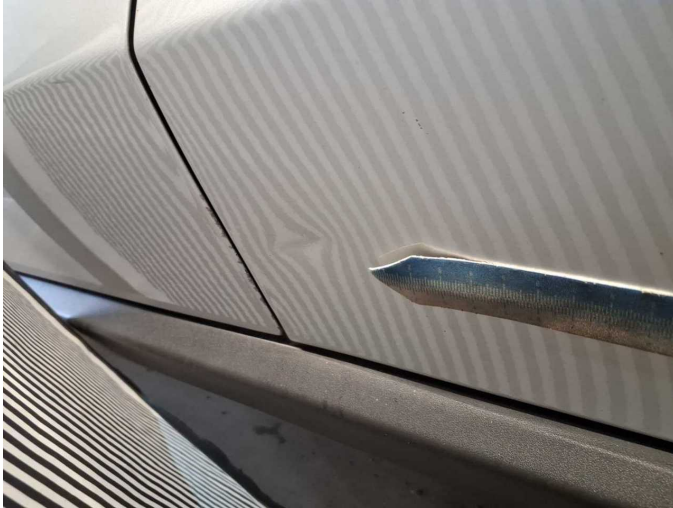
Damage 7: Door - rear left side: Door - dent(s) - Smooth repair work

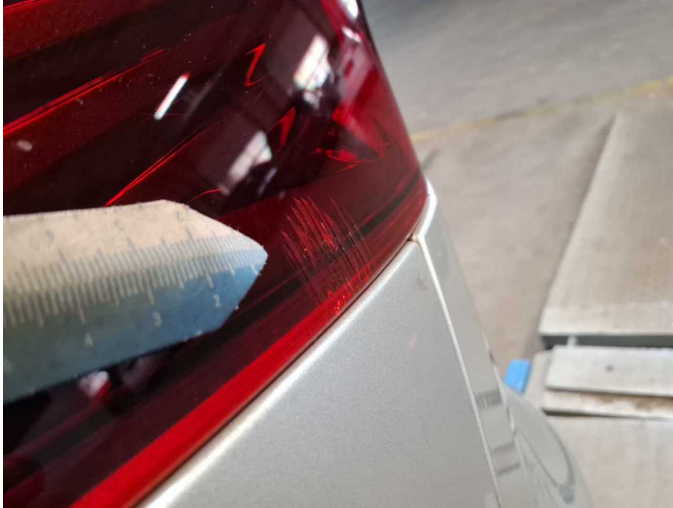
Damage 18: Tail light: Tail lamp - left side - Broken / torn - Replace

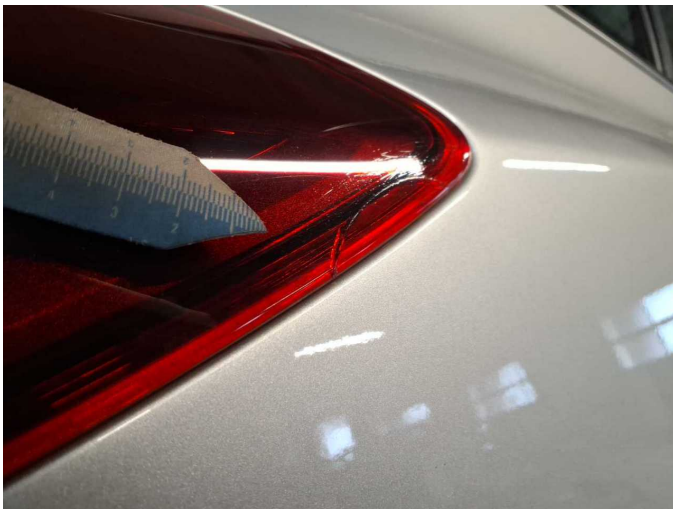
Damage 19: Tail light: Tail lamp - right side - Broken / torn - Replace

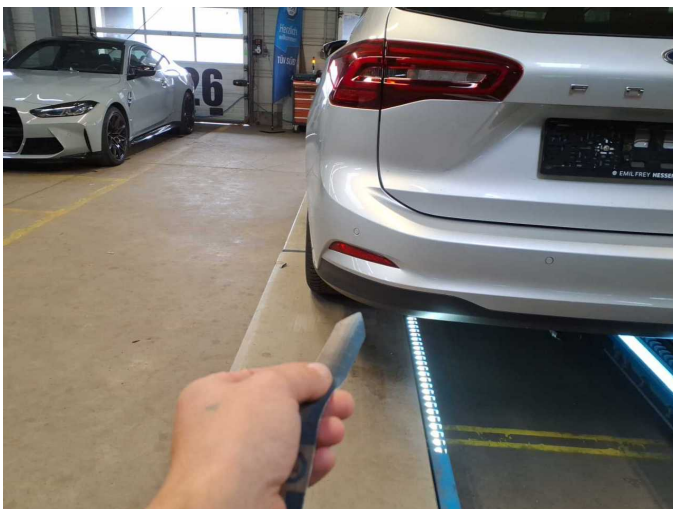
Damage 20: Rear bumper: Spoiler - Deformed - Replace
