Expertise

Protocol number: 46710467  
Order No. / Reference: 26759860  
Inspection date: 24 Jul 2026

| Manufacturer: Mercedes-Benz | Model: C 220 d T 9G-TRONIC AMG Line |
| VIN: W1KAH0EB7PF114324 | |

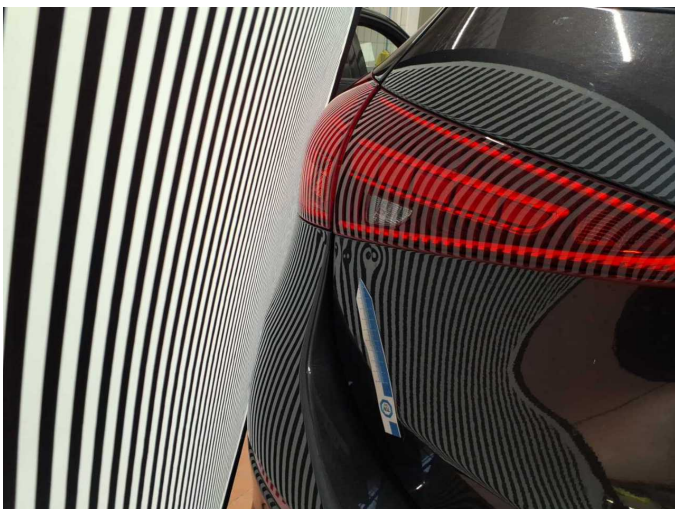
**Accident 1:** Rear

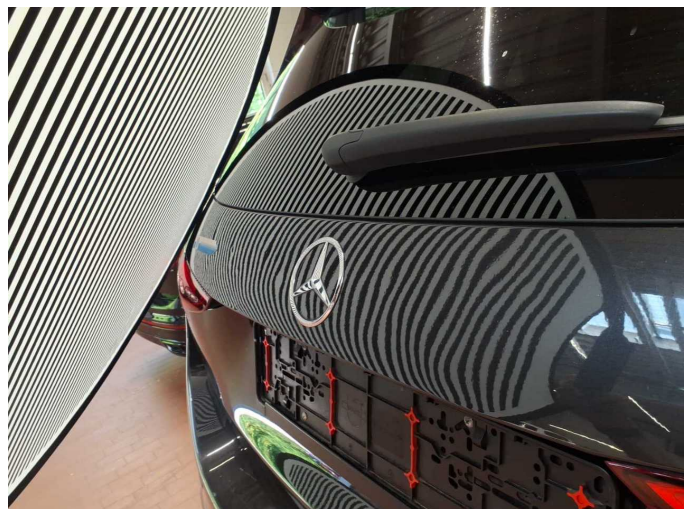
**Accident 1:** Rear

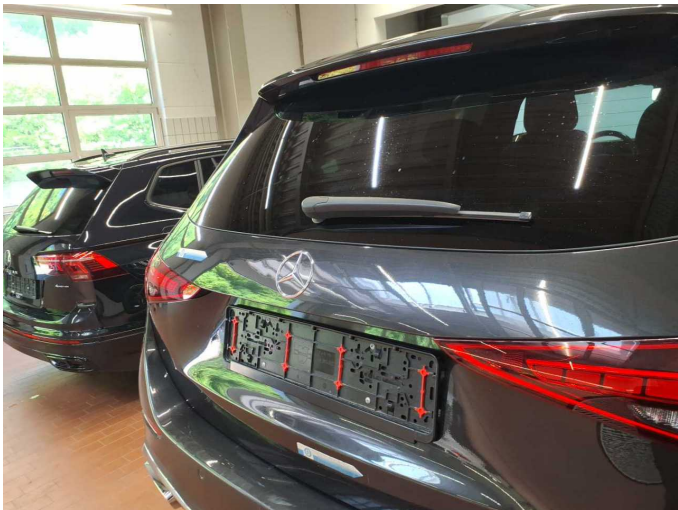
**Accident 1:** Rear

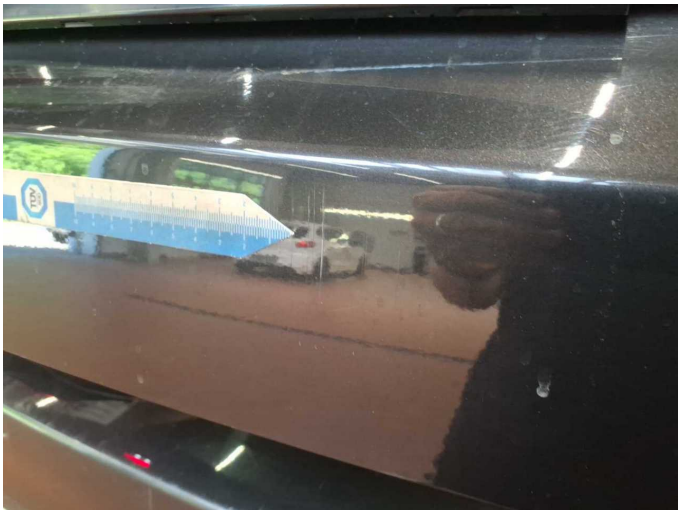
Accident 1: Rear

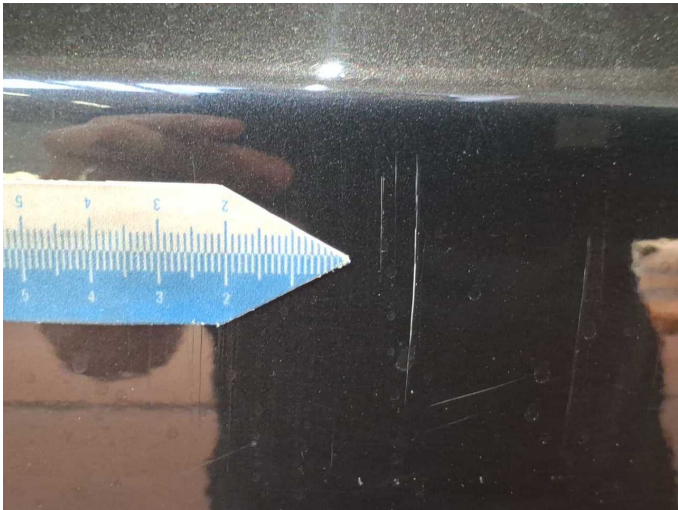
Accident 1: Rear

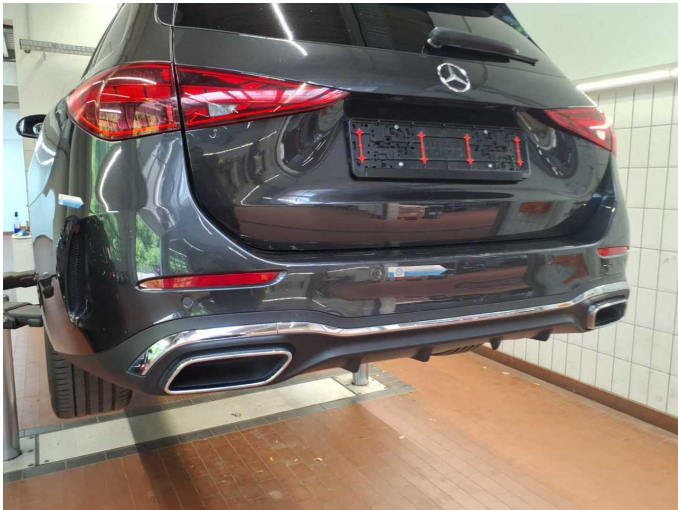
Accident 1: Rear

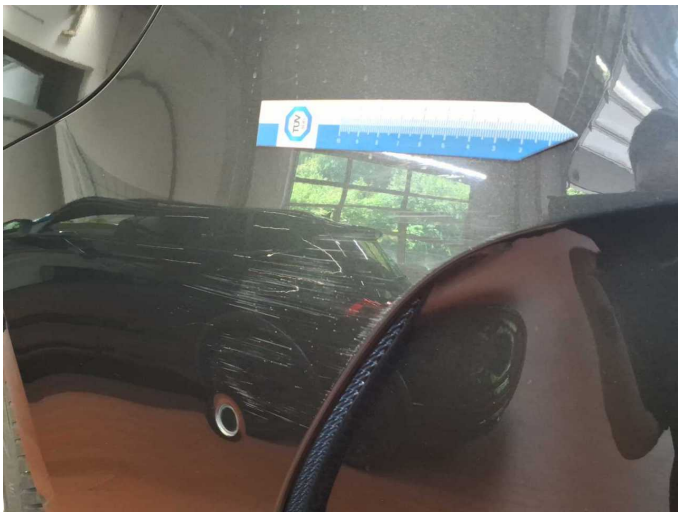
Accident 1: Rear

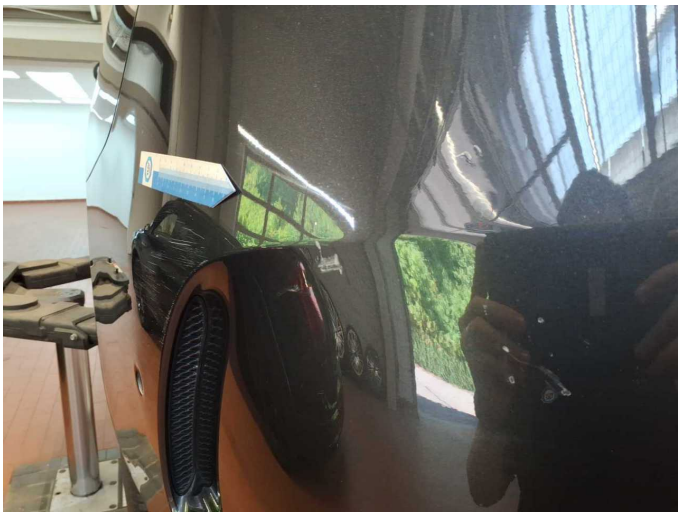
Accident 1: Rear

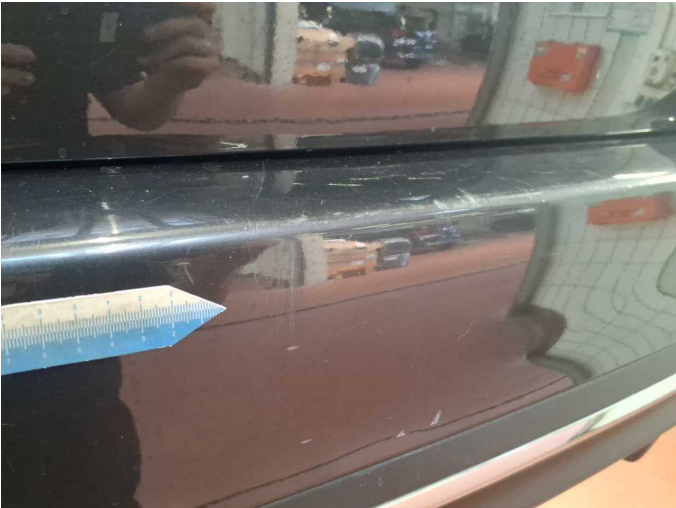
Accident 1: Rear

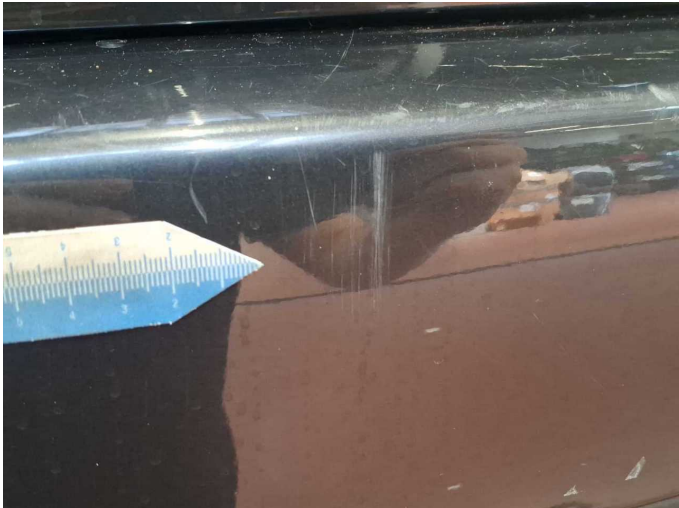
Accident 1: Rear

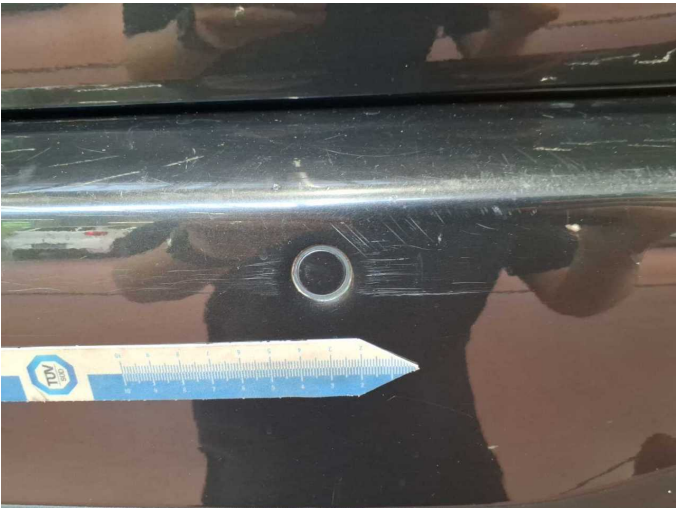
Accident 1: Rear

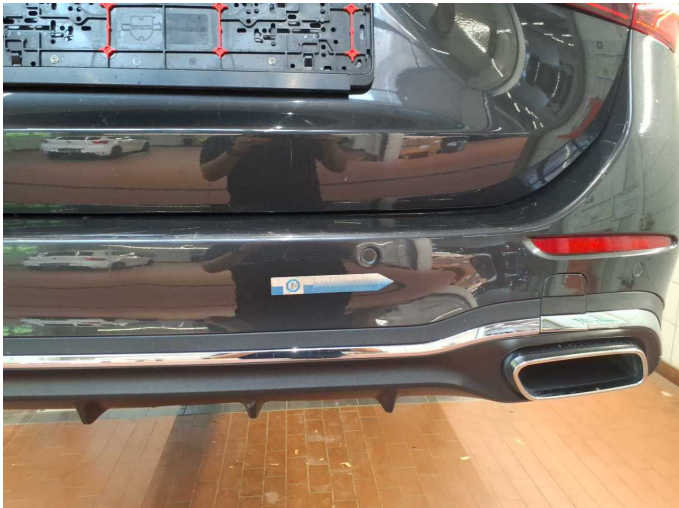
Accident 1: Rear

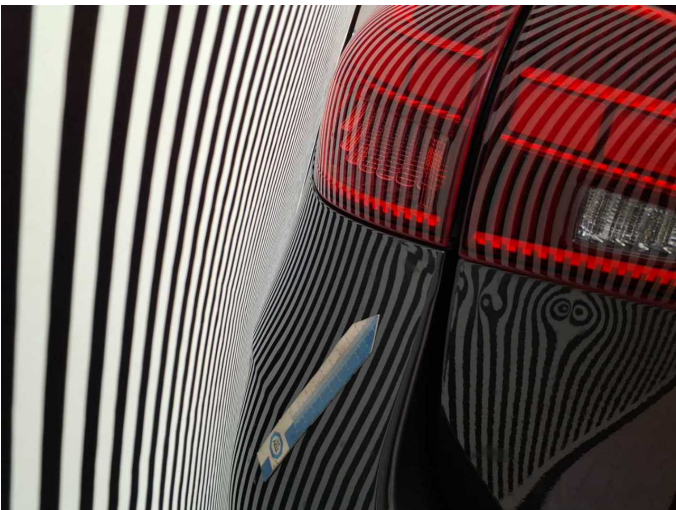
Accident 1: Rear

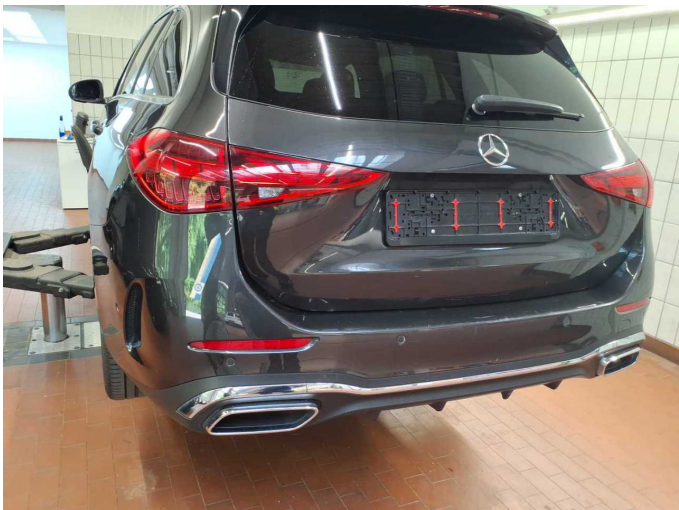
Accident 1: Rear

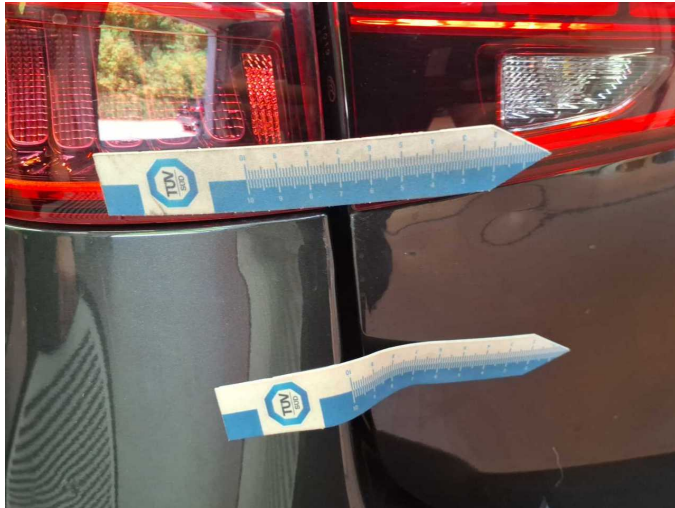
Accident 1: Rear

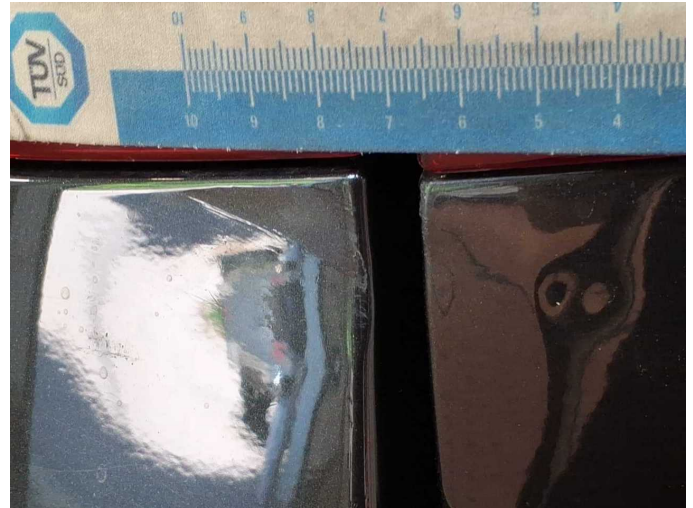
**Accident 1: Rear**

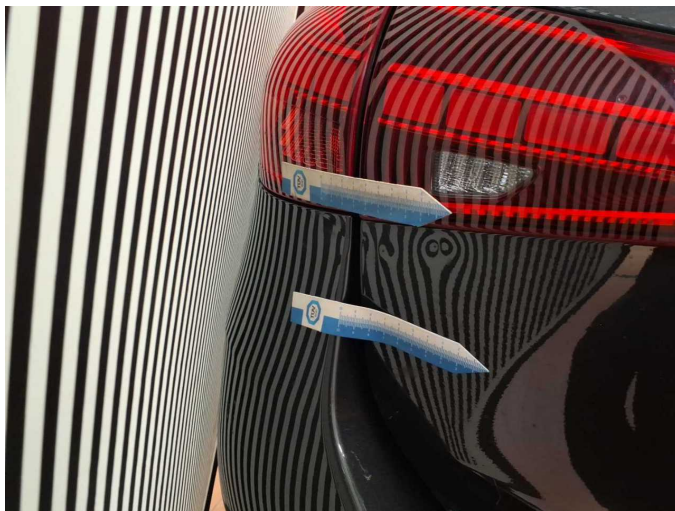
**Accident 1: Rear**

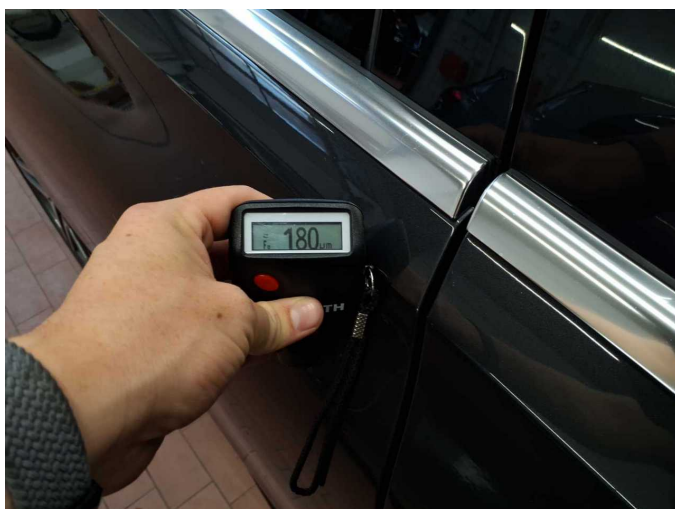
**Repainting 1: Mudguard - right side**
