Expertise

Protocol number: 46334850  
Order No. / Reference: 26615109  
Inspection date: 1 Jul 2026

Manufacturer: Seat

Model: Ateca 1.6 TDI Style

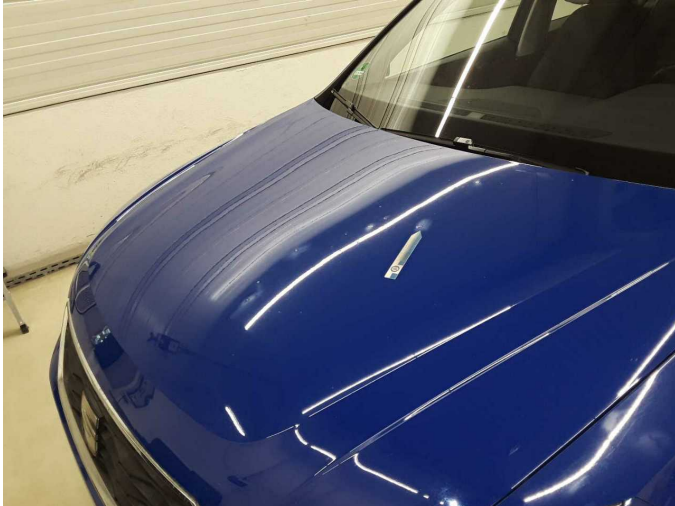
**Damage 4:** Body: Body (Baumharz: Lackaufbereitung) - Soiled - Clean

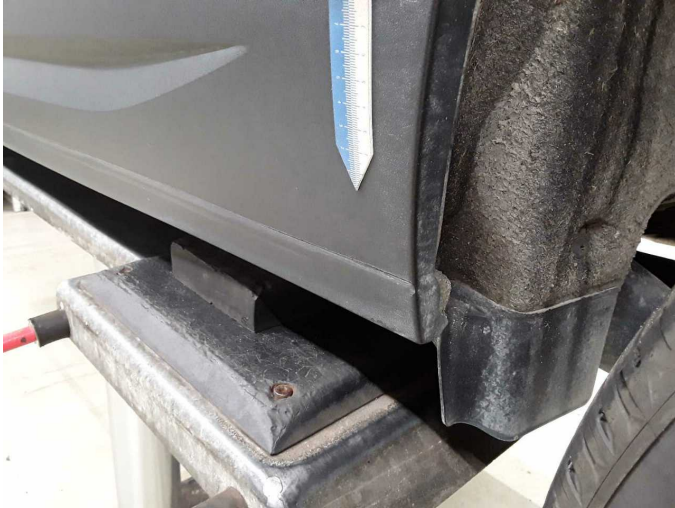
| No. | Component group | Description |
|---|---|---|
| 10 | Door - rear left side | Brightware - lower - Scratched - Replace |

**Damage 10:** Door - rear left side: Brightware - lower - Scratched - Replace

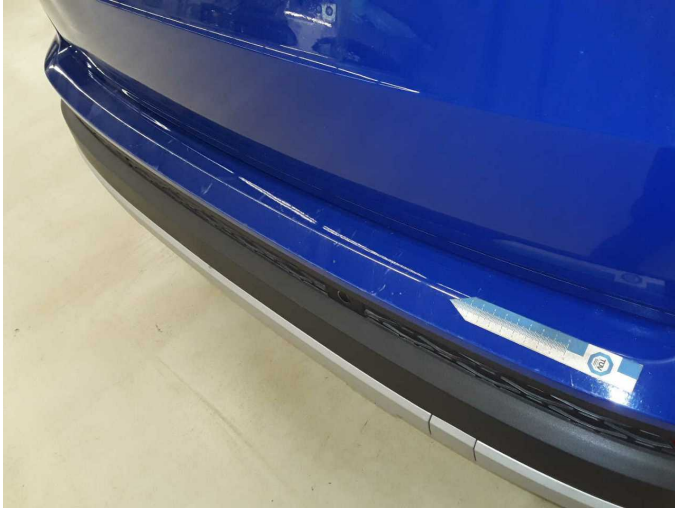
**Damage 12:** Rear bumper: Rear bumper - Scratch(es) - Paint

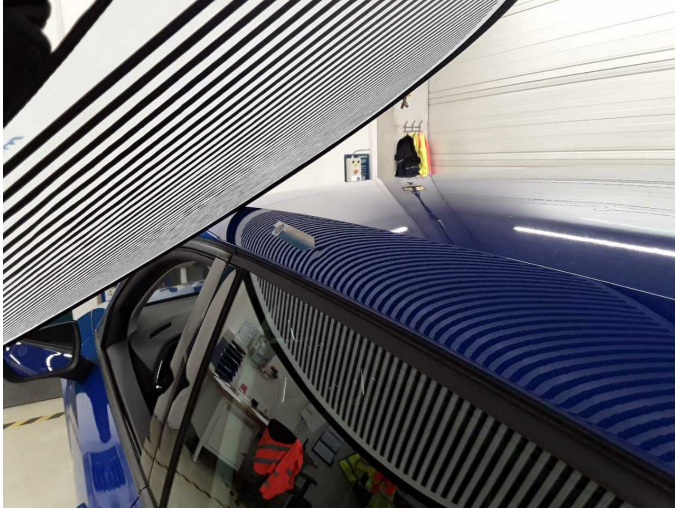
**Wear and tear 3:** Roof: Roof rail - left side - dent(s) - No deduction

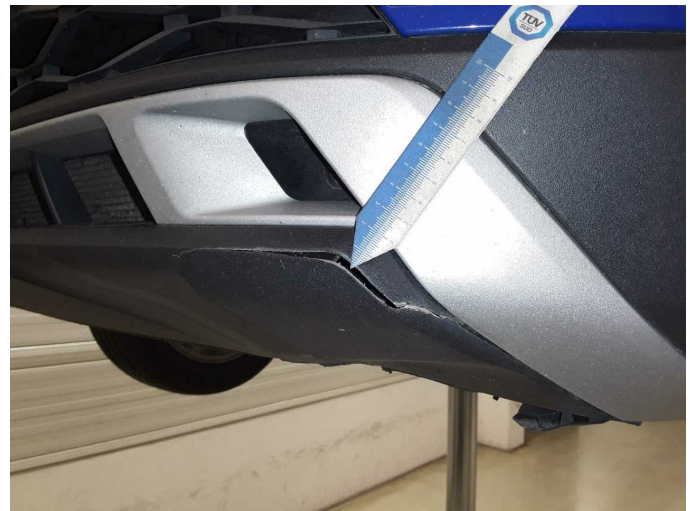
**Accident 1:** Front, Underbody

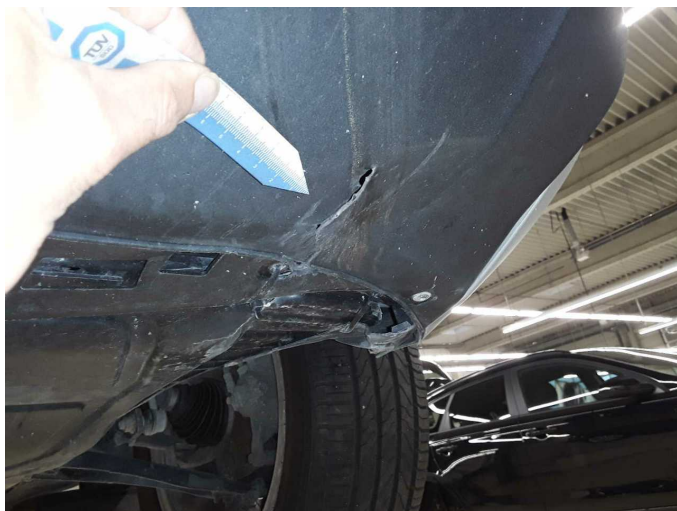
**Accident 1:** Front, Underbody

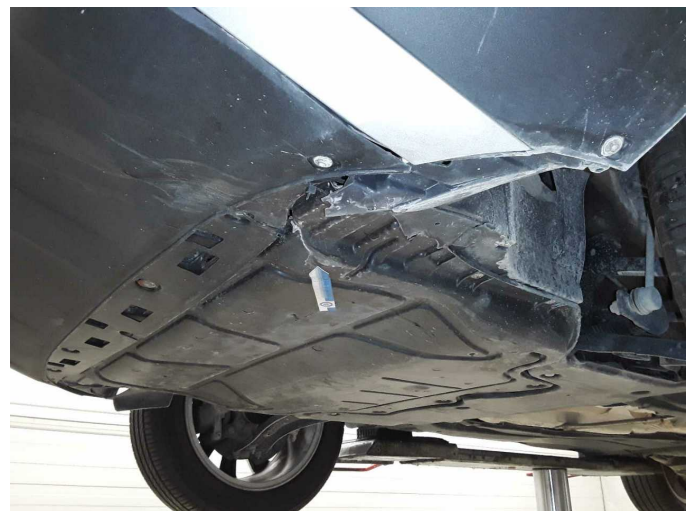
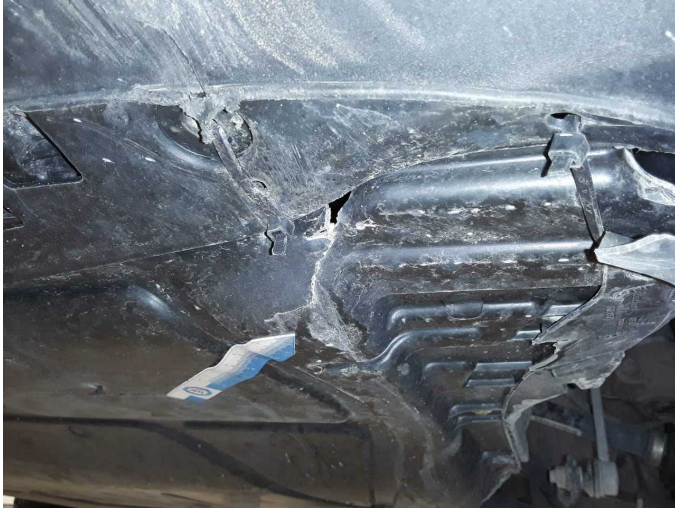
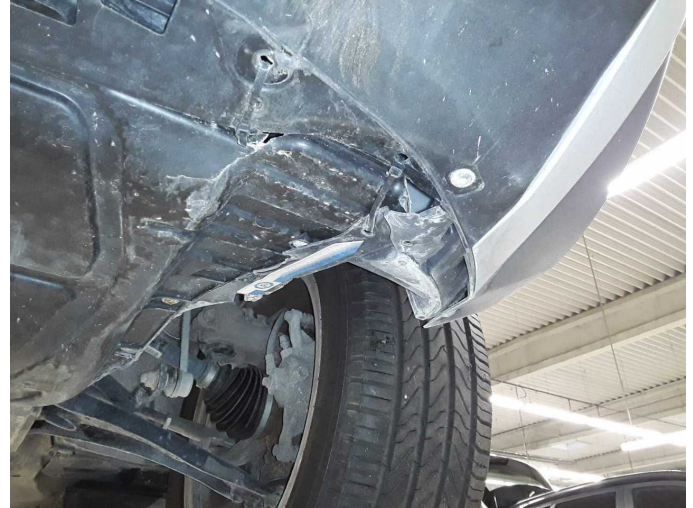
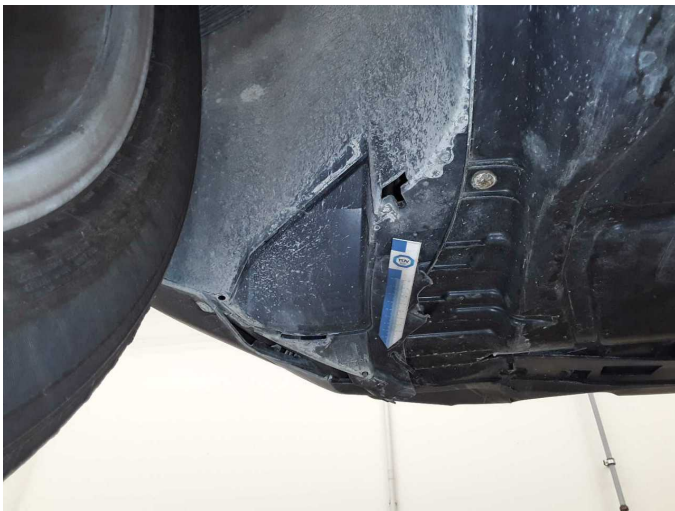
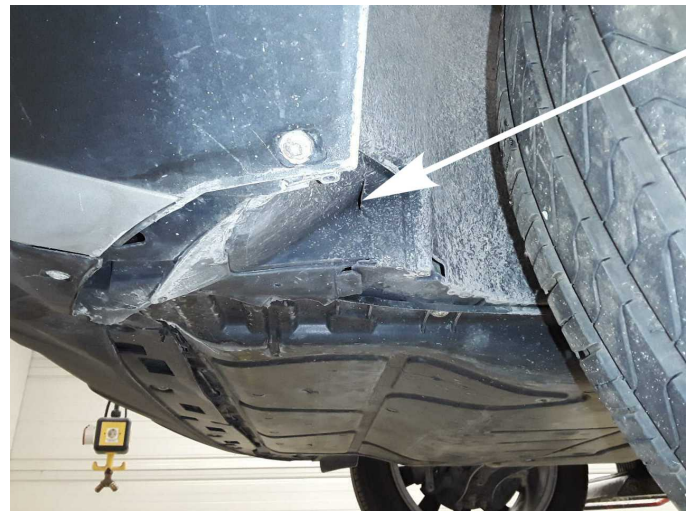
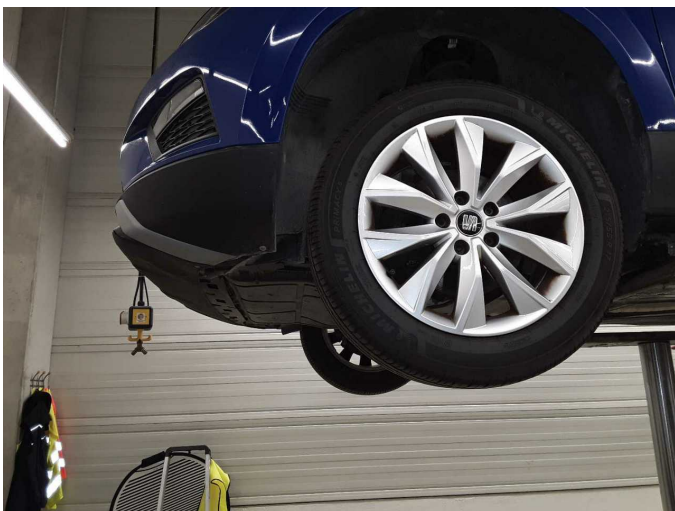
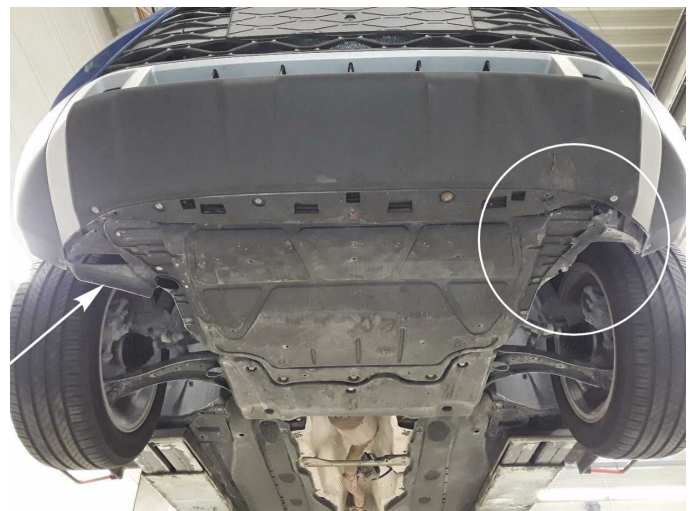
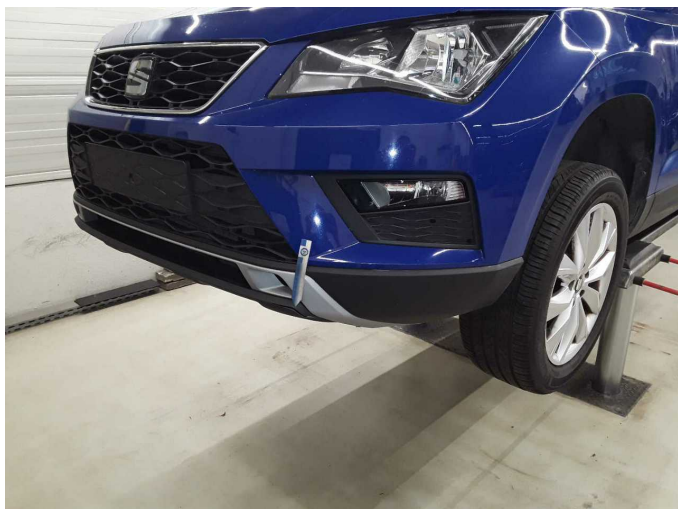
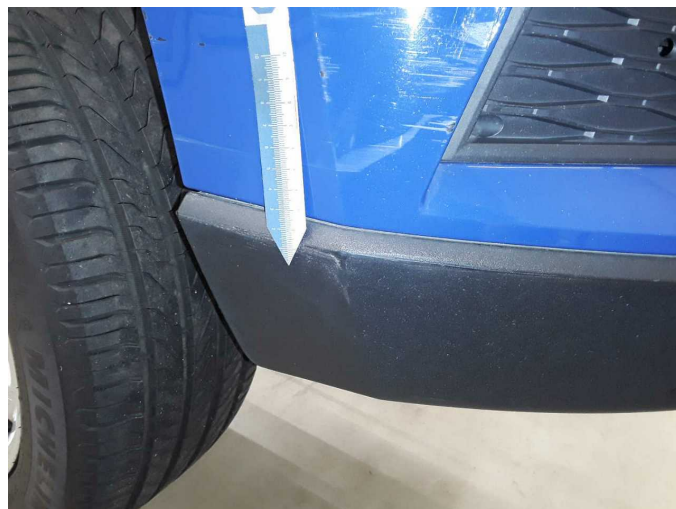
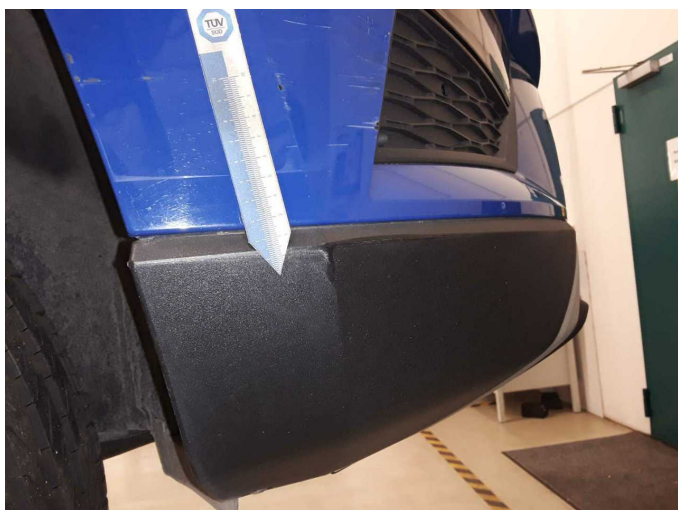
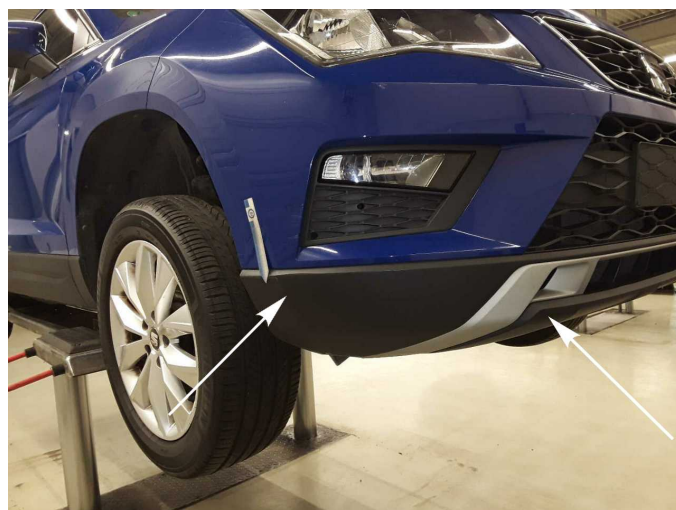
**Accident 1:** Front, Underbody

**Accident 1: Front, Underbody**
