Expertise

Protocol number: 46543964  
Order No. / Reference: 26603030  
Inspection date: 14 Jul 2026

Manufacturer: Peugeot

Model: 508 SW Hybrid 225 e-EAT8 Allure

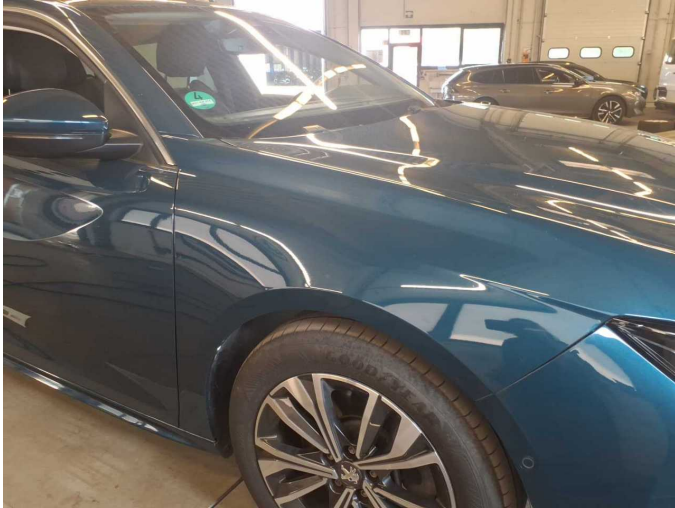
**Repainting 1:** Mudguard - left side, Mudguard - right side, Door - rear left side
