Expertise

Protocol number: 45425301
Order No. / Reference: 26215774
Inspection date: 7 May 2026

Model: Trafic ENERGY dCi 120 L1H1 3,0t Komfort

VIN: VF1FL000666129284

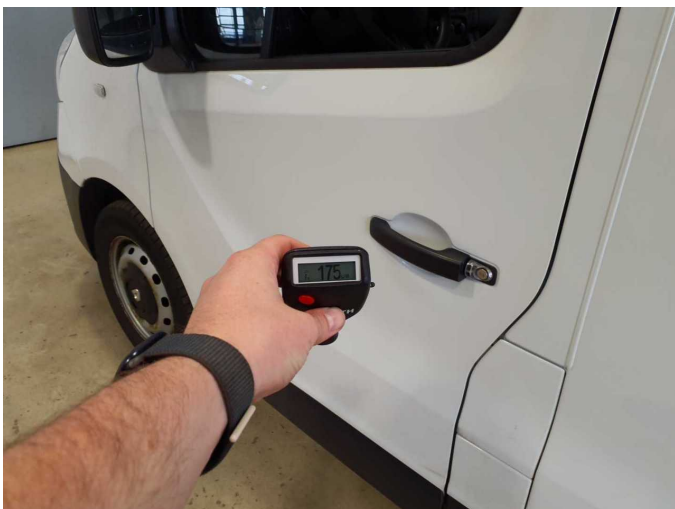
Repainting 2: Door - front left side
