Expertise

Protocol number: 46328397
Order No. / Reference: 26631764
Inspection date: 2 Jul 2026

Manufacturer: Audi

Model: S6 Avant TDI quattro tiptronic

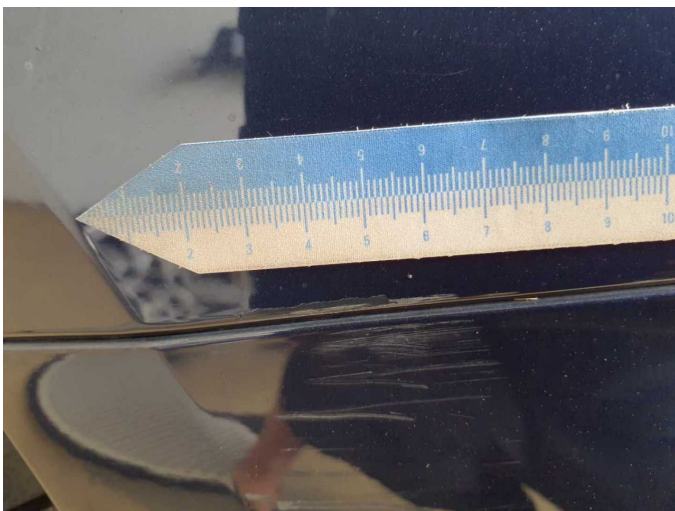
Accident 1: Rear, Side - left

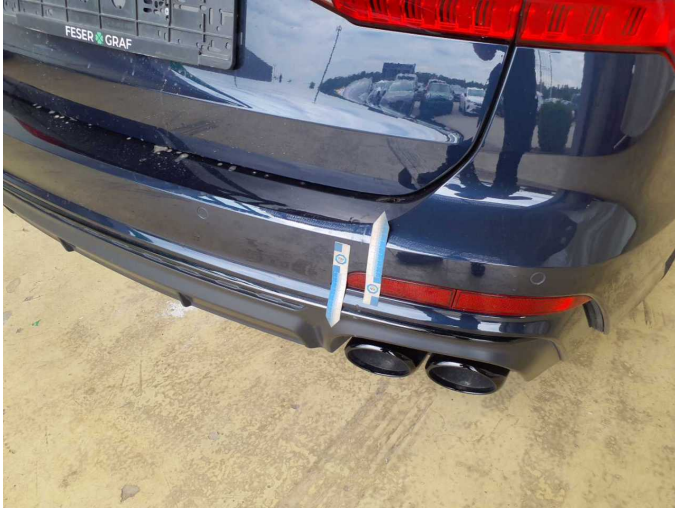
Accident 1: Rear, Side - left

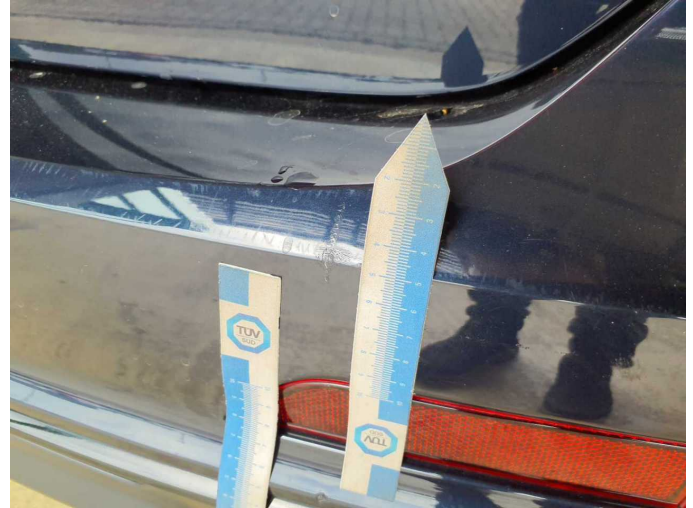
Accident 1: Rear, Side - left

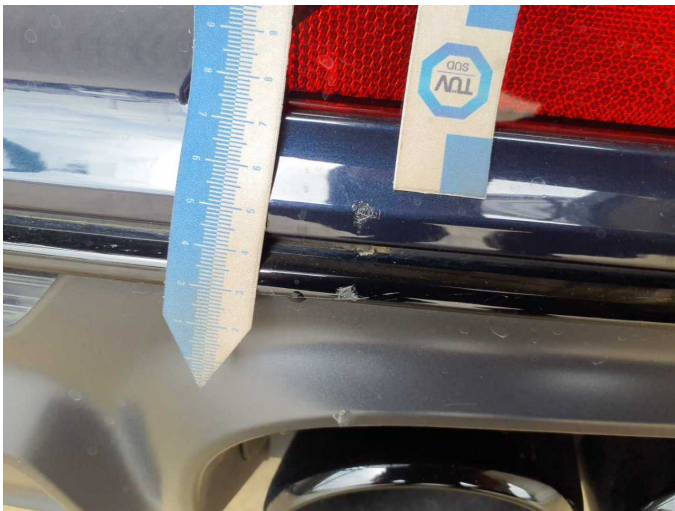
Accident 1: Rear, Side - left

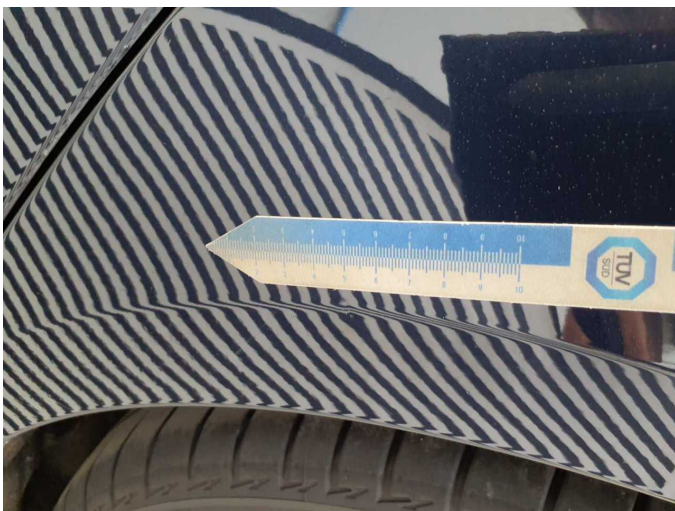
Accident 1: Rear, Side - left
