Expertise

Protocol number: 45449892
Order No. / Reference: 26368233
Inspection date: 8 May 2026

Model: Astra 1.5 D Automatik Business Elegance

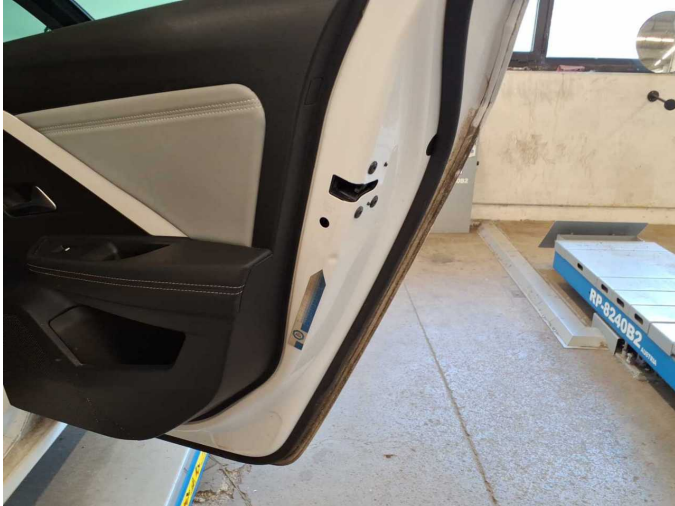
Damage 3: Door - rear right side: Door (Innen) - dent(s) - Smooth repair work

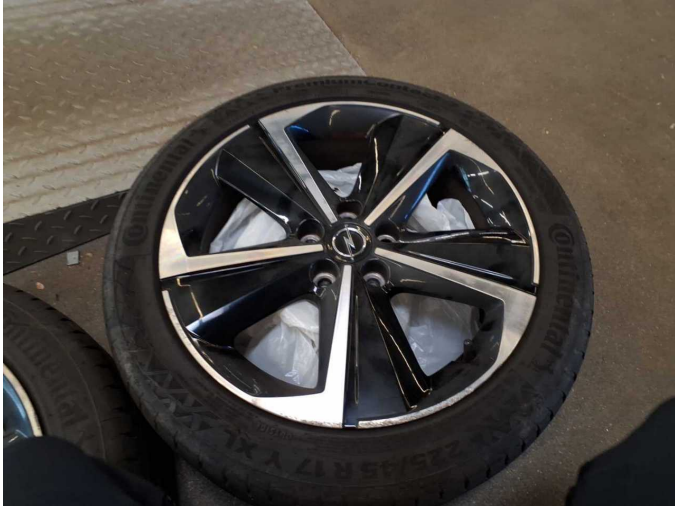
Damage 6: 2nd wheel set: 1 tyre - Damaged - Replace

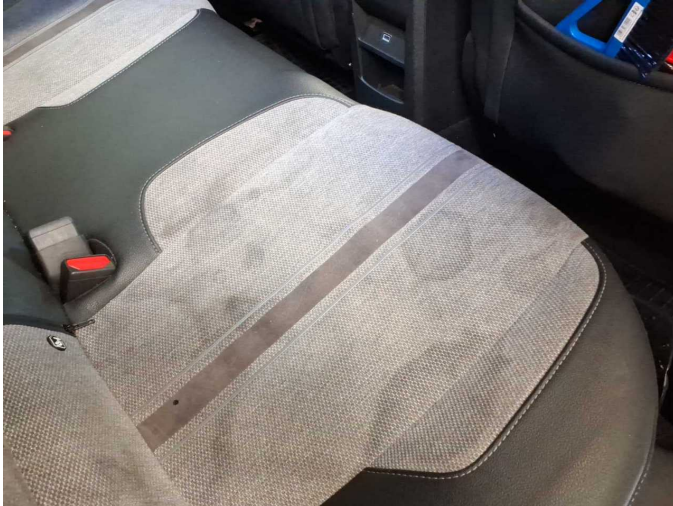
Damage 12: Interior: Interior (Sitze) - Soiled - Clean

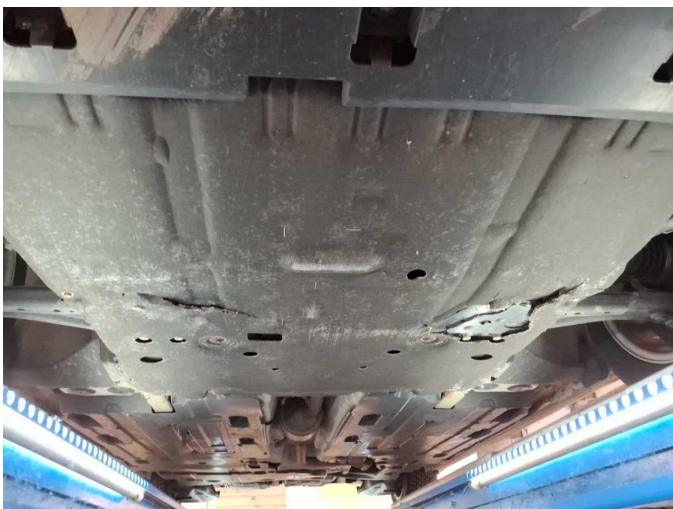
Damage 14: Engine: Engine cowling - lower - Broken / torn - Replace

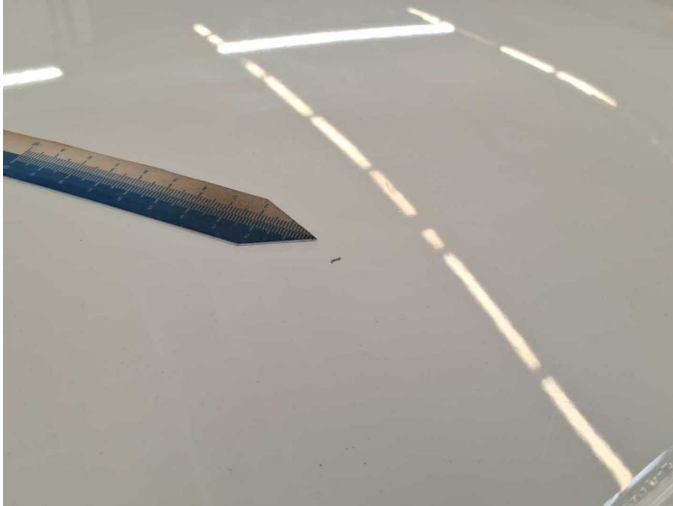
Damage 19: Roof: Roof - Dent / paintcoat damage - Repair and paint

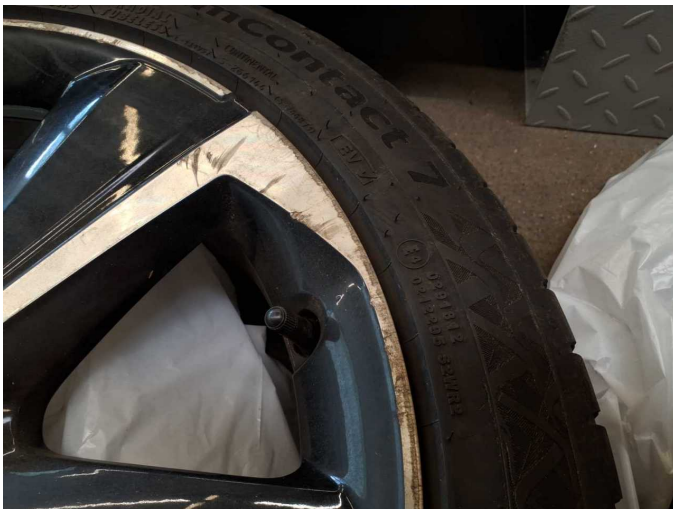
Damage 20: 2nd wheel set: Alloy rim set - complete - Scratch(es) - Replace

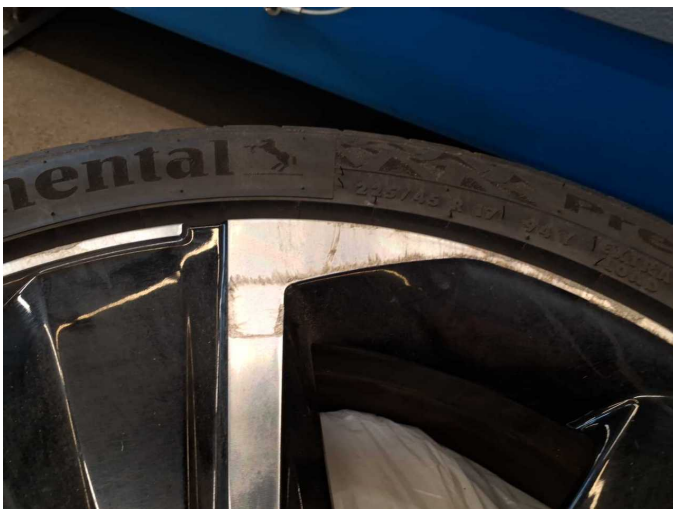
Damage 20: 2nd wheel set: Alloy rim set - complete - Scratch(es) - Replace

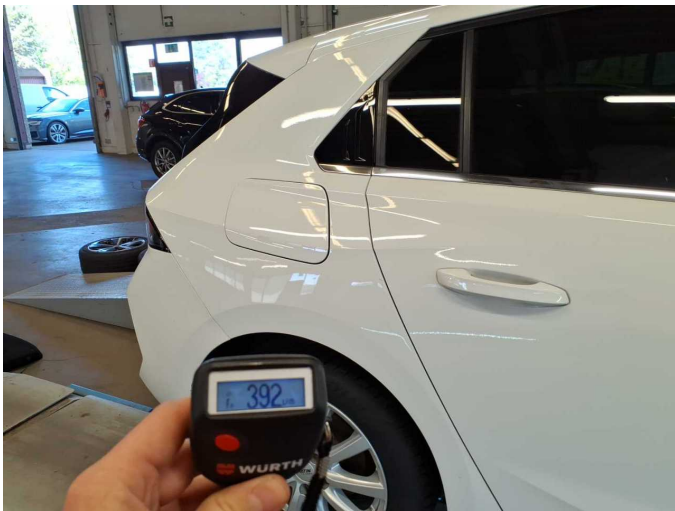
Repainting 2: Side panel - rear right side

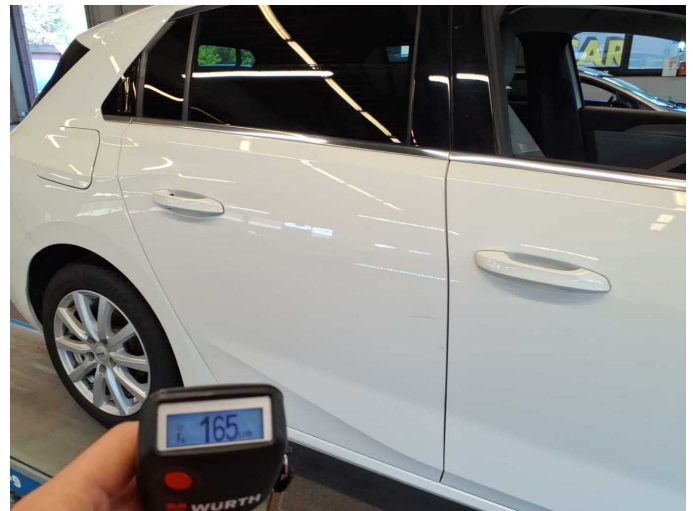
Repainting 3: Door - rear right side
