Expertise

Protocol number: 46630590  
Order No. / Reference: 26801840  
Inspection date: 20 Jul 2026

Manufacturer: Skoda  
VIN: TMBJH9NP6N7007508

Model: Superb Combi 2.0 TDI DSG Ambition

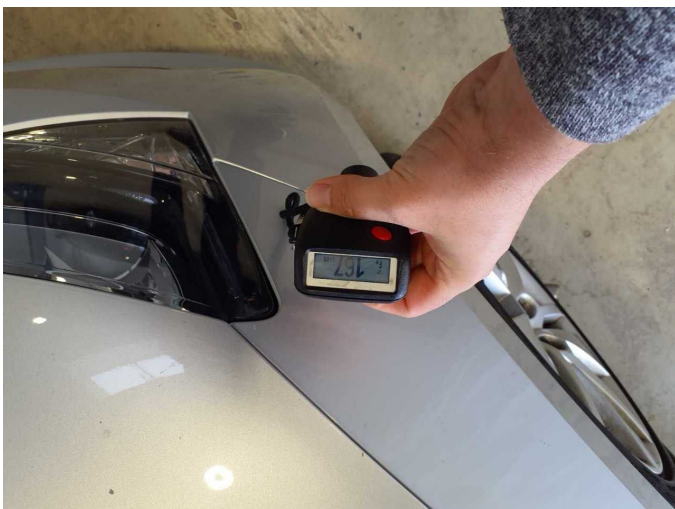
- Mudguard - right side, Bonnet, Door - rear right side, Door - front right side, Professionally carried out, Invoice of repair done Non-existent
- Side panel - rear right side, Unprofessionally carried out, Invoice of repair done Non-existent

**Repainting 1:** Mudguard - right side, Bonnet, Door - rear right side, Door - front right side

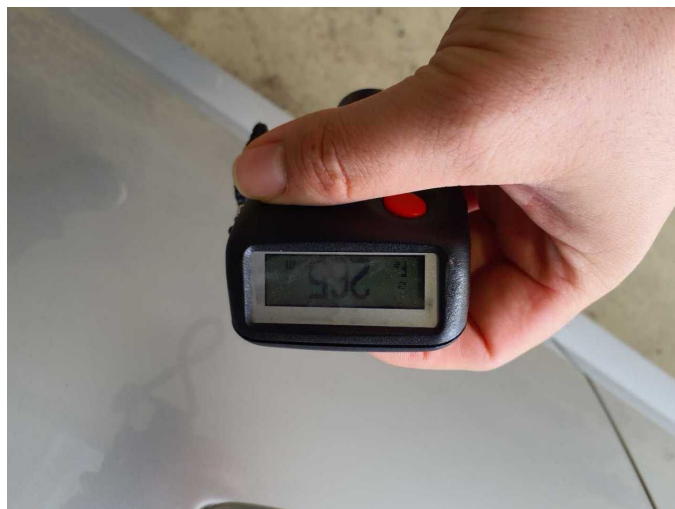
**Repainting 1:** Mudguard - right side, Bonnet, Door - rear right side, Door - front right side

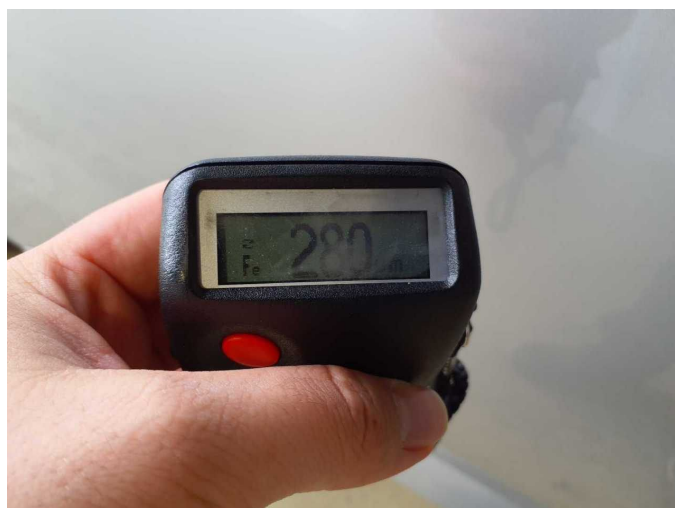
**Repainting 1:** Mudguard - right side, Bonnet, Door - rear right side, Door - front right side
