Expertise

Protocol number: 46844895  
Order No. / Reference: 26816532  
Inspection date: 3 Aug 2026

Manufacturer: Mercedes-Benz  
VIN: W1VVKFZ1P4281925

Model: EQV 300 lang

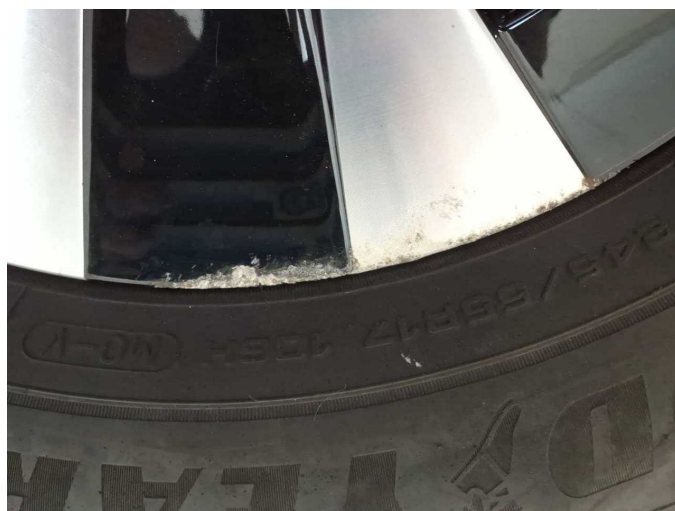
Damage 1: 2nd wheel set: 1 alloy rim - Scratched - No deduction

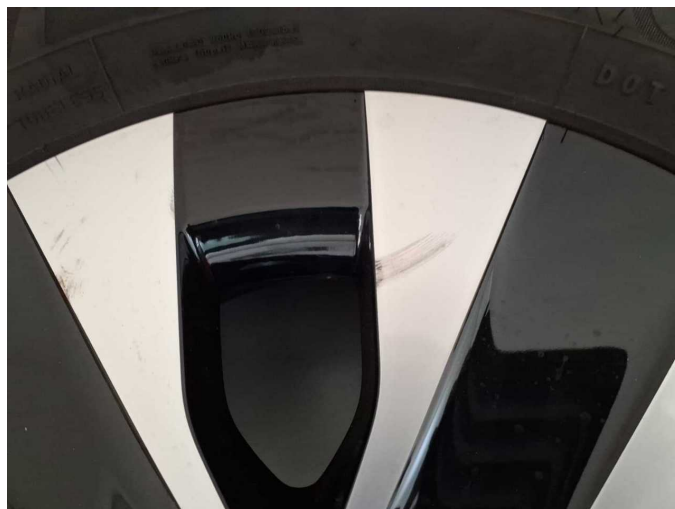
**Damage 2:** 2nd wheel set: 1 alloy rim - Scratch(es) - No deduction

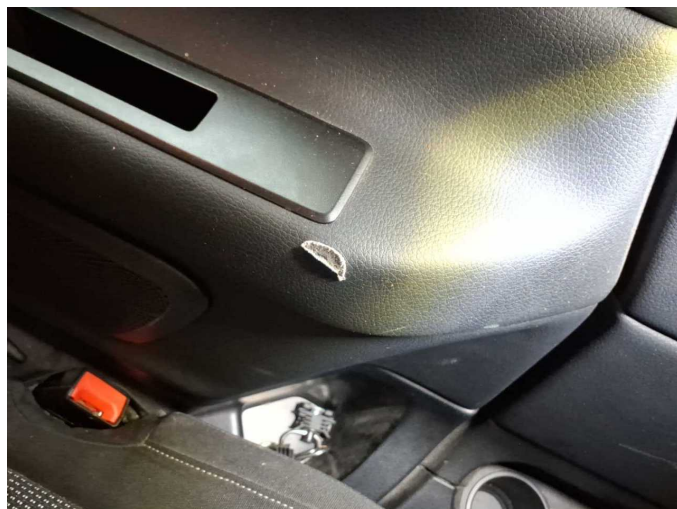
| No. | Component group | Description |
|---|---|---|
| 8 | Side panel - rear left side | Interior trim - Damaged - Smart repair |

**Damage 8:** Side panel - rear left side: Interior trim - Damaged - Smart repair

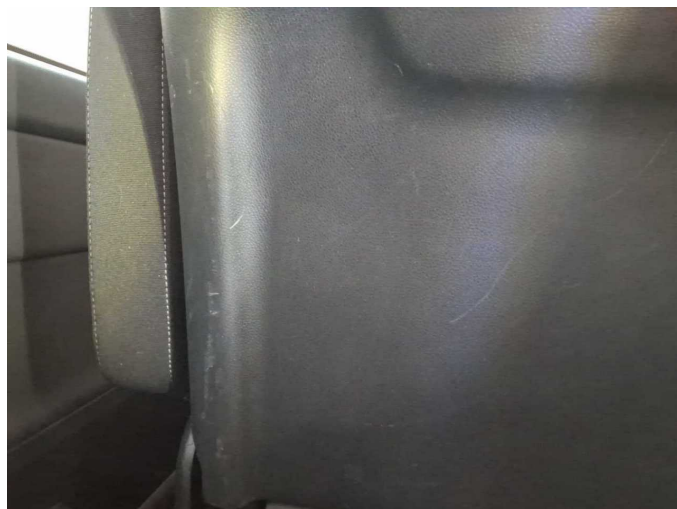
**Damage 10:** Trim / covers: Trim / covers (Innenraum) - Scratched - Loss in value

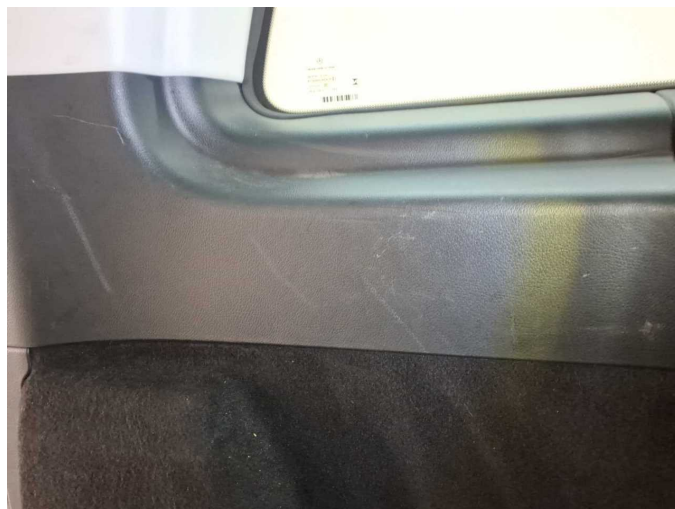
**Damage 10:** Trim / covers: Trim / covers (Innenraum) - Scratched - Loss in value

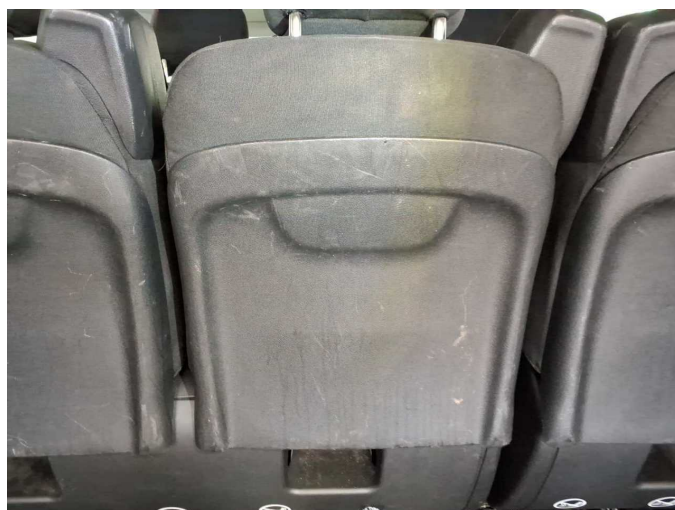
**Damage 10:** Trim / covers: Trim / covers (Innenraum) - Scratched - Loss in value

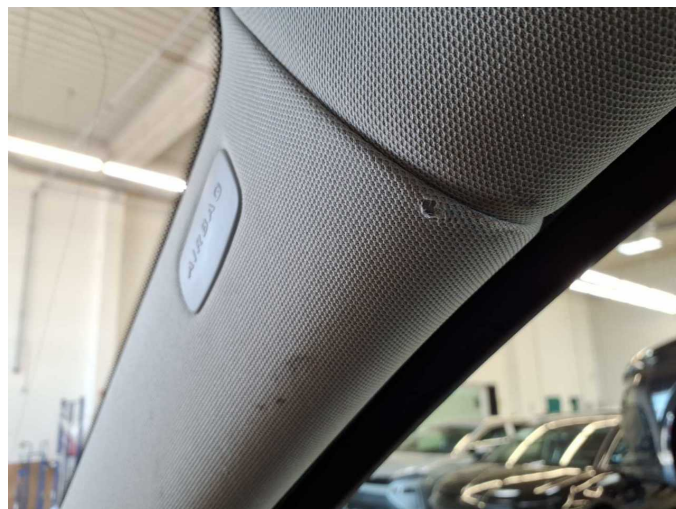
| No. | Component group | Description |
|---|---|---|
| 11 | Trim / covers | A-pillar - interior trim - right side - Damaged - Replace |

**Damage 11:** Trim / covers: A-pillar - interior trim - right side - Damaged - Replace

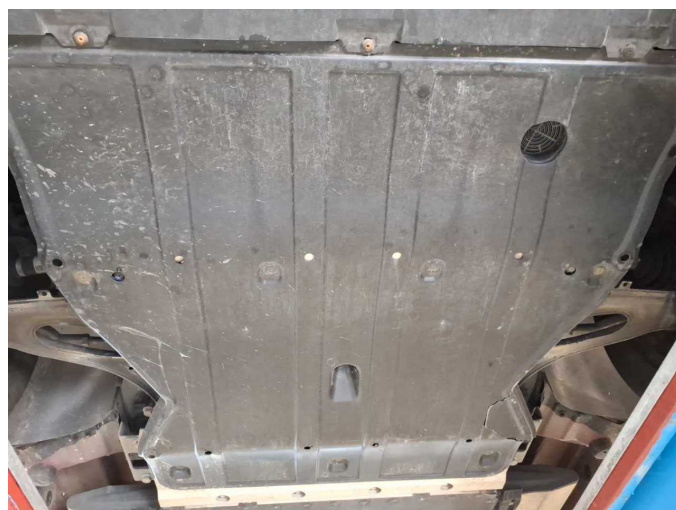
| No. | Component group | Description |
|---|---|---|
| 12 | Engine | Engine cowling lower front - Broken / torn - Replace |

**Damage 12:** Engine: Engine cowling lower front - Broken / torn - Replace

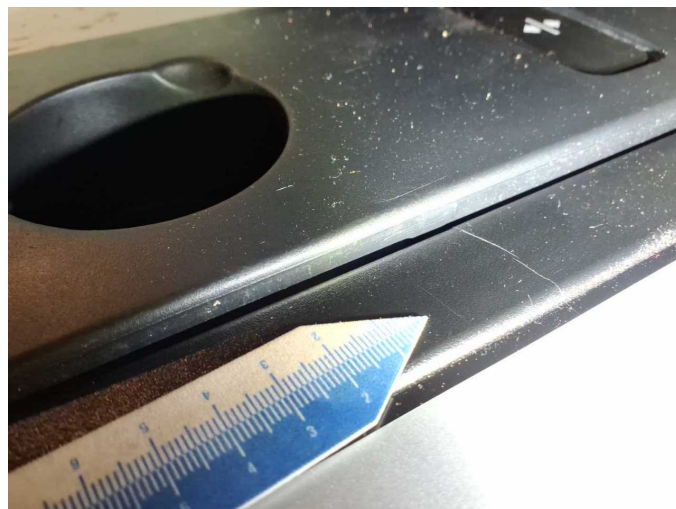
| No. | Component group | Description |
|---|---|---|
| 13 | Equipment | tabletop (+ verschmutzt) - Scratched - Replace |

**Damage 13:** Equipment: tabletop (+ verschmutzt) - Scratched - Replace

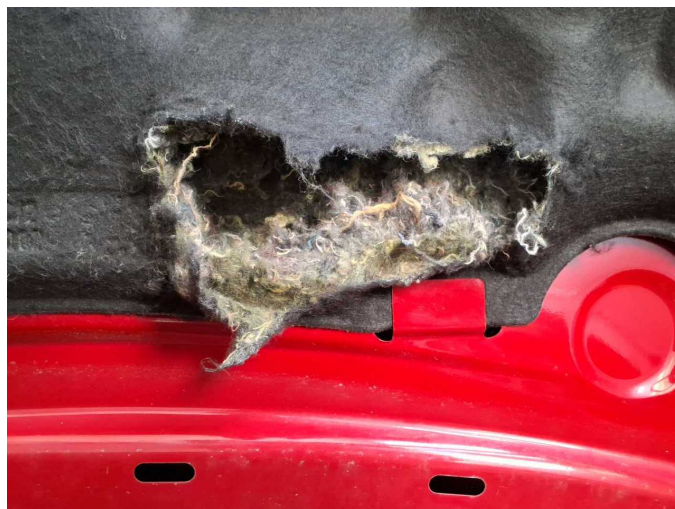
**Damage 14:** Cab: Insulation lining (+ Motorhaube) - Damage caused by marten / rodent - Replace

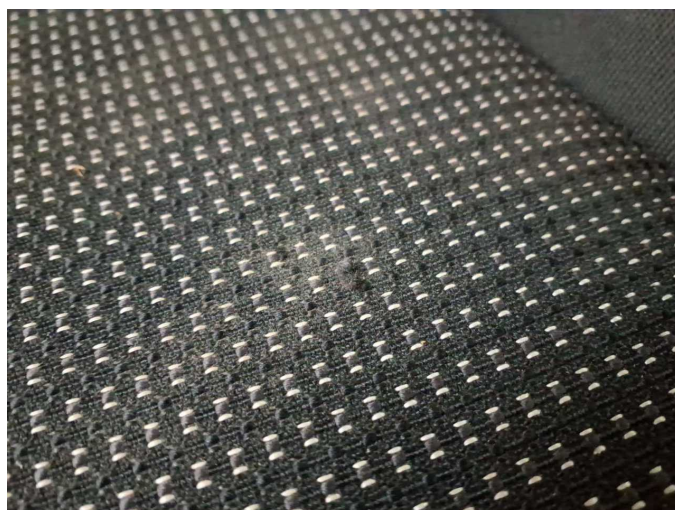
**Damage 15:** Seat - front: Seat cover - right side (+ verschmutzt) - Damaged - Replace

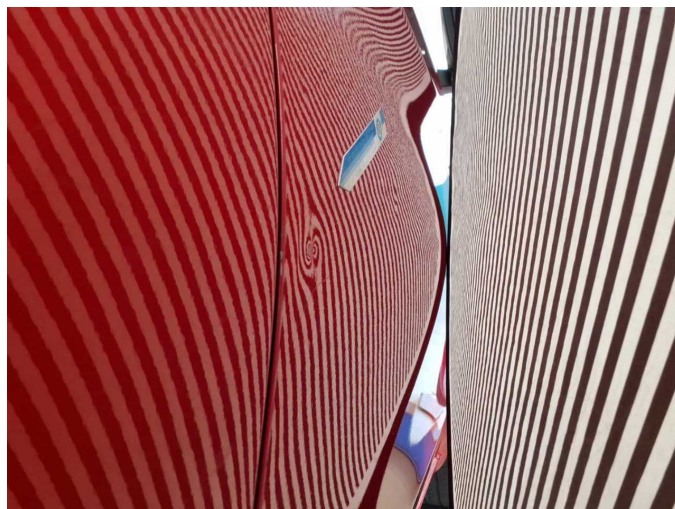
**Damage 16:** Door - front right side: Door - Dent / paintcoat damage - Repair and paint

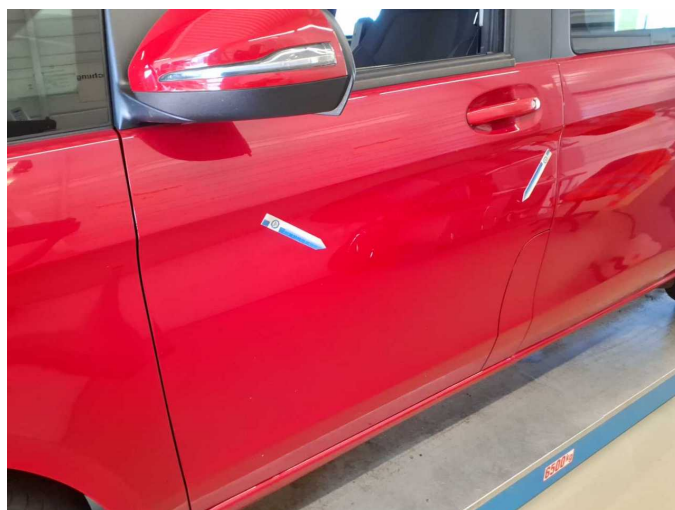
**Damage 16:** Door - front right side: Door - Dent / paintcoat damage - Repair and paint
