Expertise

Protocol number: 46643335  
Order No. / Reference: 26539219  
Inspection date: 17 Jul 2026

Manufacturer: Ford

Model: Transit Custom 320 L2H1 LKW VA MH Basis

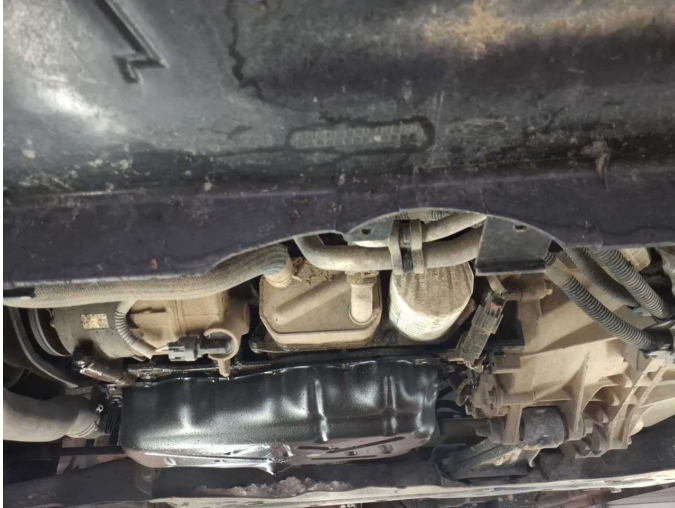
**Accident 1: Underbody**
