Expertise

Protocol number: 46400646  
Order No. / Reference: 26527946  
Inspection date: 1 Jul 2026

Manufacturer: Volkswagen

Model: Touran 2.0 TDI SCR DSG Comfortline

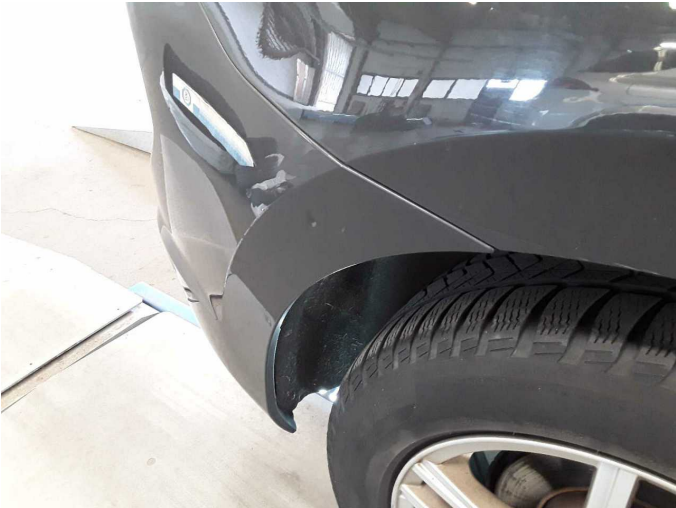
**Accident 1:** Side right

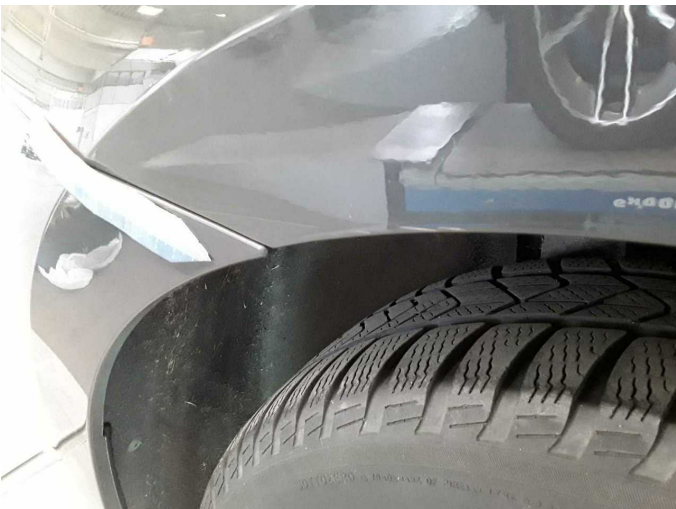
**Accident 1:** Side right

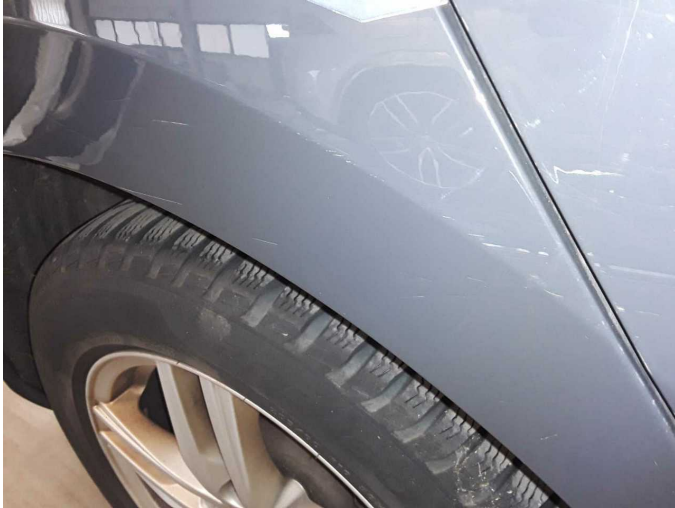
**Accident 1: Side right**

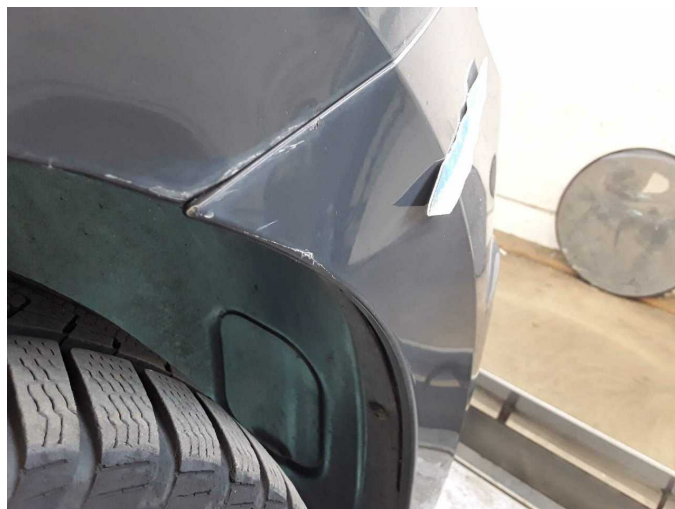
**Accident 2: Side right**
