Expertise

Protocol number: 45796891
Order No. / Reference: 26529501
Inspection date: 5 Jun 2026

Model: Focus Turnier 1.5 EcoBlue Start-Stopp-System Aut. TITANIUM

VIN: WF0PXXGCHPPL84048

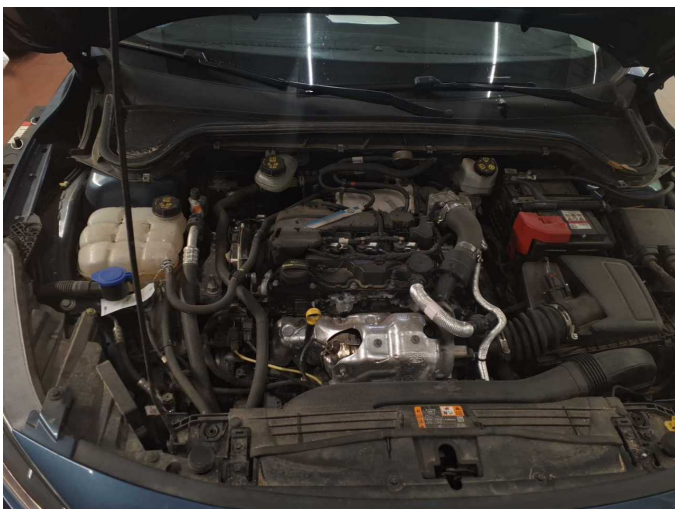
Damage 1: Misc.: Misc. (Isolierung Motor) - Damage caused by marten / rodent - Replace
