Expertise

Protocol number: 46320929
Order No. / Reference: 26530458
Inspection date: 3 Jul 2026

Manufacturer: Opel

Model: Zafira Life 2.0 D L Selection

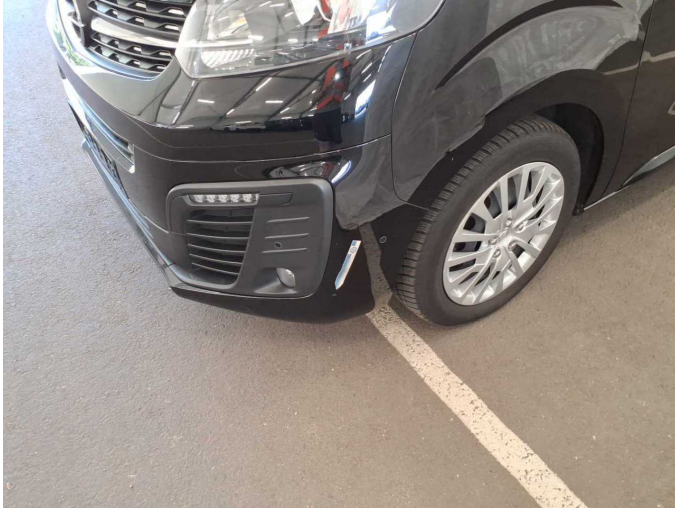
Accident 1: Front
