## Expertise

Protocol number: 46237484  
Order No. / Reference: 26529837  
Inspection date: 29 Jun 2026

Model: Tiguan Allspace 2.0 TDI SCR DSG Life

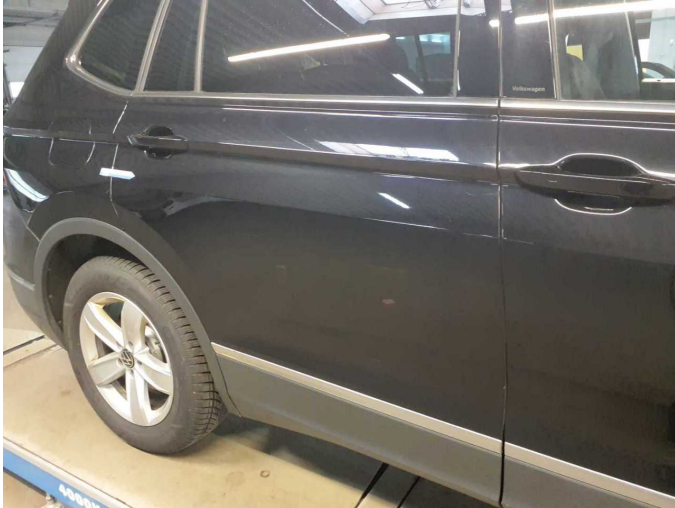
Accident 1: Side right

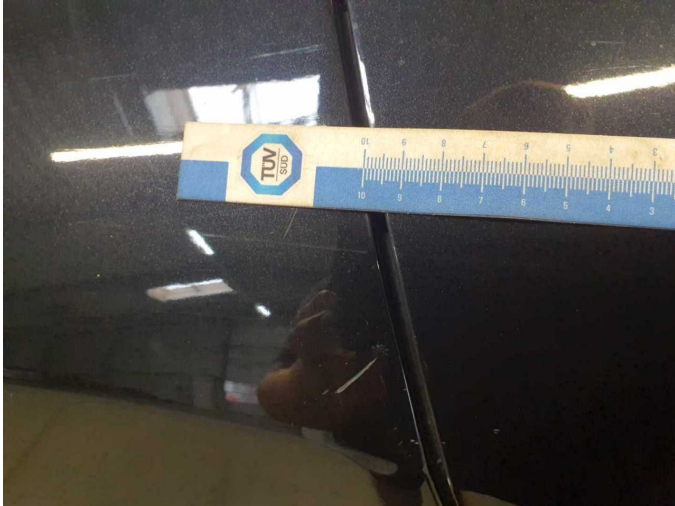
**Accident 1: Side right**
