Expertise

Protocol number: 46363508
Order No. / Reference: 26505209
Inspection date: 6 Jul 2026

Manufacturer: Volkswagen

Model: Multivan 2,0 TDI SCR KÜ Life

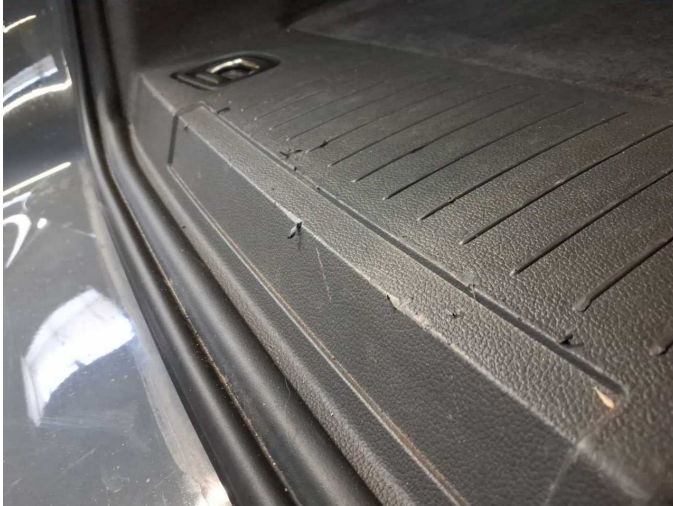
Damage 6: Trim / covers: Boot sill cover (Materialabtrag) - Scratched - Replace

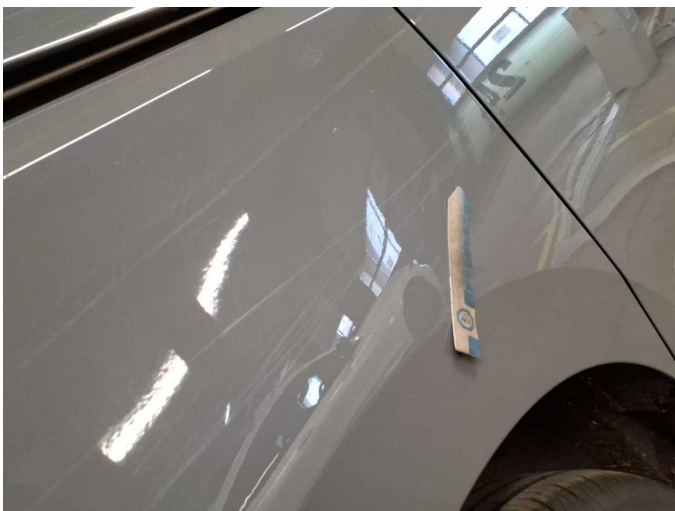
Accident 1: Side right

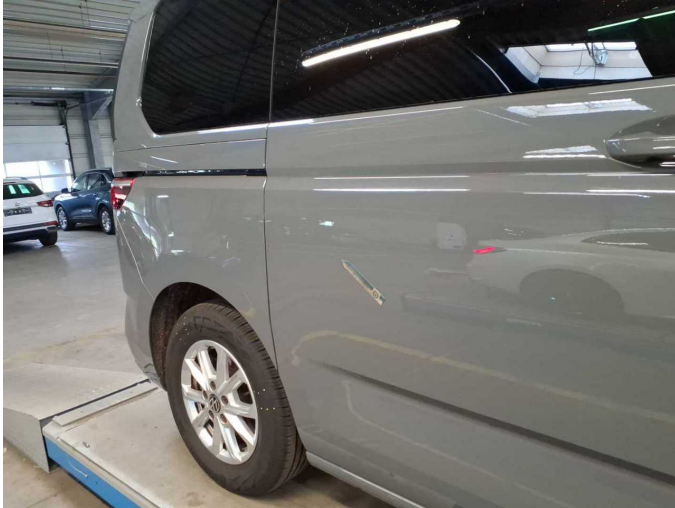
Accident 1: Side right

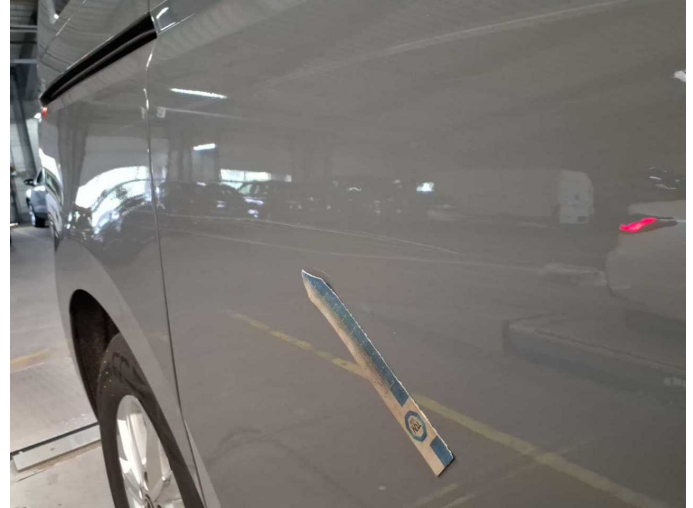
Accident 1: Side right

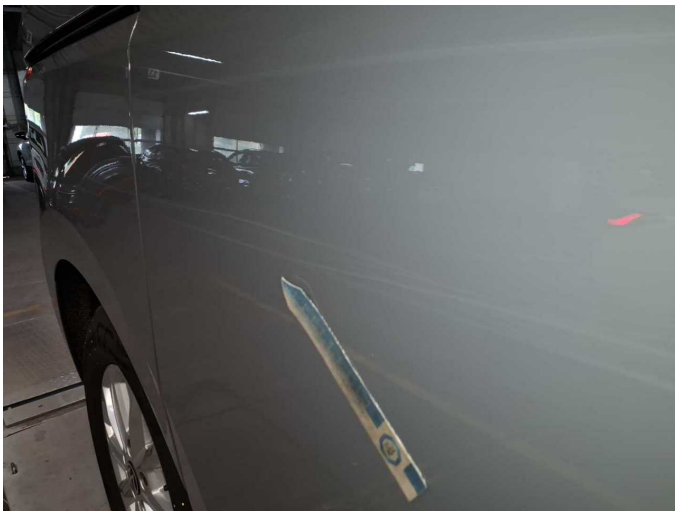
Accident 1: Side right

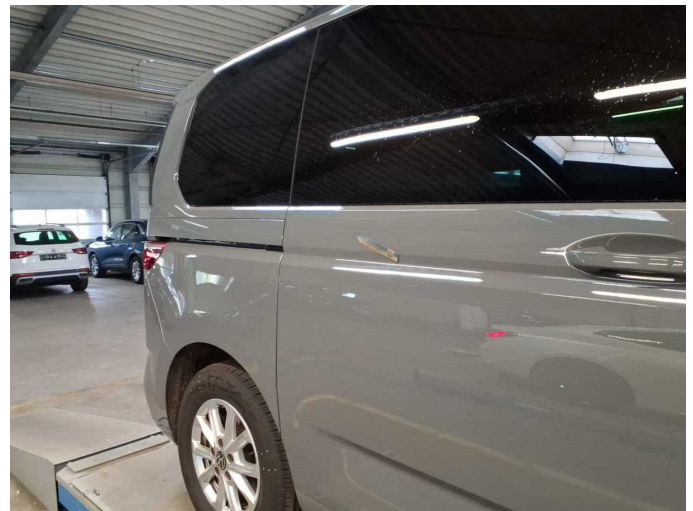
Accident 1: Side right

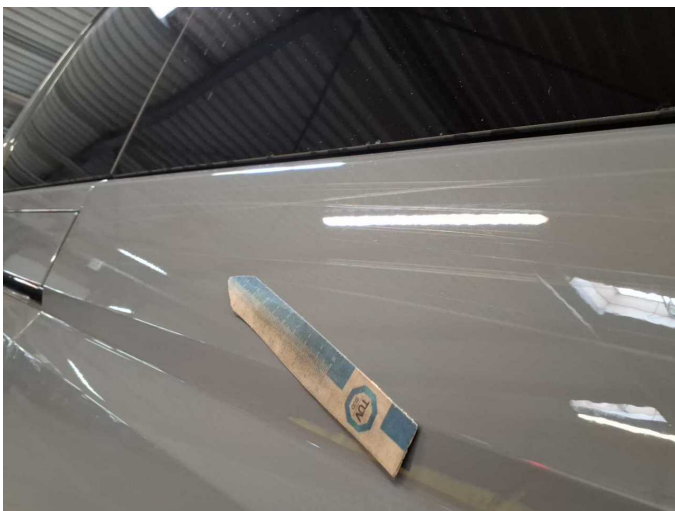
Accident 1: Side right
