Expertise

Protocol number: 46320684
Order No. / Reference: 26503667
Inspection date: 3 Jul 2026

Model: Octavia Combi 2.0 TDI DSG Style

VIN: TMBJJ0NX4PY100671

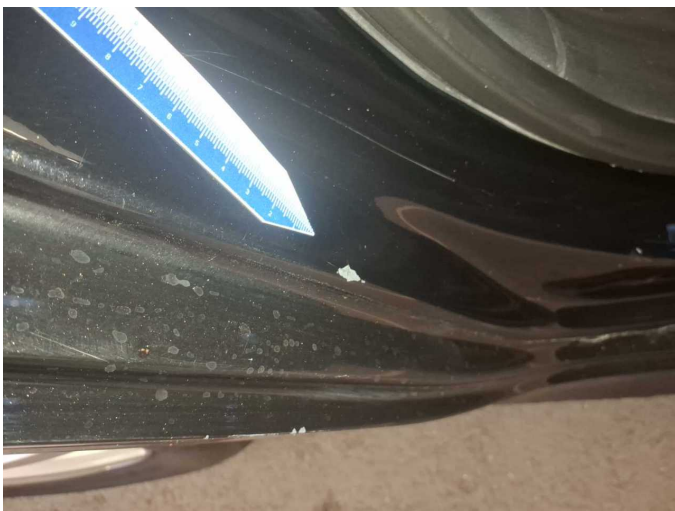
| No. | Component group | Description |
|---|---|--|
| 1 | Side panel - rear right side | Sill - Scratch(es) - Smart repair |

Damage 1: Side panel - rear right side: Sill - Scratch(es) - Smart repair

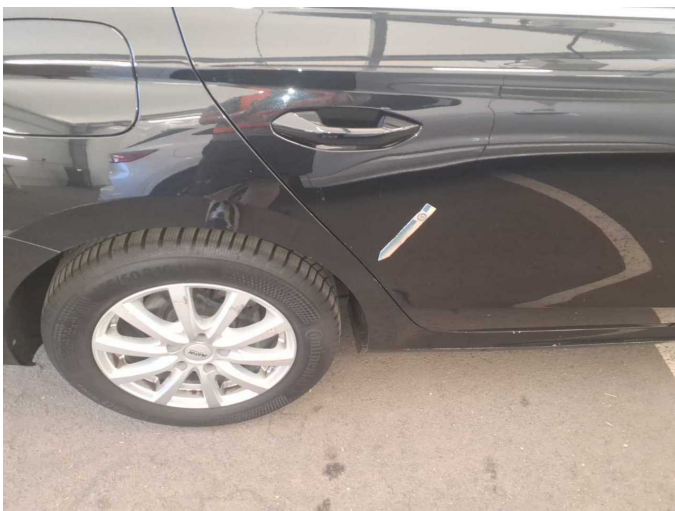
Accident 1: Side right

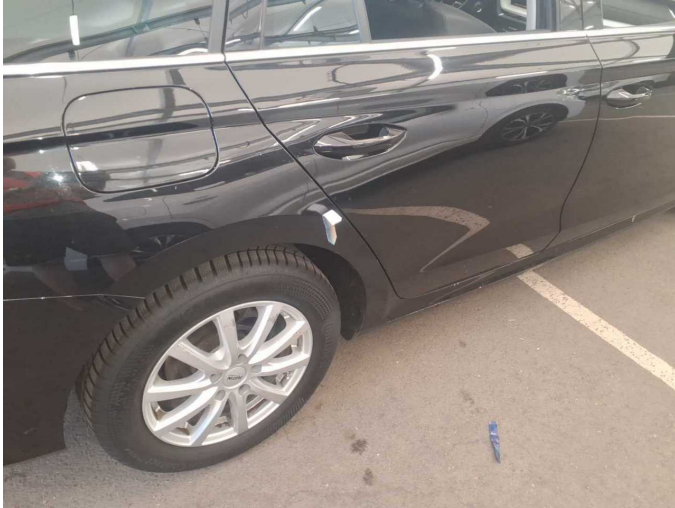
Accident 1: Side right

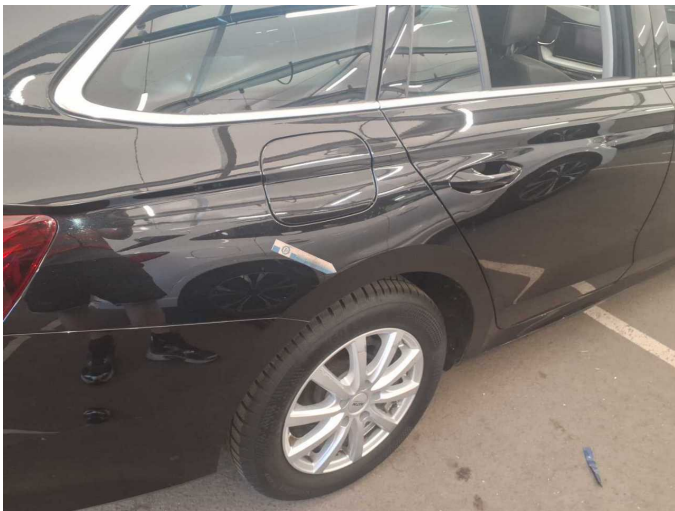
Accident 1: Side right

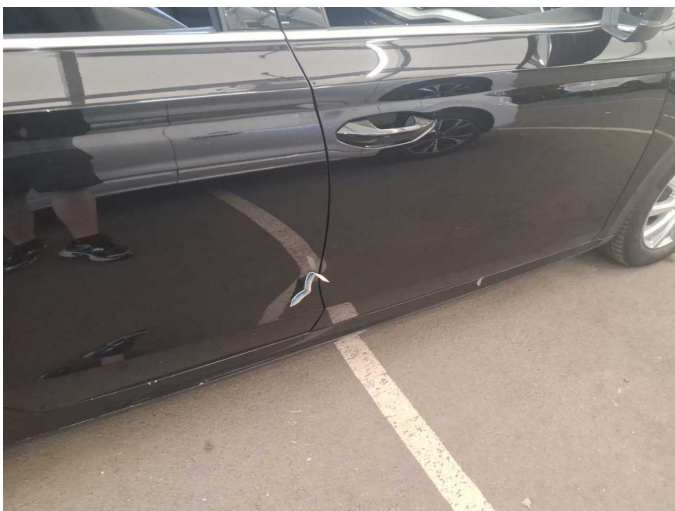
Accident 1: Side right
