Expertise

Protocol number: 45914975  
Order No. / Reference: 26437548  
Inspection date: 11 Jun 2026

| Manufacturer: Opel | Model: Astra 1.5 D Start/Stop Sports Tourer Automatik Business Edition |
| VIN: W0VBD8EVXN8038401 | |

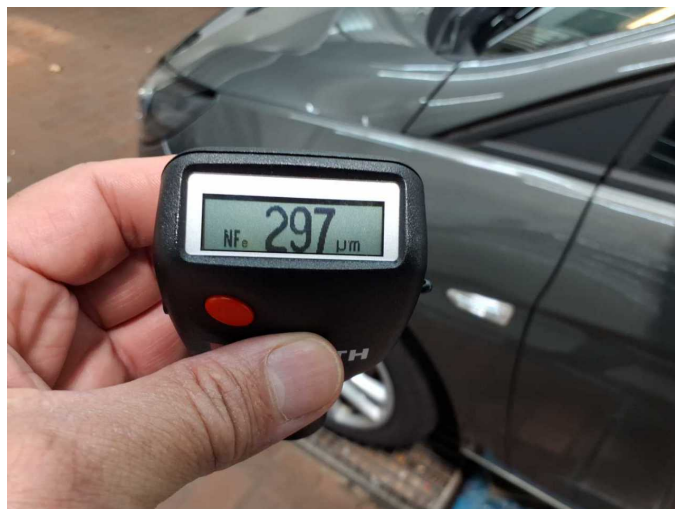
**Repainting 1:** Mudguard - left side, Bonnet
