Expertise

Protocol number: 46365685
Order No. / Reference: 26412190
Inspection date: 2 Jul 2026

Model: Focus Turnier 1.0 EcoBoost Start-Stopp-System TITANIUM

VIN: WF0PXXGCHPNG35446

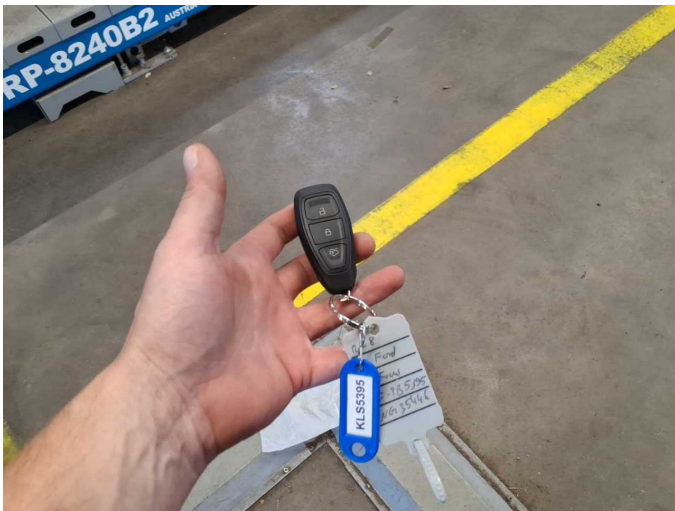
Missing part 1: Equipment: Vehicle key with remote control - Missing - Replace

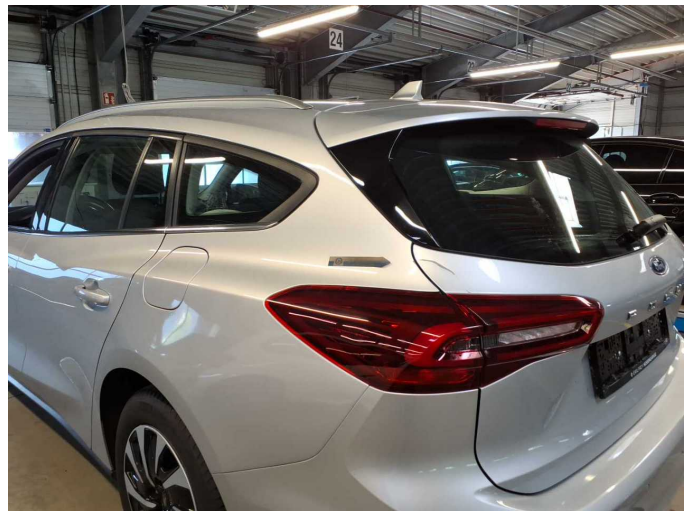
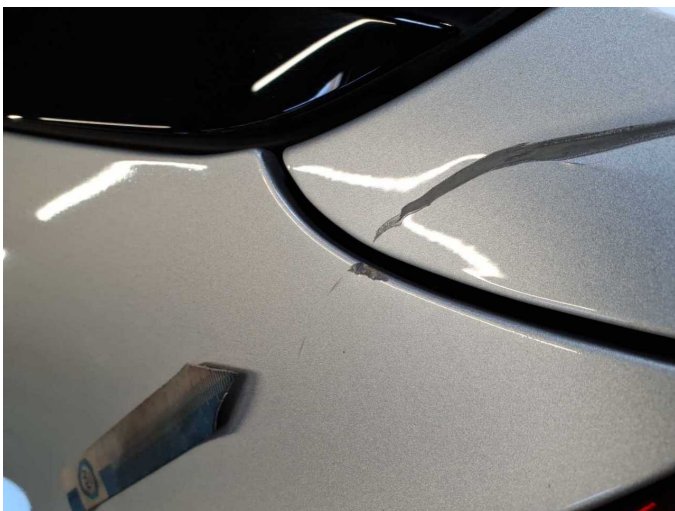
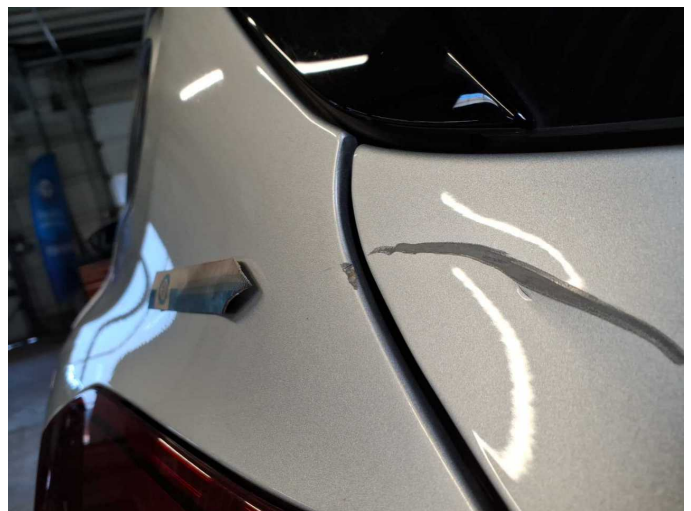
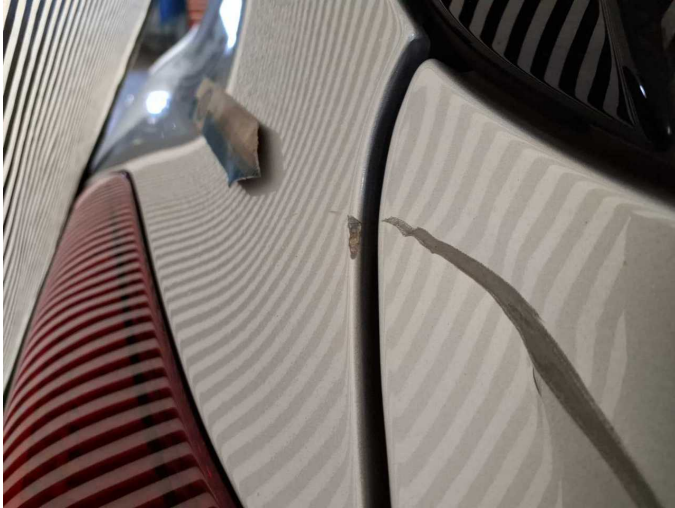
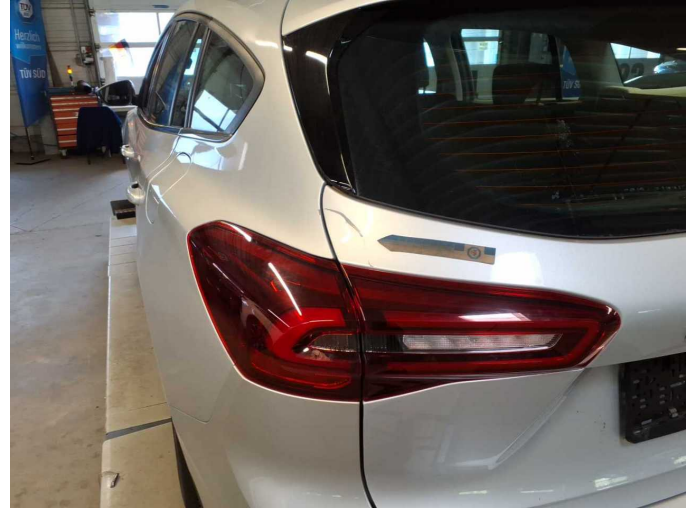
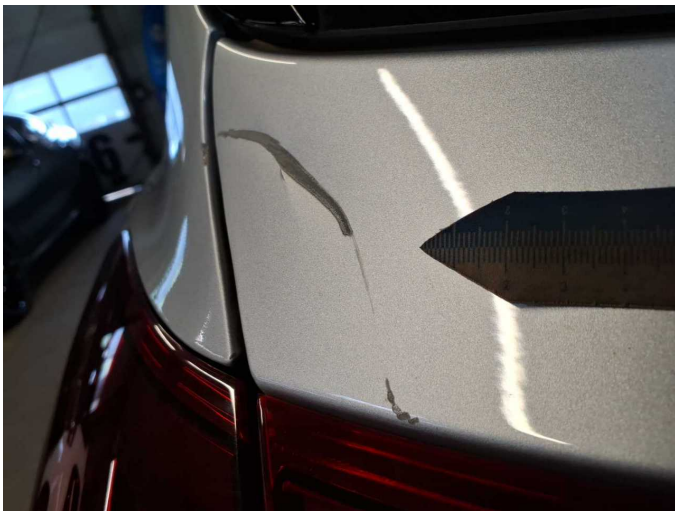
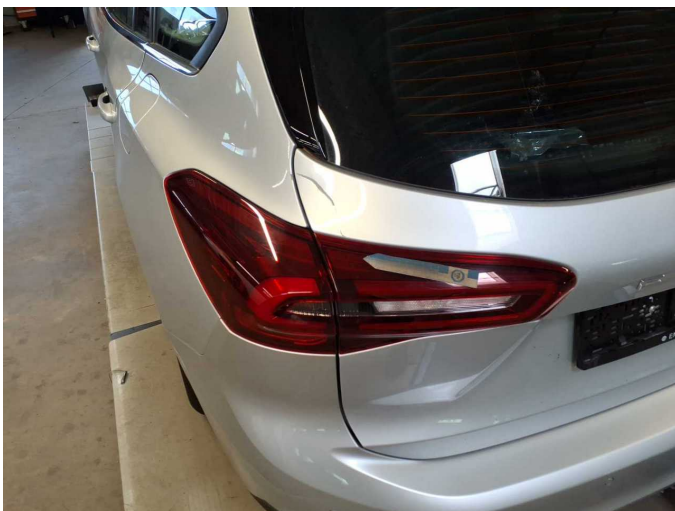
- 1 Side panel - rear left side, Professionally carried out, Invoice of repair done Non-existent

Accident 1: Rear, Side - left

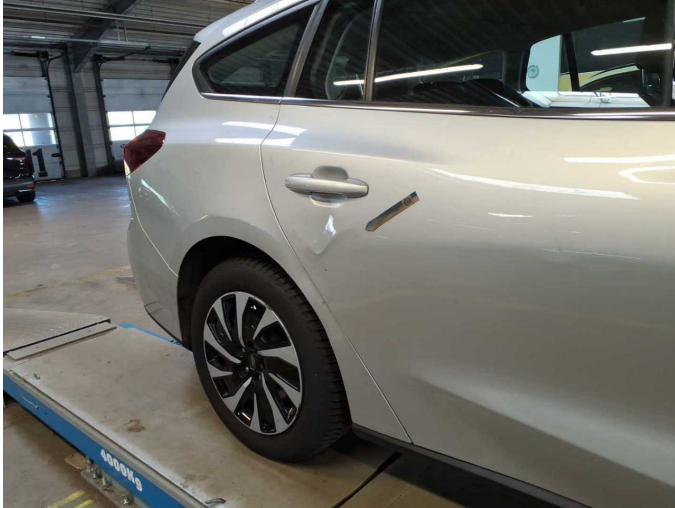
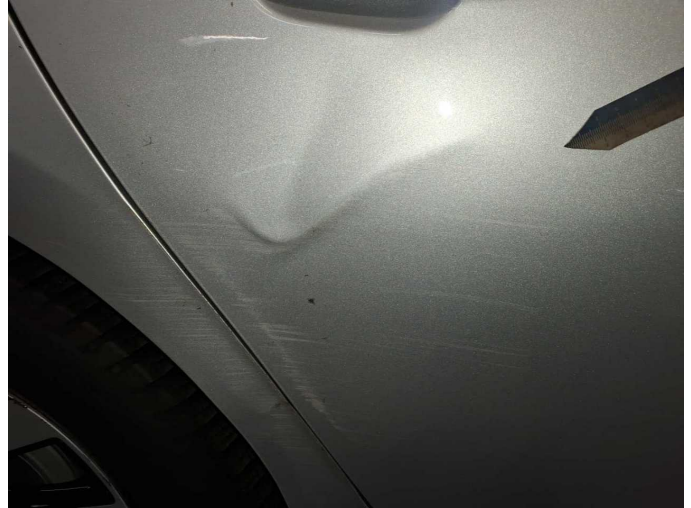
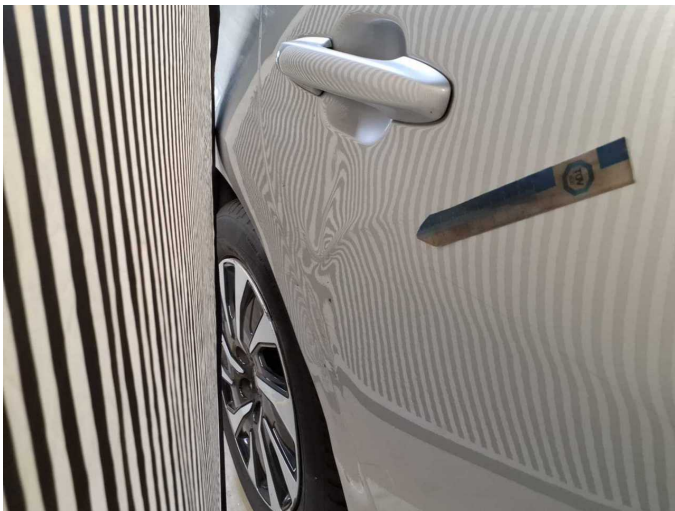
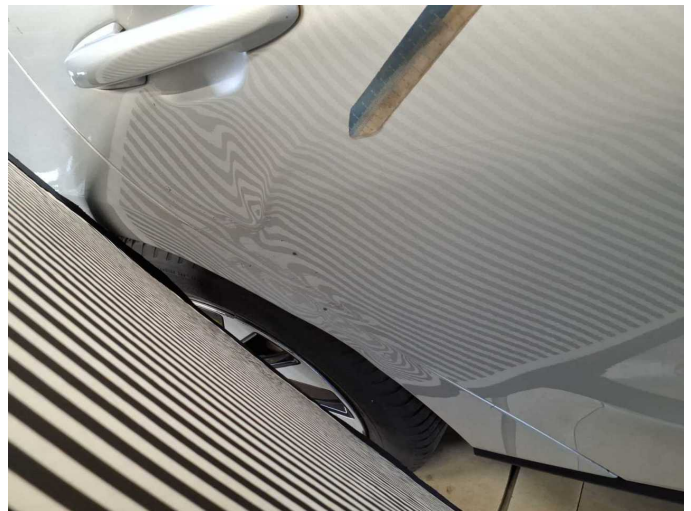
Accident 2: Side right

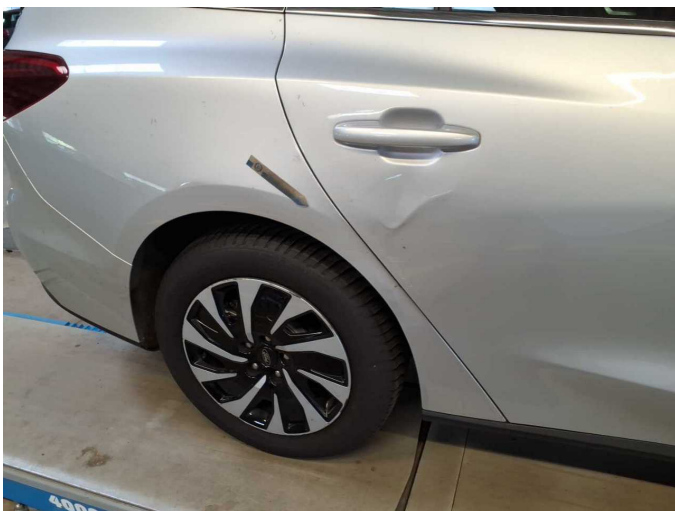
Accident 2: Side right

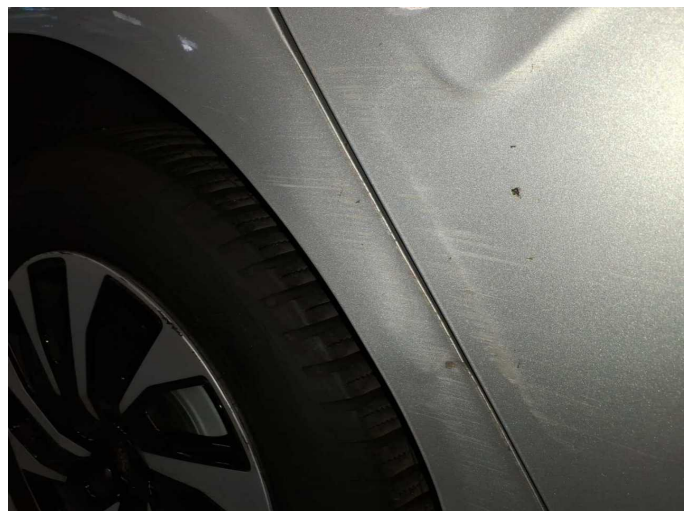
Accident 2: Side right

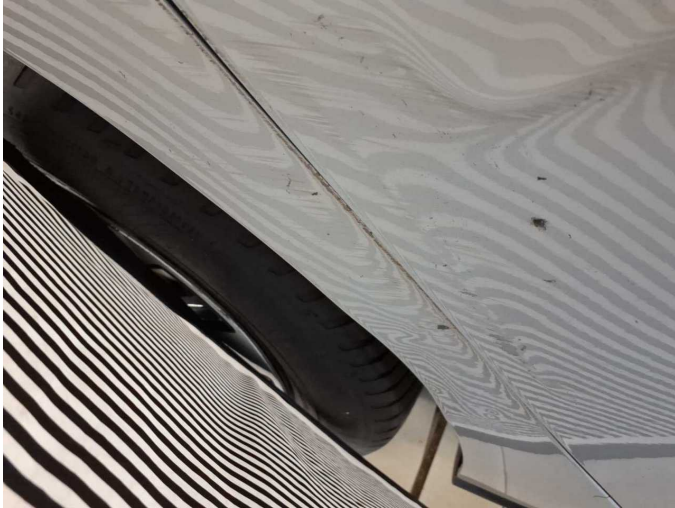
Accident 2: Side right

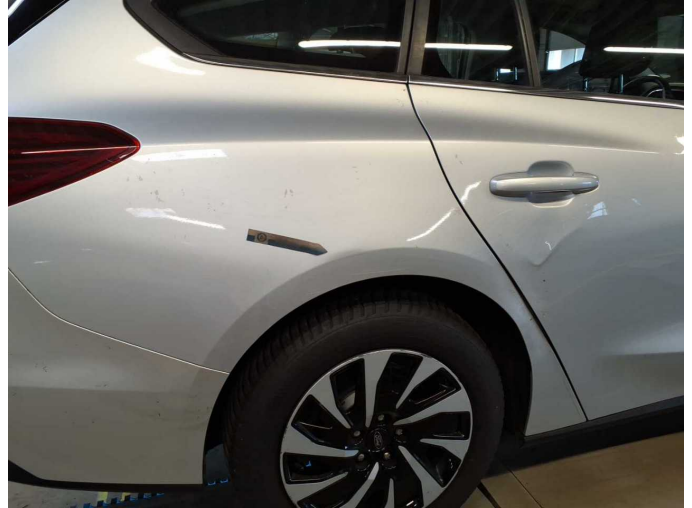
Accident 2: Side right

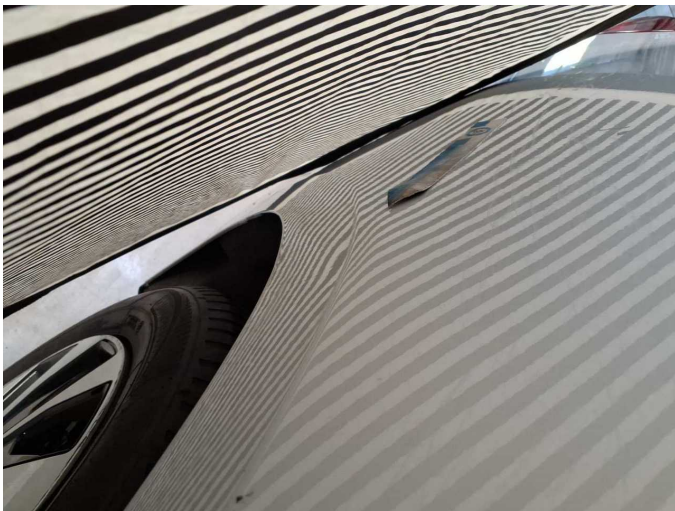
Accident 2: Side right

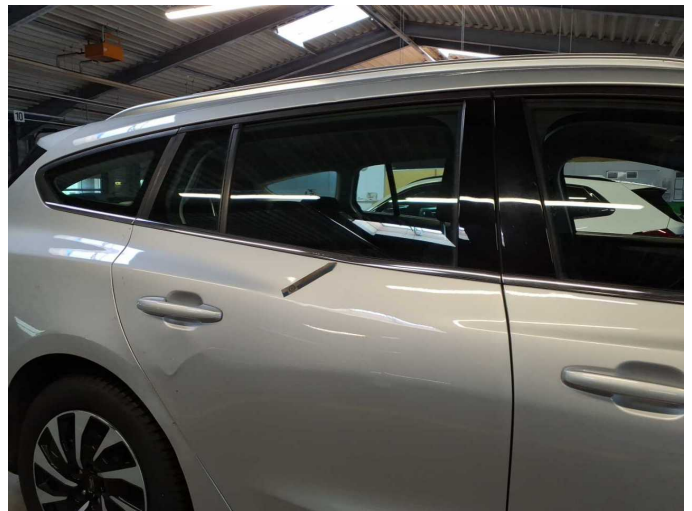
Accident 2: Side right

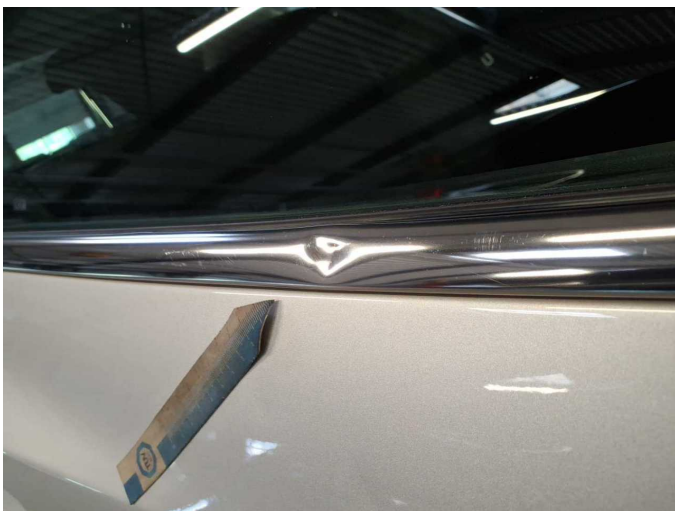
Accident 2: Side right

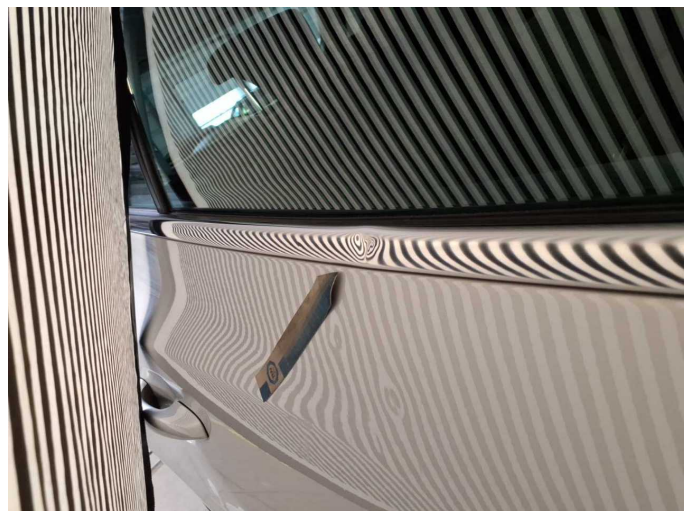
Accident 2: Side right

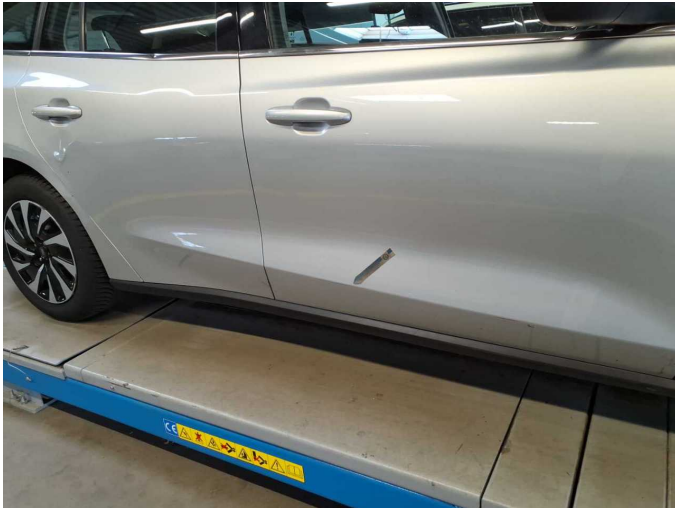
Accident 2: Side right

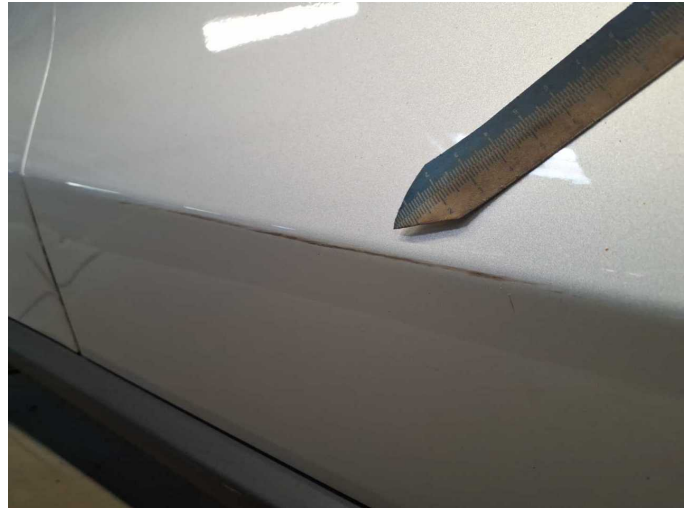
Accident 2: Side right

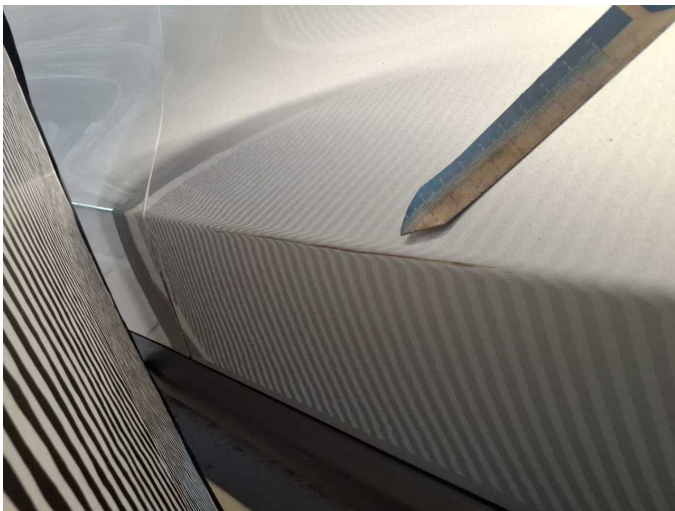
Accident 2: Side right

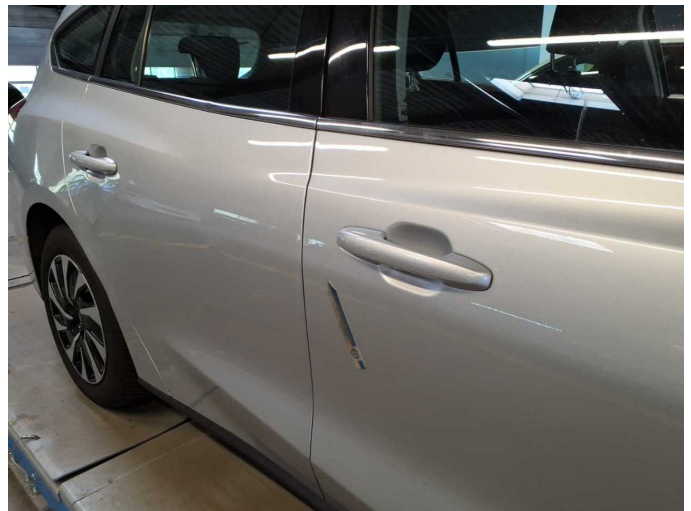
Accident 2: Side right

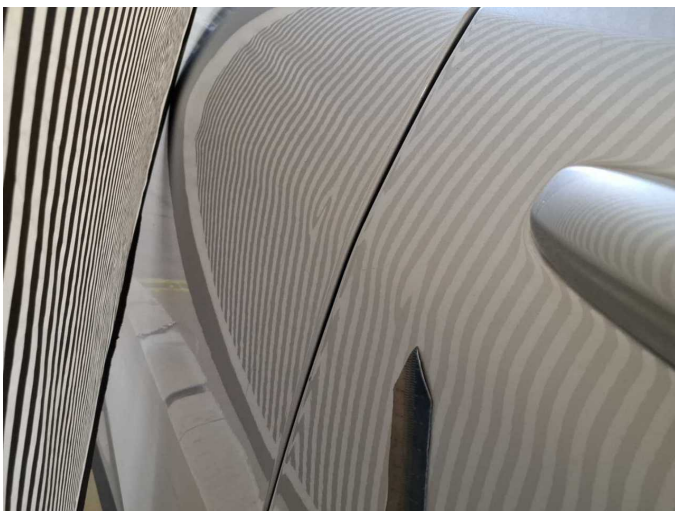
Accident 2: Side right

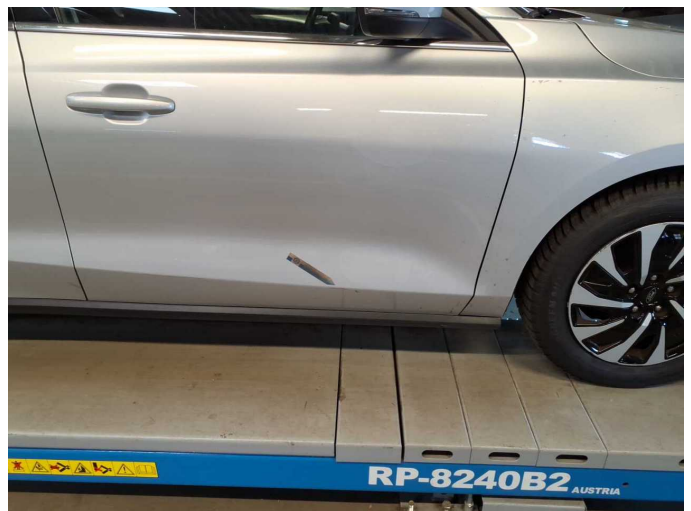
Accident 2: Side right

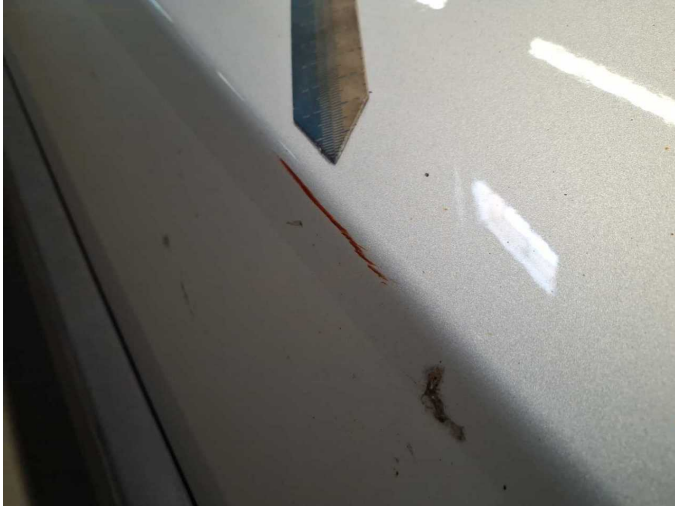
Accident 2: Side right

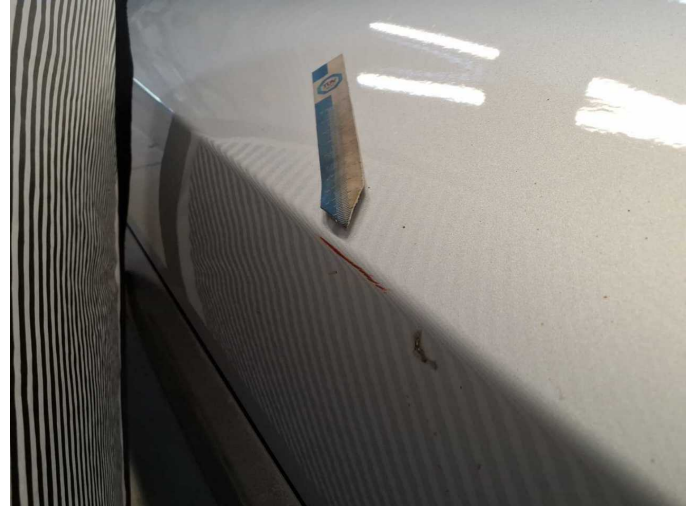
Accident 2: Side right

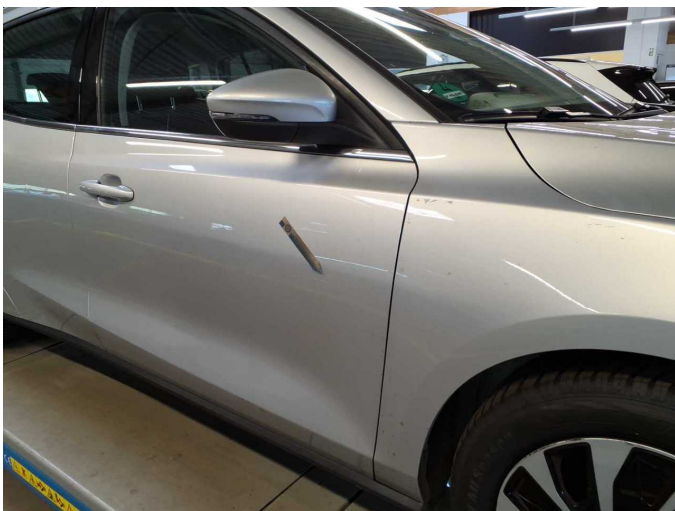
Accident 2: Side right

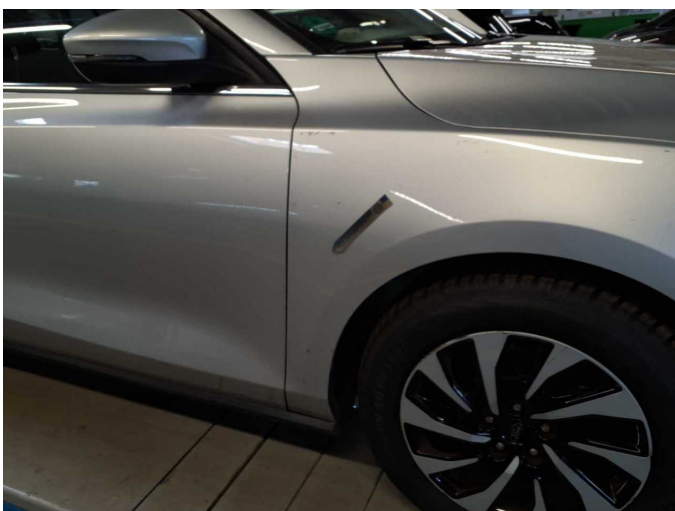
Accident 2: Side right

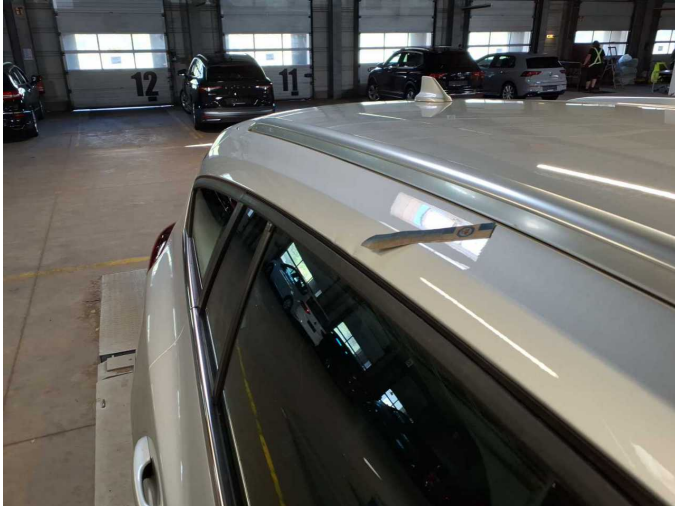
Accident 2: Side right

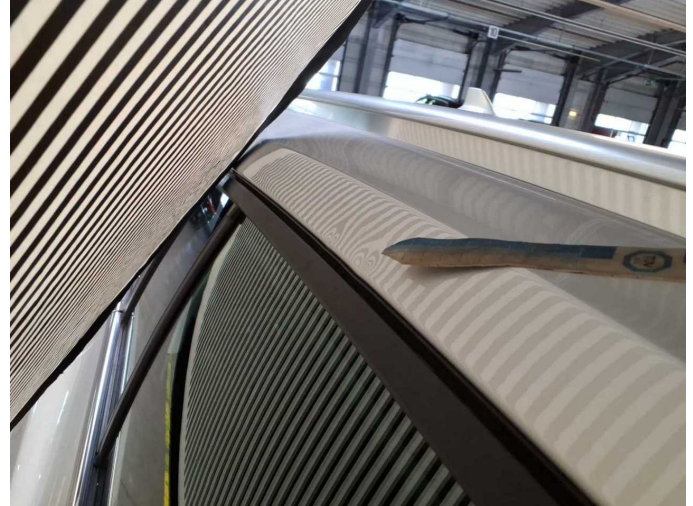
Accident 2: Side right

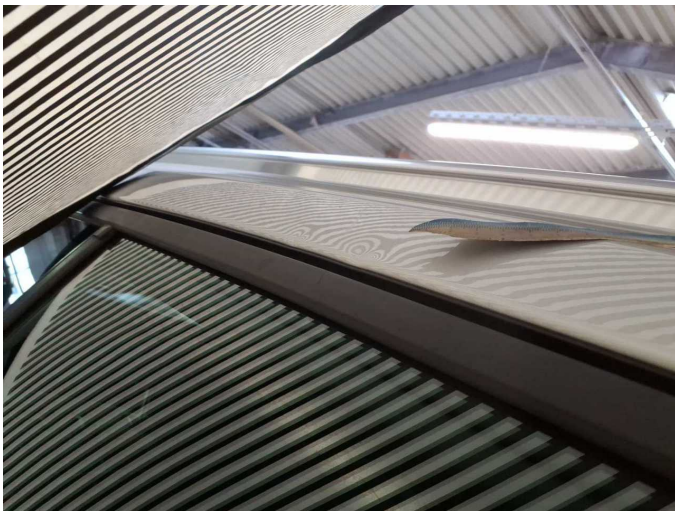
Accident 2: Side right

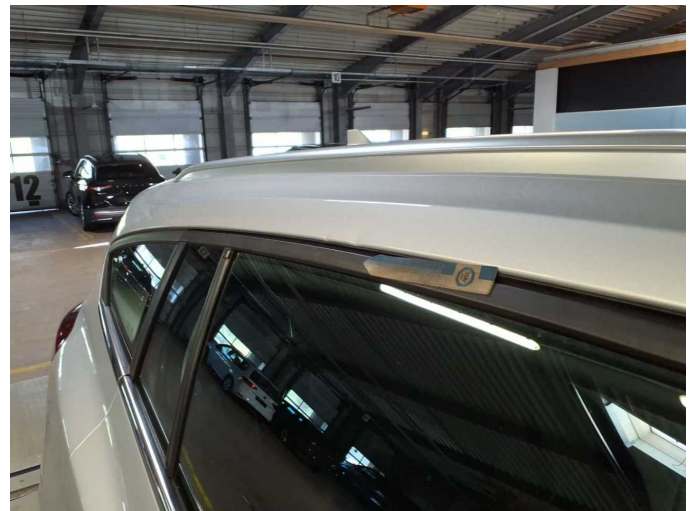
Accident 2: Side right

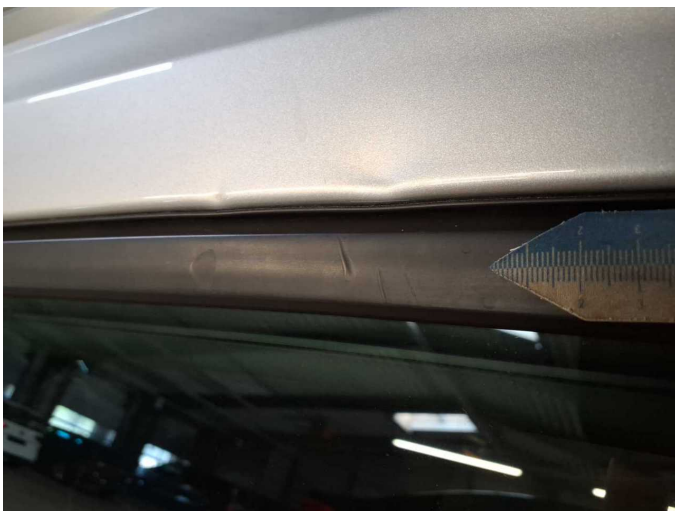
Accident 2: Side right

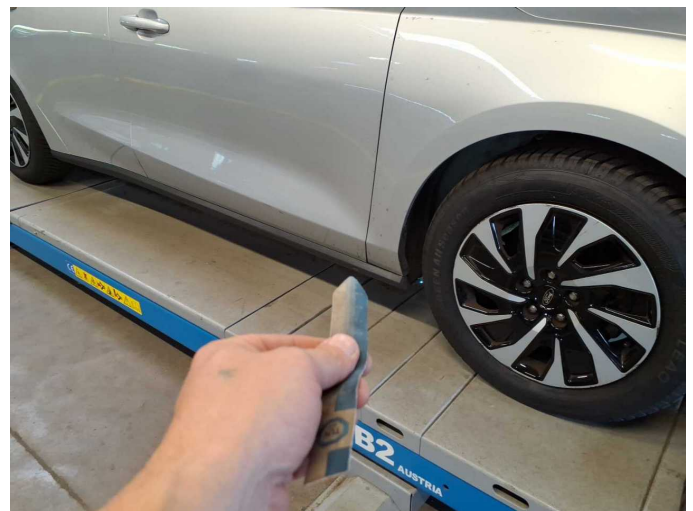
Accident 2: Side right

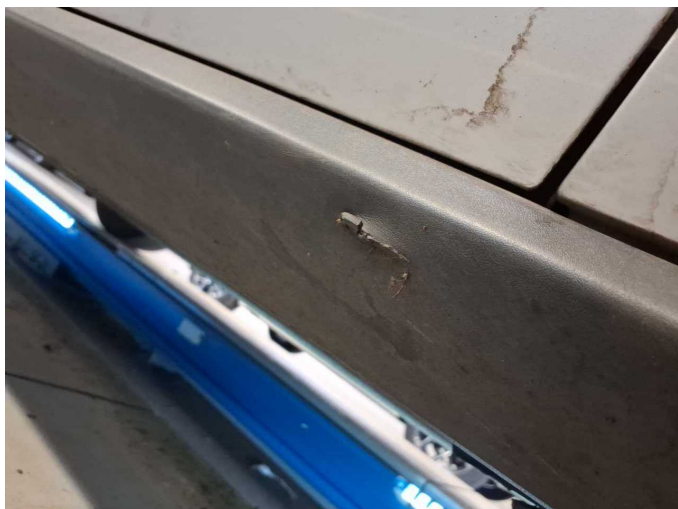
Accident 2: Side right

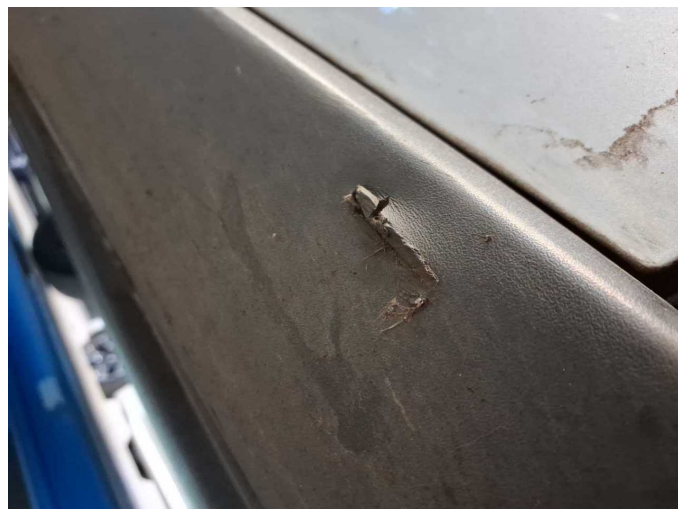
Accident 2: Side right

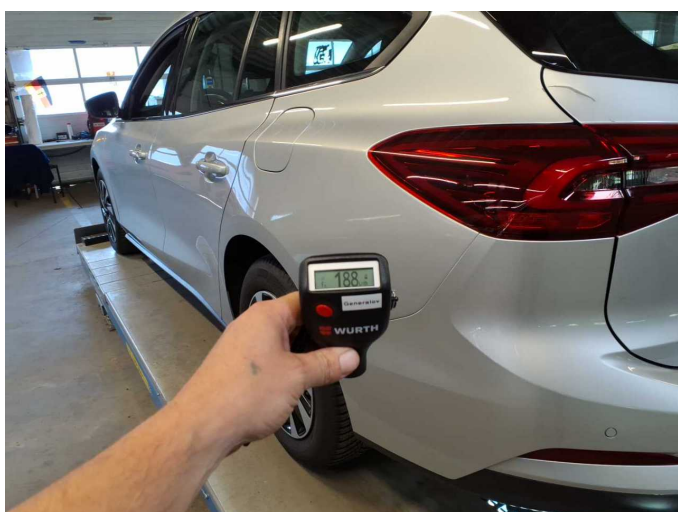
Accident 2: Side right
