Expertise

Protocol number: 46454328  
Order No. / Reference: 26691915  
Inspection date: 9 Jul 2026

Manufacturer: Ford

Model: Mondeo Turnier 2.0 EcoBlue Aut. Titanium

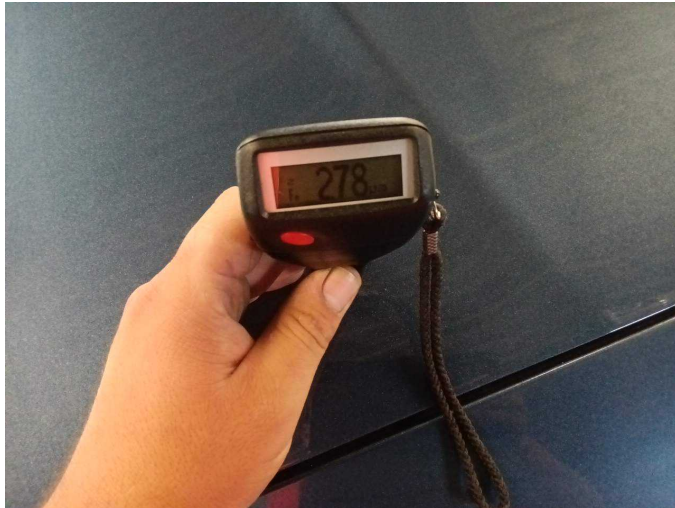
**Bonnet:** 278 µm

**Bonnet:** 278  $\mu\text{m}$
