Expertise

Protocol number: 46494078  
Order No. / Reference: 26488445  
Inspection date: 10 Jul 2026

| Manufacturer: Opel | Model: Astra 1.2 Turbo Start/Stop Sports Tourer Edition |

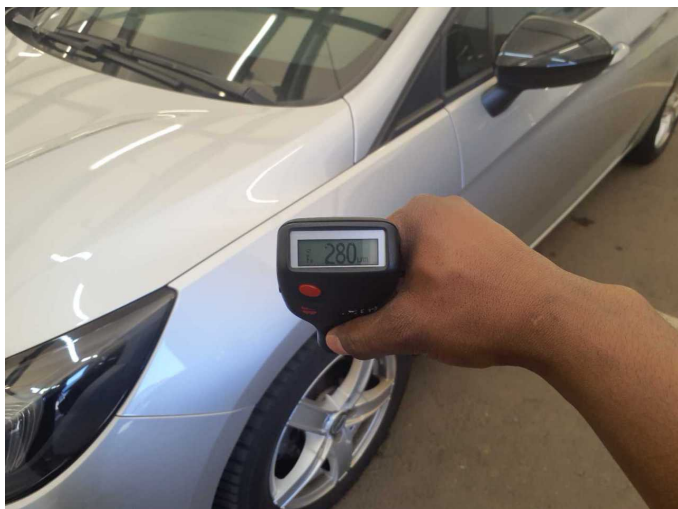
- 3 Roof rail - right side, Professionally carried out, Invoice of repair done Non-existent
- 4 Mudguard - left side, Professionally carried out, Invoice of repair done Non-existent

**Repainting 4:** Mudguard - left side

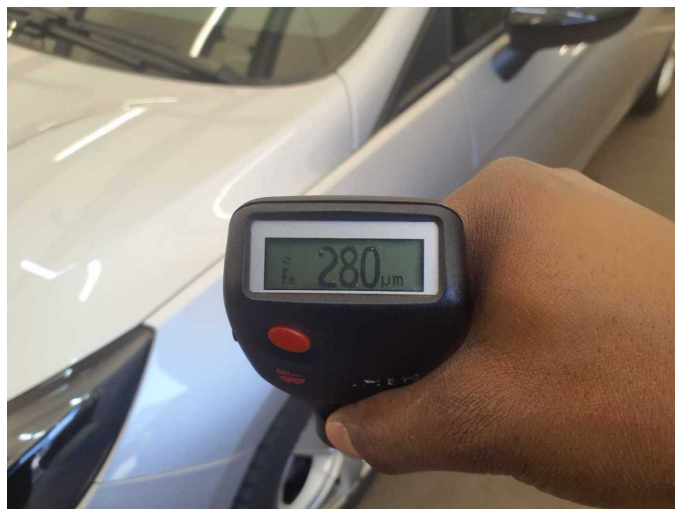
**Repainting 4:** Mudguard - left side

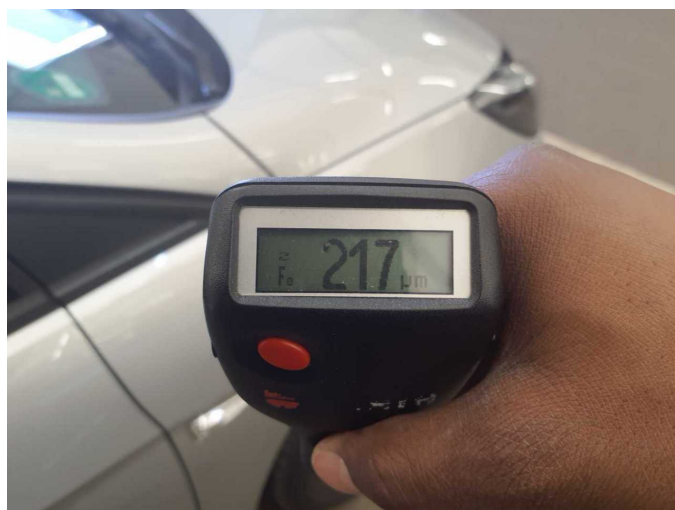
- 5 Mudguard - right side, Professionally carried out, Invoice of repair done Non-existent
- 6 Bonnet, Professionally carried out, Invoice of repair done Non-existent

**Repainting 5:** Mudguard - right side

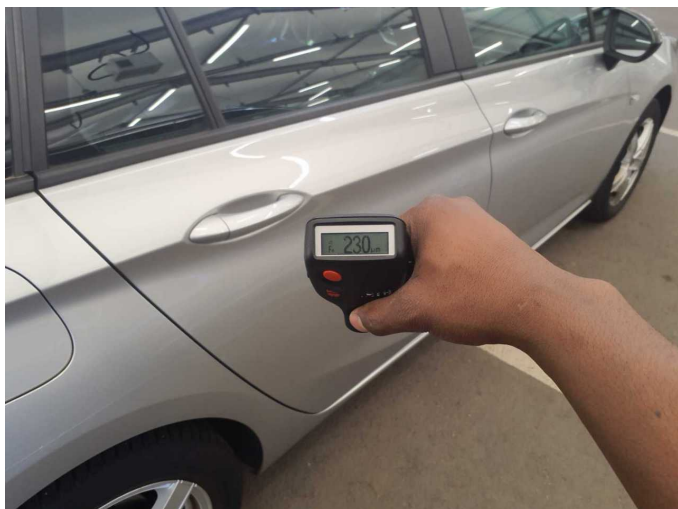
**Repainting 9:** Door - rear left side

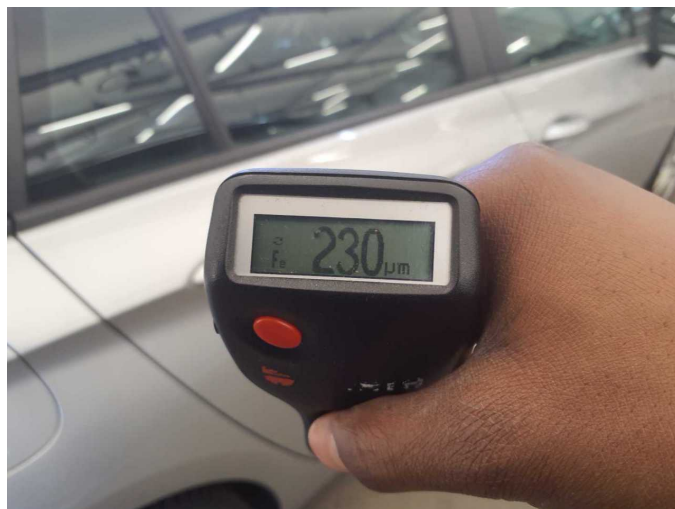
**Repainting 10:** Door - rear right side

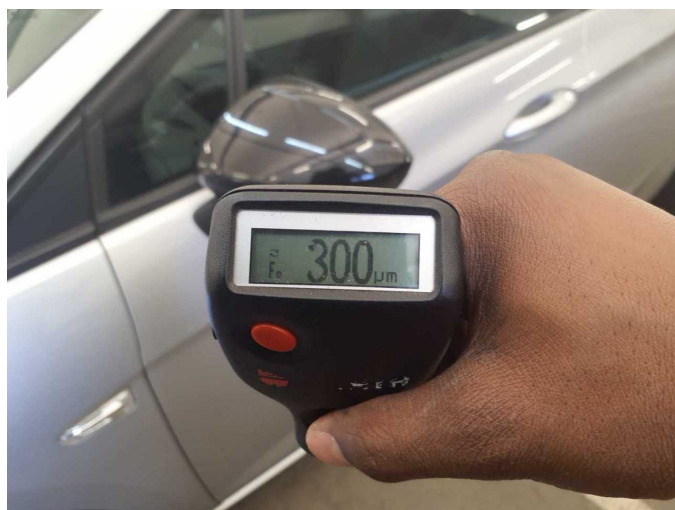
**Repainting 11:** Door - front left side

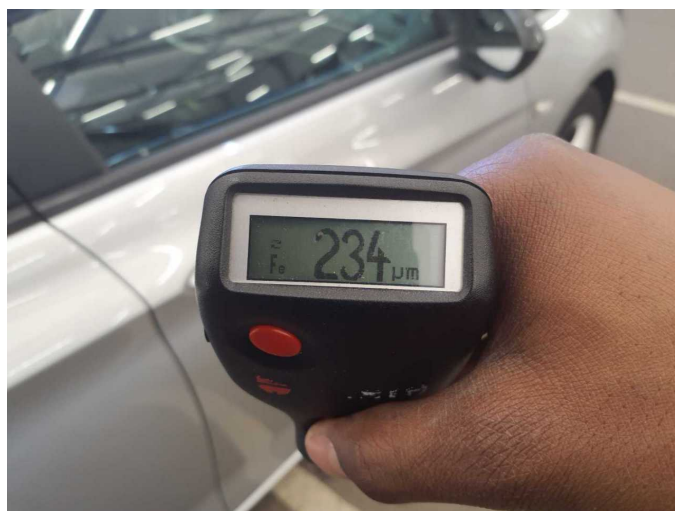
**Repainting 12:** Door - front right side
