Expertise

Protocol number: 45440513
Order No. / Reference: 26104880
Inspection date: 12 May 2026

Manufacturer: Opel

Model: Astra Sports Tourer 1.5 D Automatik Elegance

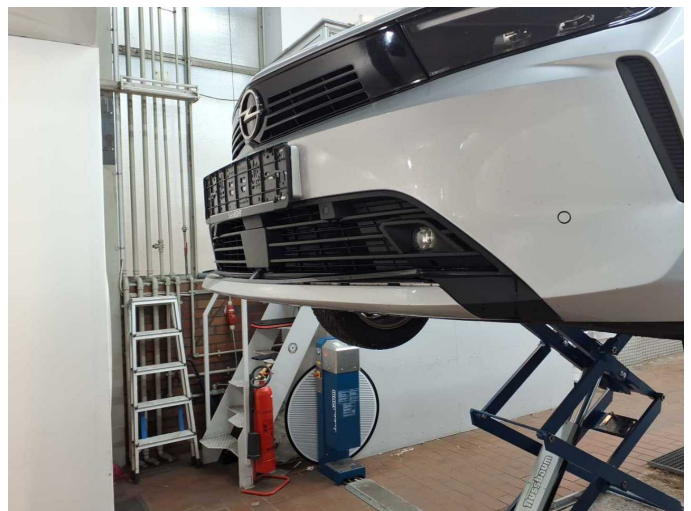
Damage 1: Trim / covers: Brightware / decorative strip - Loose - Repair

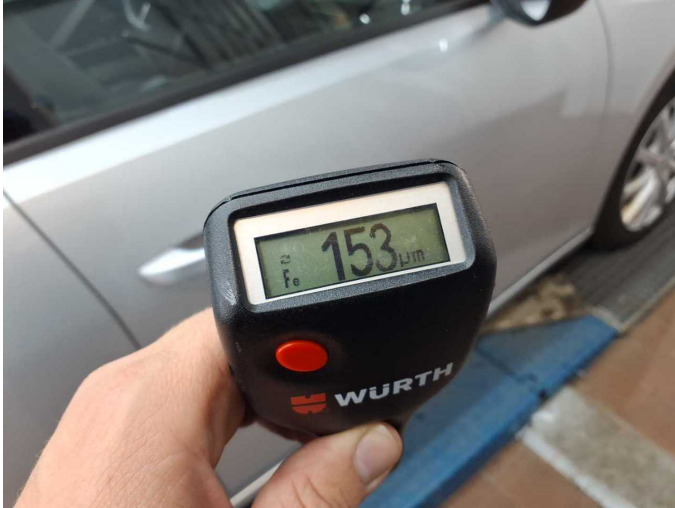
No.	Repainting
1	Side panel - rear left side, Door - rear right side, Professionally carried out, Invoice of repair done Non-existent

Repainting 1: Side panel - rear left side, Door - rear right side
