Expertise

Protocol number: 45786034
Order No. / Reference: 26446372
Inspection date: 2 Jun 2026

Manufacturer: Mercedes-Benz

Model: E 300 e 9G-TRONIC Exclusive

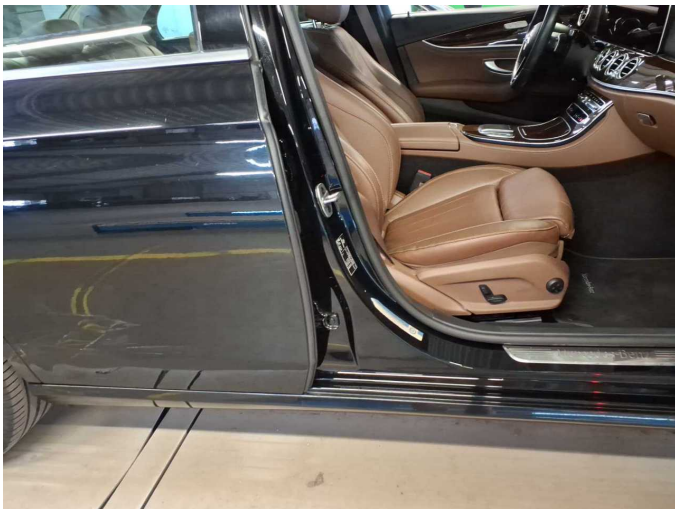
Damage 1: Body: B-pillar - right side - Dent / paintcoat damage - Smart repair

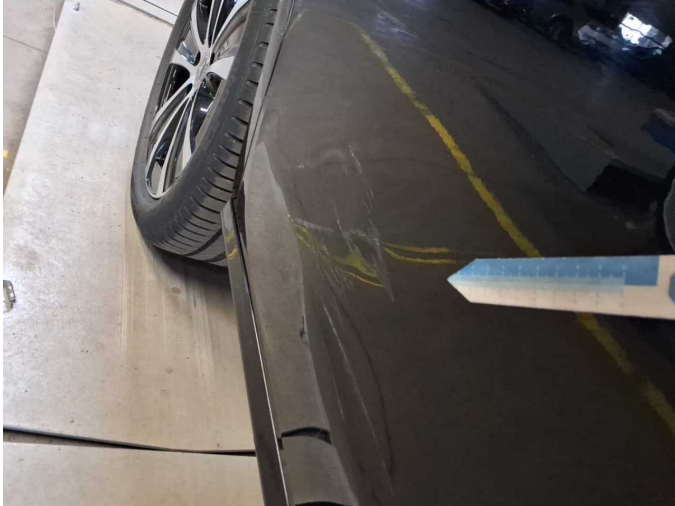
No.	Previous damage	Extent of damage (Net)
1	Rear, Provided by user / customer, from 21 Feb 2026	3.528,55 €
2	Side right, Provided by user / customer, from 3 Jan 2023	4.413,02 €

Accident 1: Side right

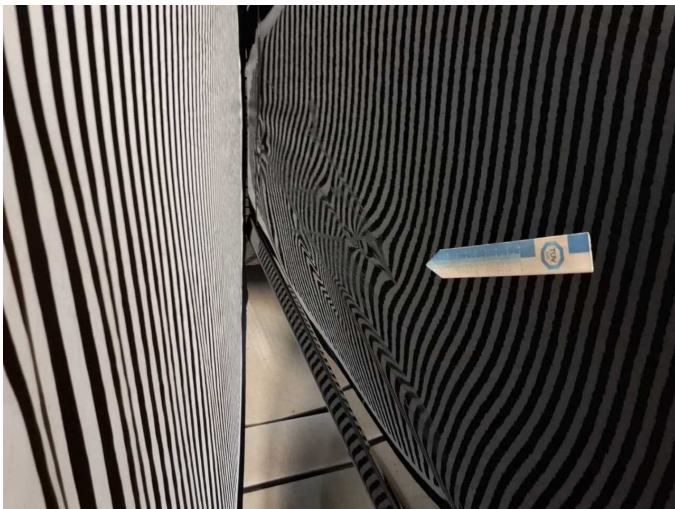
Accident 1: Side right

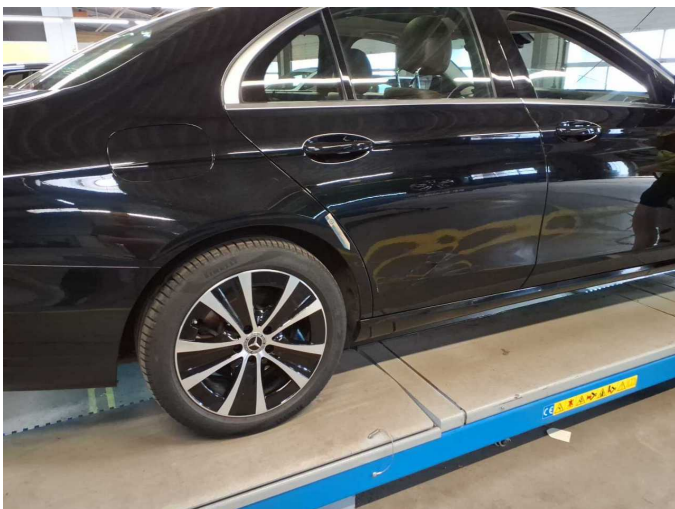
Accident 1: Side right

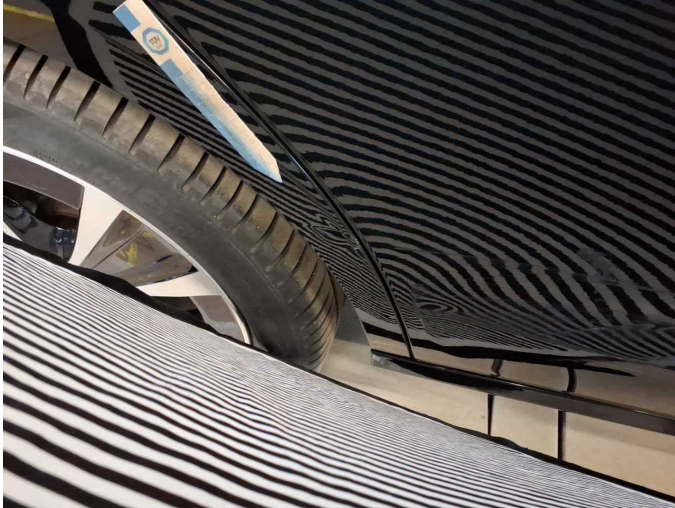
Accident 1: Side right

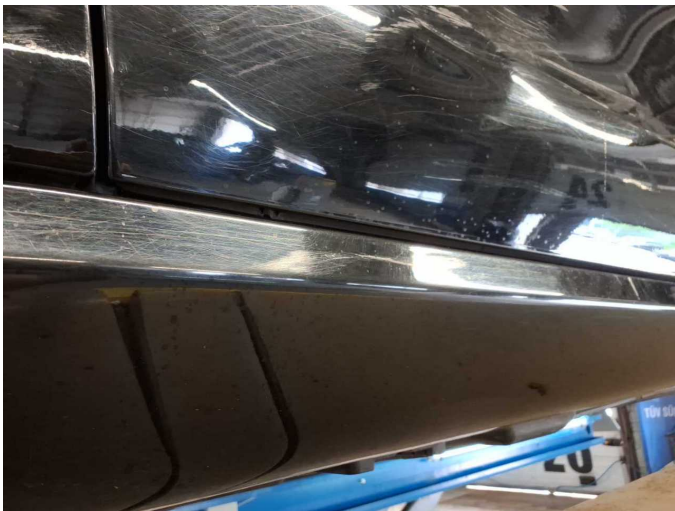
Accident 1: Side right

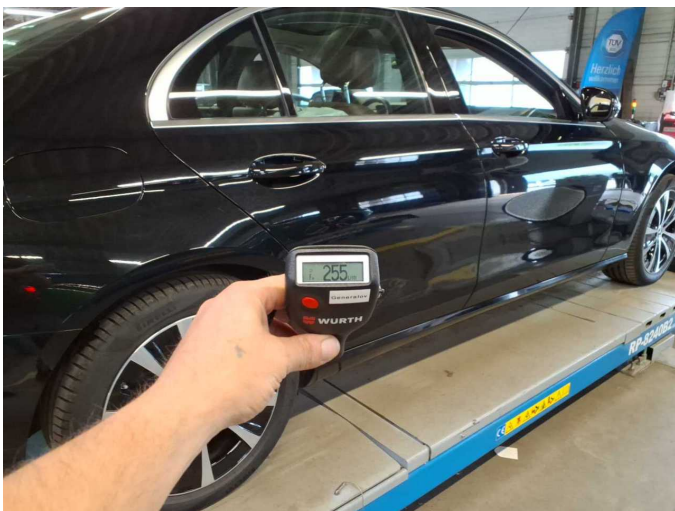
No.	Repainting
1	Mudguard - right side, Professionally carried out, Invoice of repair done Non-existent
2	Door - rear right side, Professionally carried out, Invoice of repair done Non-existent
3	Door - front right side, Professionally carried out, Invoice of repair done Non-existent

Repainting 2: Door - rear right side
