Expertise

Protocol number: 44529452  
Order number / reference: 26003252  
Inspection date: 17 Mar 2026

Manufacturer: Ford

Model: Mondeo Turnier 2.0 EcoBlue Aut. Titanium

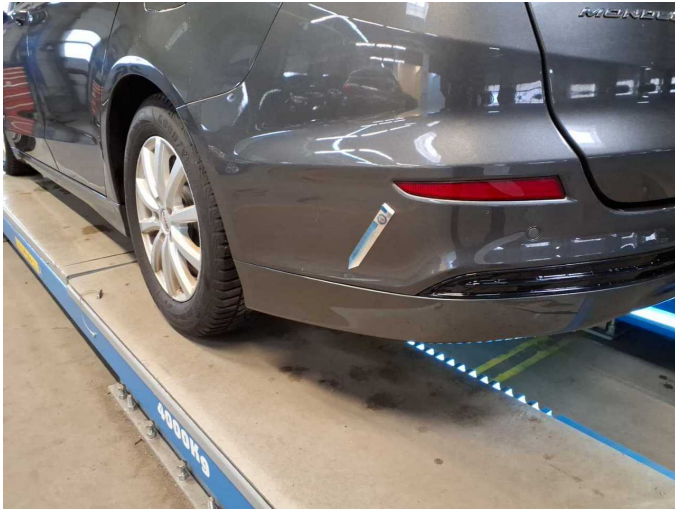
**Accident 1: Side - left**

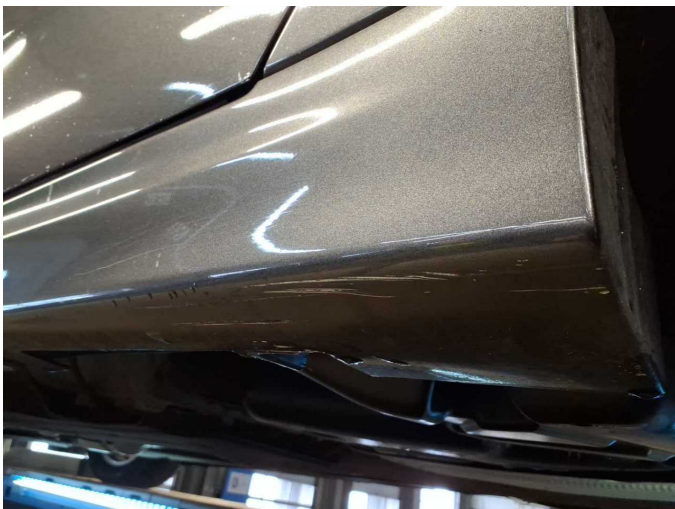
**Accident 1: Side - left**

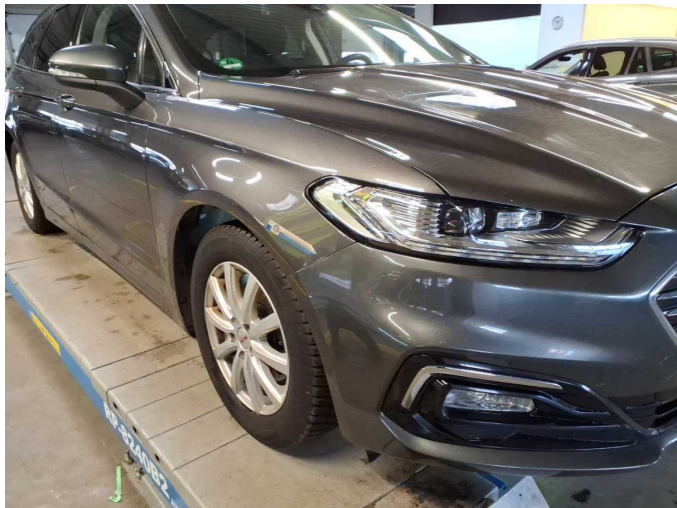
**Accident 1: Side - left**

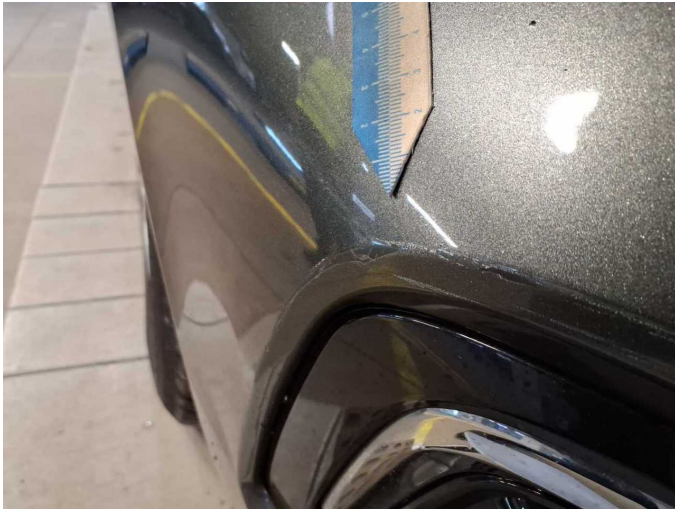
**Accident 2: Front, Side right**

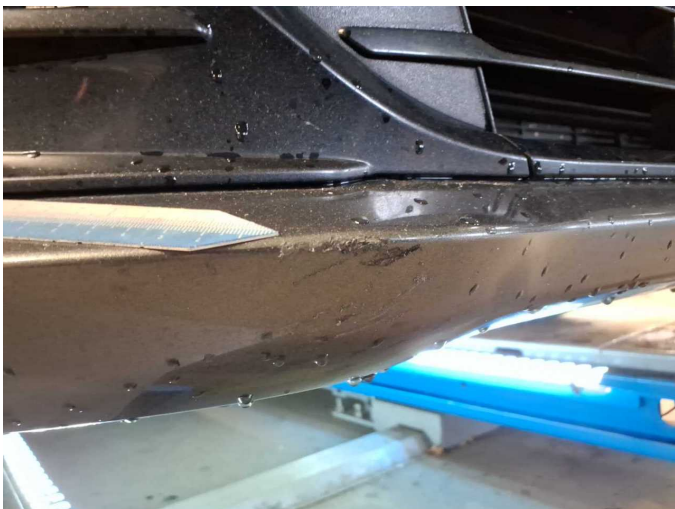
**Accident 2: Front, Side right**
