Expertise

Protocol number: 46536184  
Order No. / Reference: 26649007  
Inspection date: 15 Jul 2026

Manufacturer: Opel

Model: Astra Sports Tourer 1.5 D Automatik Elegance

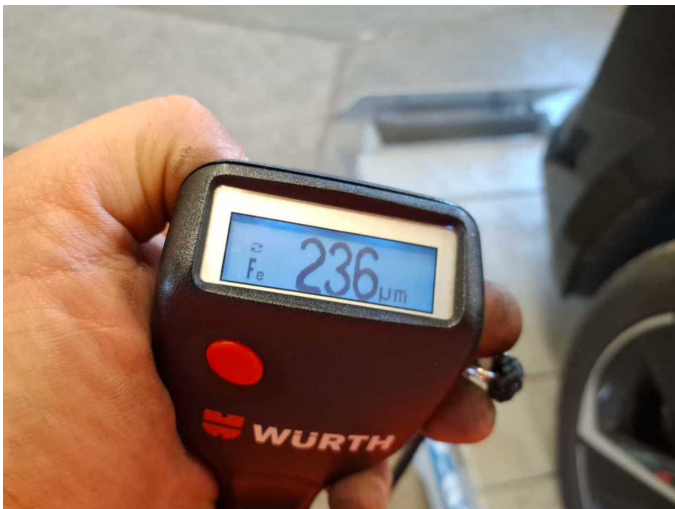
**Repainting 1:** Mudguard - left side
