Expertise

Protocol number: 45905125
Order No. / Reference: 26487907
Inspection date: 11 Jun 2026

Manufacturer: Volvo

Model: XC60 T8 AWD Recharge Geartronic R-Design

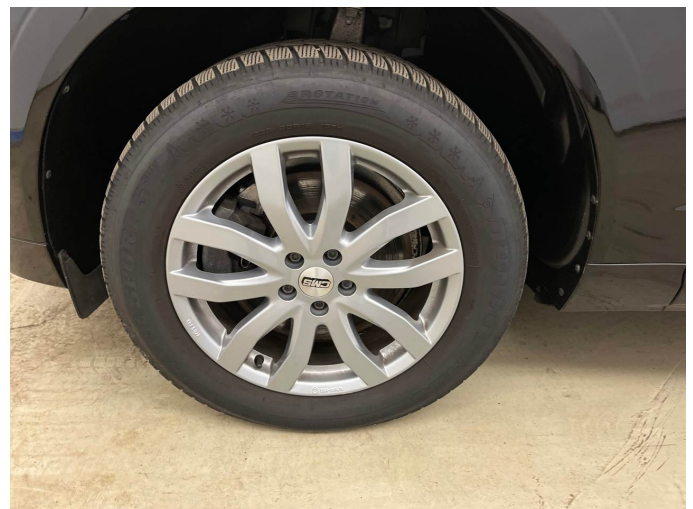
Figure 12: Mounted tyres

- Für den montierten Radsatz wurde kein Nachweis erbracht.
- Winterradsatz ist kein Bestandteil des Auslieferungsumfangs.
