Expertise

Protocol number: 45232666  
Order No. / Reference: 26006377  
Inspection date: 14 Apr 2026

Manufacturer: Skoda  
VIN: TMBJJ8NX0PY076190

Model: Octavia Combi 2.0 TDI DSG Tour

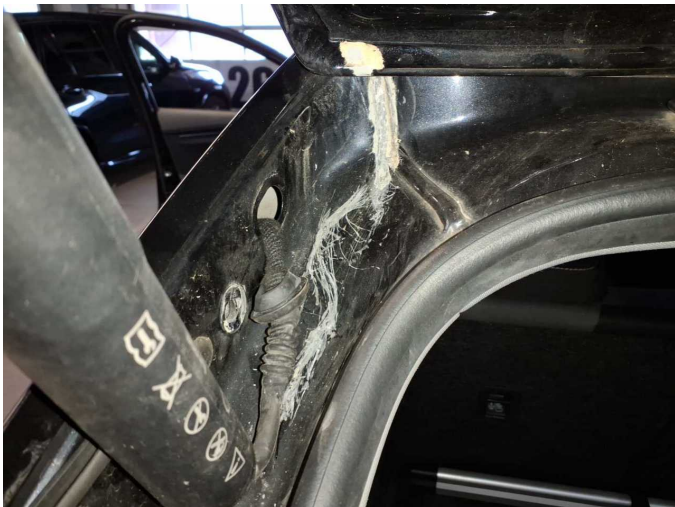
**Damage 17:** Boot lid / rear door: Gas pressure damper (Motor, links + Halterinkl. inkl. Halter) - Loose - Replace

| No. | Component group | Description |
|---|---|---|
| 17 | Boot lid / rear door | Gas pressure damper (Motor, links + Halterinkl. inkl. Halter) - Loose - Replace |

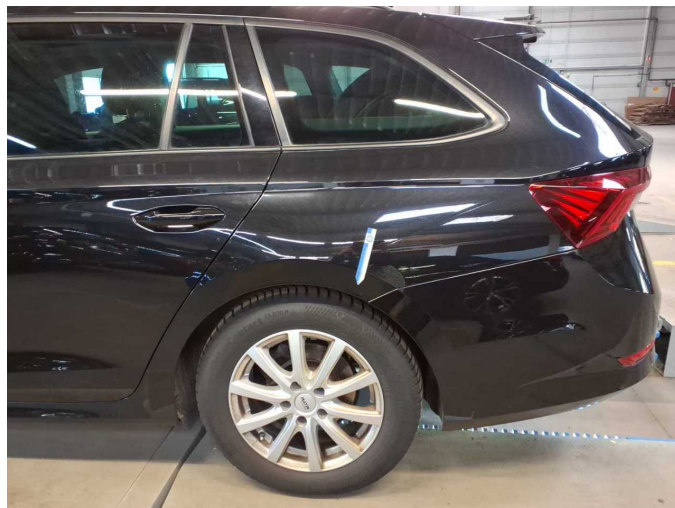
**Damage 20:** Side panel - rear left side: Side panel - Dent / paintcoat damage - Repair and paint

| No. | Component group | Description |
|---|---|---|
| 20 | Side panel - rear left side | Side panel - Dent / paintcoat damage - Repair and paint |

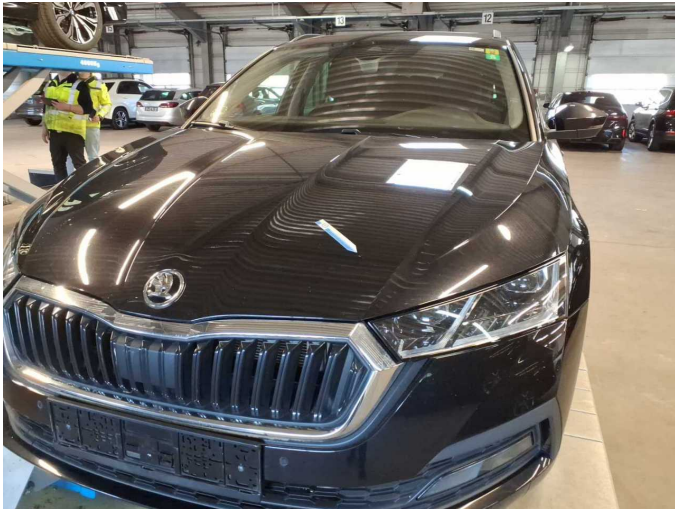
**Damage 22:** Bonnet: Bonnet (Verformt) - Dent / paintcoat damage - Repair and paint

| No. | Component group | Description |
|---|---|---|
| 22 | Bonnet | Bonnet (Verformt) - Dent / paintcoat damage - Repair and paint |

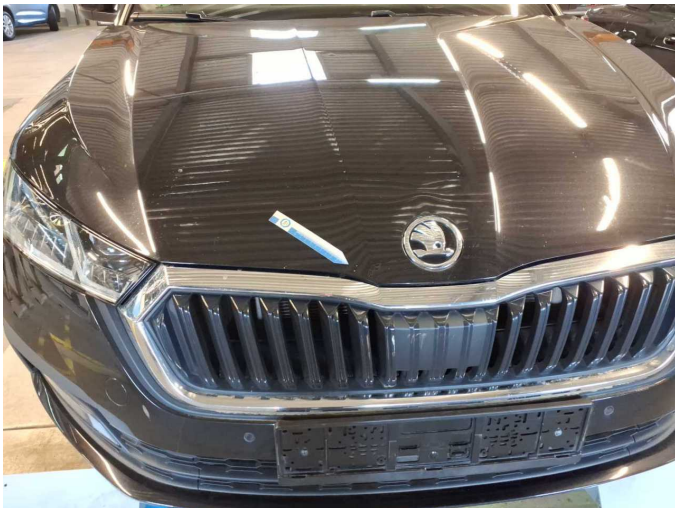
**Damage 22:** Bonnet: Bonnet (Verformt) - Dent / paintcoat damage - Repair and paint

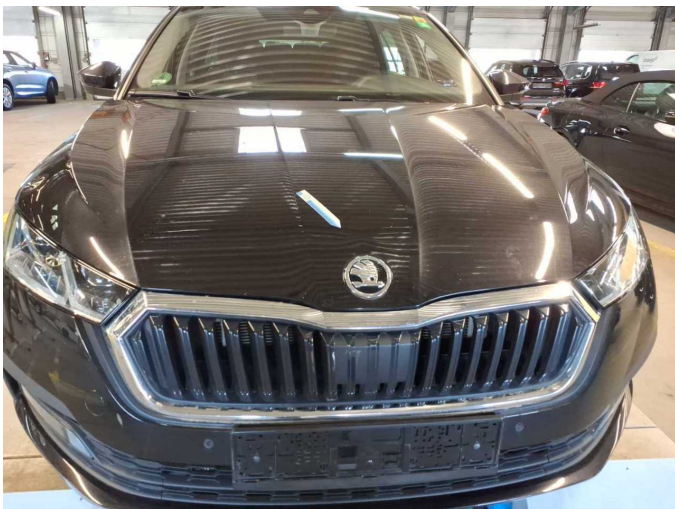
**Damage 22:** Bonnet: Bonnet (Verformt) - Dent / paintcoat damage - Repair and paint

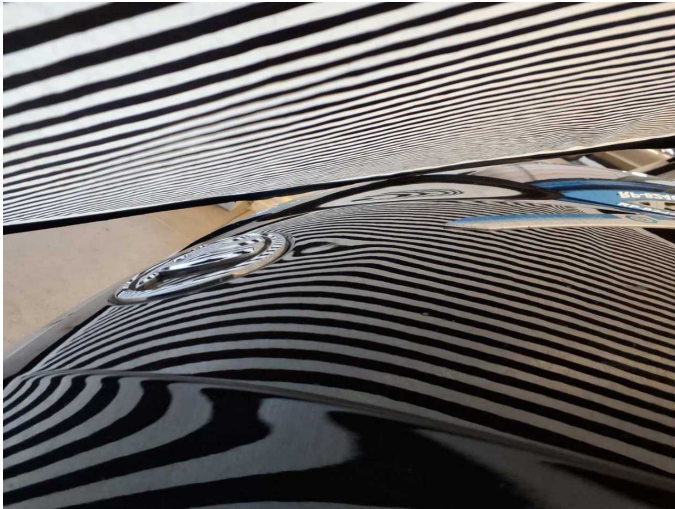
**Damage 22:** Bonnet: Bonnet (Verformt) - Dent / paintcoat damage - Repair and paint

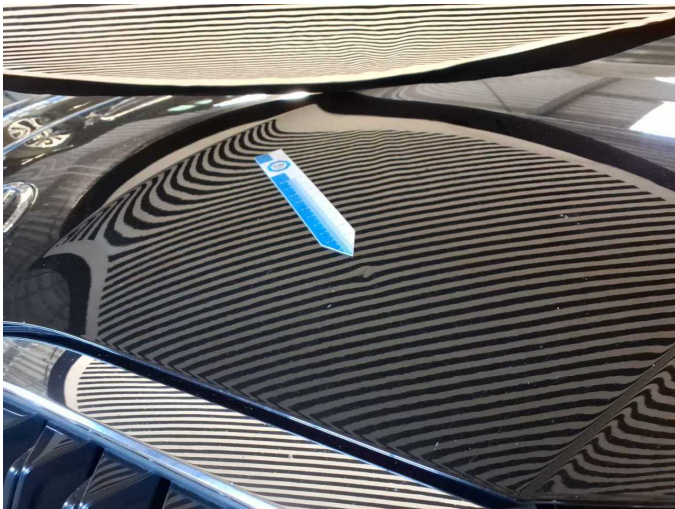
**Damage 22:** Bonnet: Bonnet (Verformt) - Dent / paintcoat damage - Repair and paint

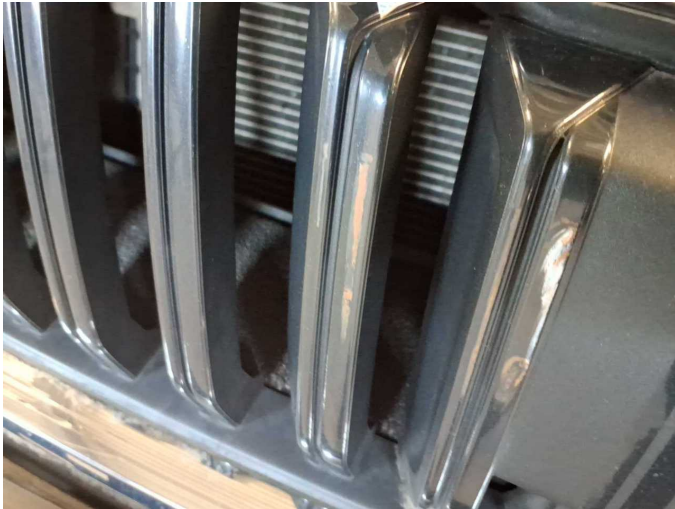
**Wear and tear 4:** Front bumper: Air-inlet grille - Scratched - No deduction

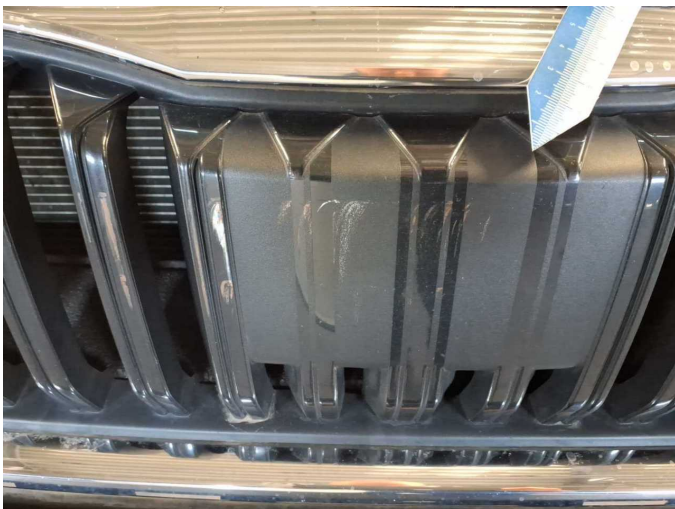
**Wear and tear 4:** Front bumper: Air-inlet grille - Scratched - No deduction

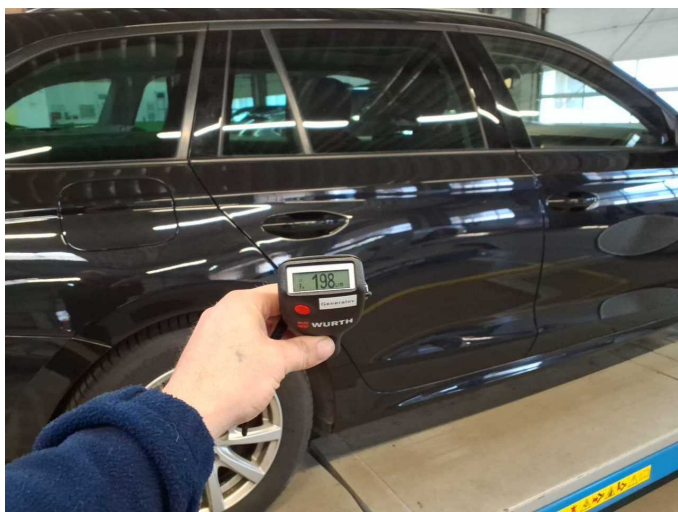
**Repainting 3:** Door - rear right side

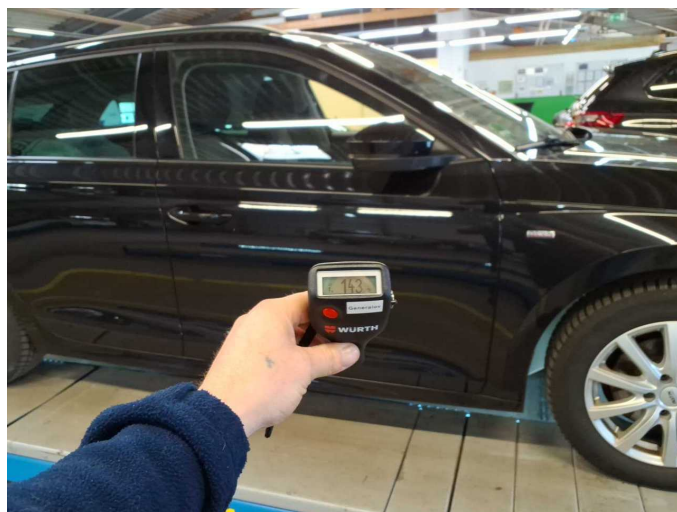
**Repainting 4:** Door - front right side
