Expertise

Protocol number: 46838950  
Order No. / Reference: 26601067  
Inspection date: 28 Jul 2026

Manufacturer: Mercedes-Benz

Model: GLC 300 e 4Matic 9G-TRONIC Avantgarde Advanced

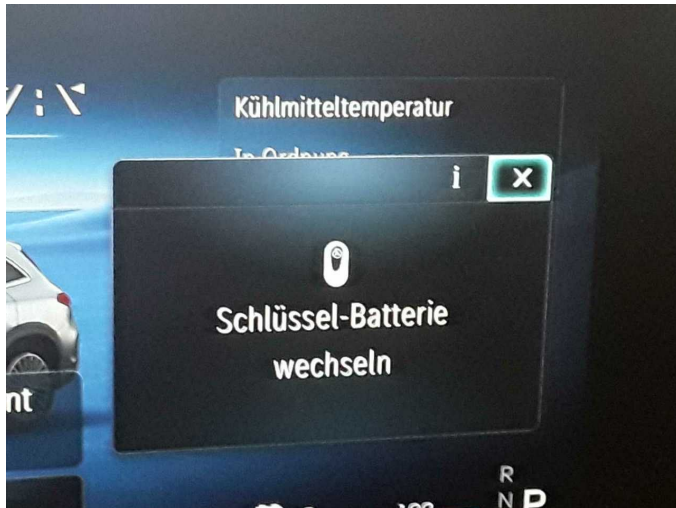
**Damage 1:** Equipment: Vehicle key - Empty - Perform
